# PLATFORM EROSION AT HOPE GAP

Compiled by Uwe Dornbusch (5-5-2006)

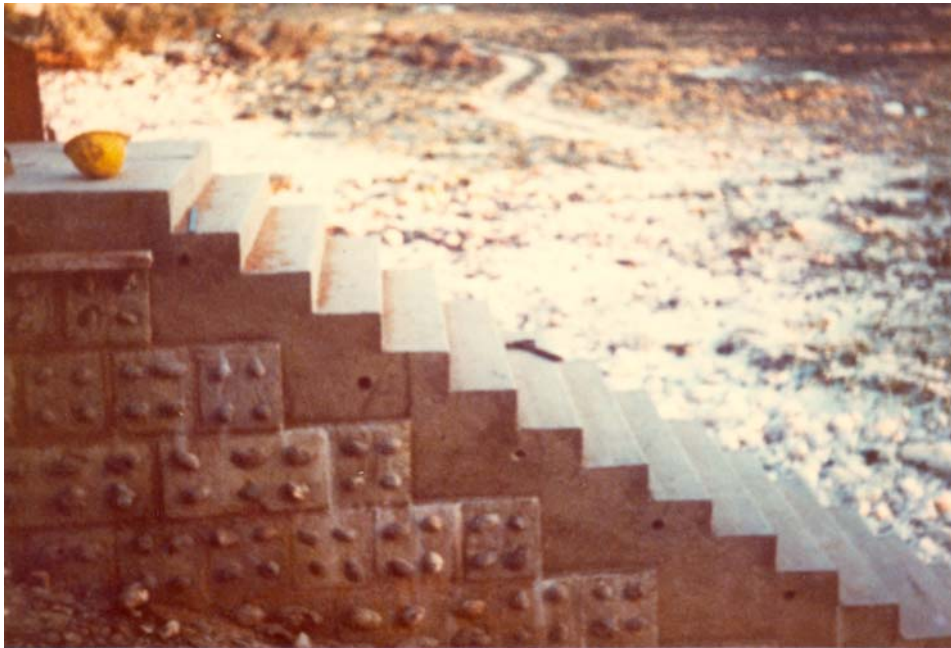
Figure 3: View eastwards across the new steps showing TVT as two parallel white bands in the background (Lewes District Council).

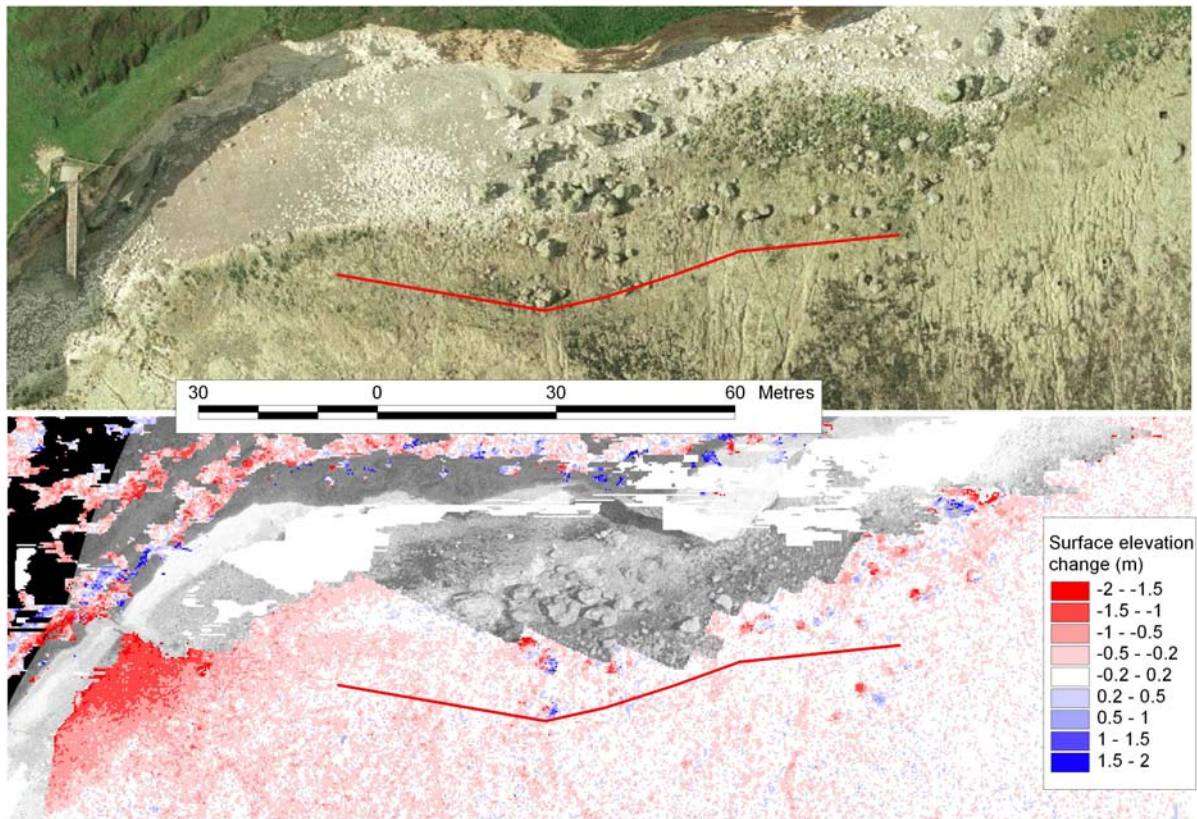
Digital elevation models were created from the air photographs taken in 1973 and 2001. The result can be seen in Figure 5. There is little indication that the TVT have eroded more than the surrounding chalk. The lowest lying area immediately south of the steps seem to have eroded more than the platform further east though most of the erosion in the vicinity of the steps is related to beach level changes.

Figure 5: Cliff and shore platform east of Hope Gap steps. Top: 2001 orthophoto with TVT weakly visible just south of the red line (curving corresponds to that shown in Figure 3). Bottom: Elevations differences overlain over 1973 orthophoto and the red line in the same place.

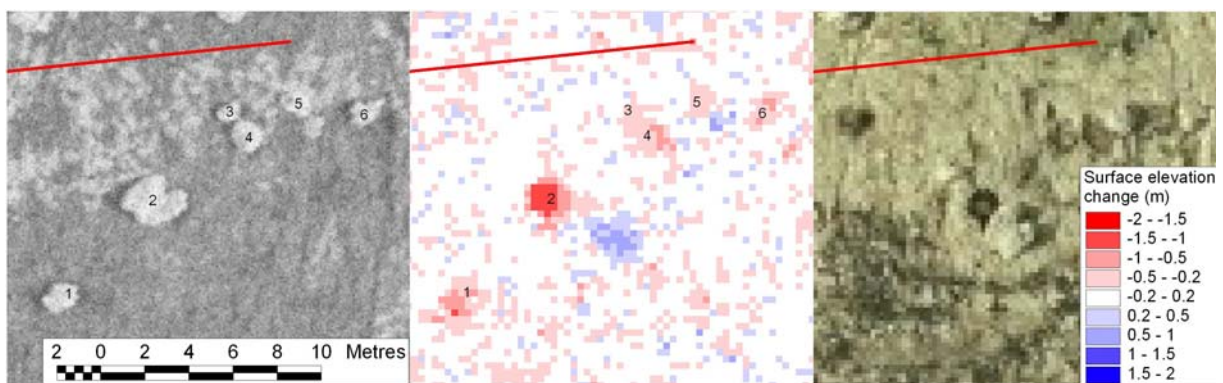
The most interesting feature as the clusters of red and blue north of the red line and to the south at its eastern end. Figure 6 shows in detail how some block seem to have moved over short distances (block 2 has moved ~3.7m to the south east) while others (e.g. block 1) have either moved much further or have broken up. Blocks 3, 4 and 5 were located in 1973 on the southern TVT so either they have moved by 1979 or they were moved away by the excavator.

Figure 6: Detail of platform elevation change at the eastern end of the red line in Figure 5.

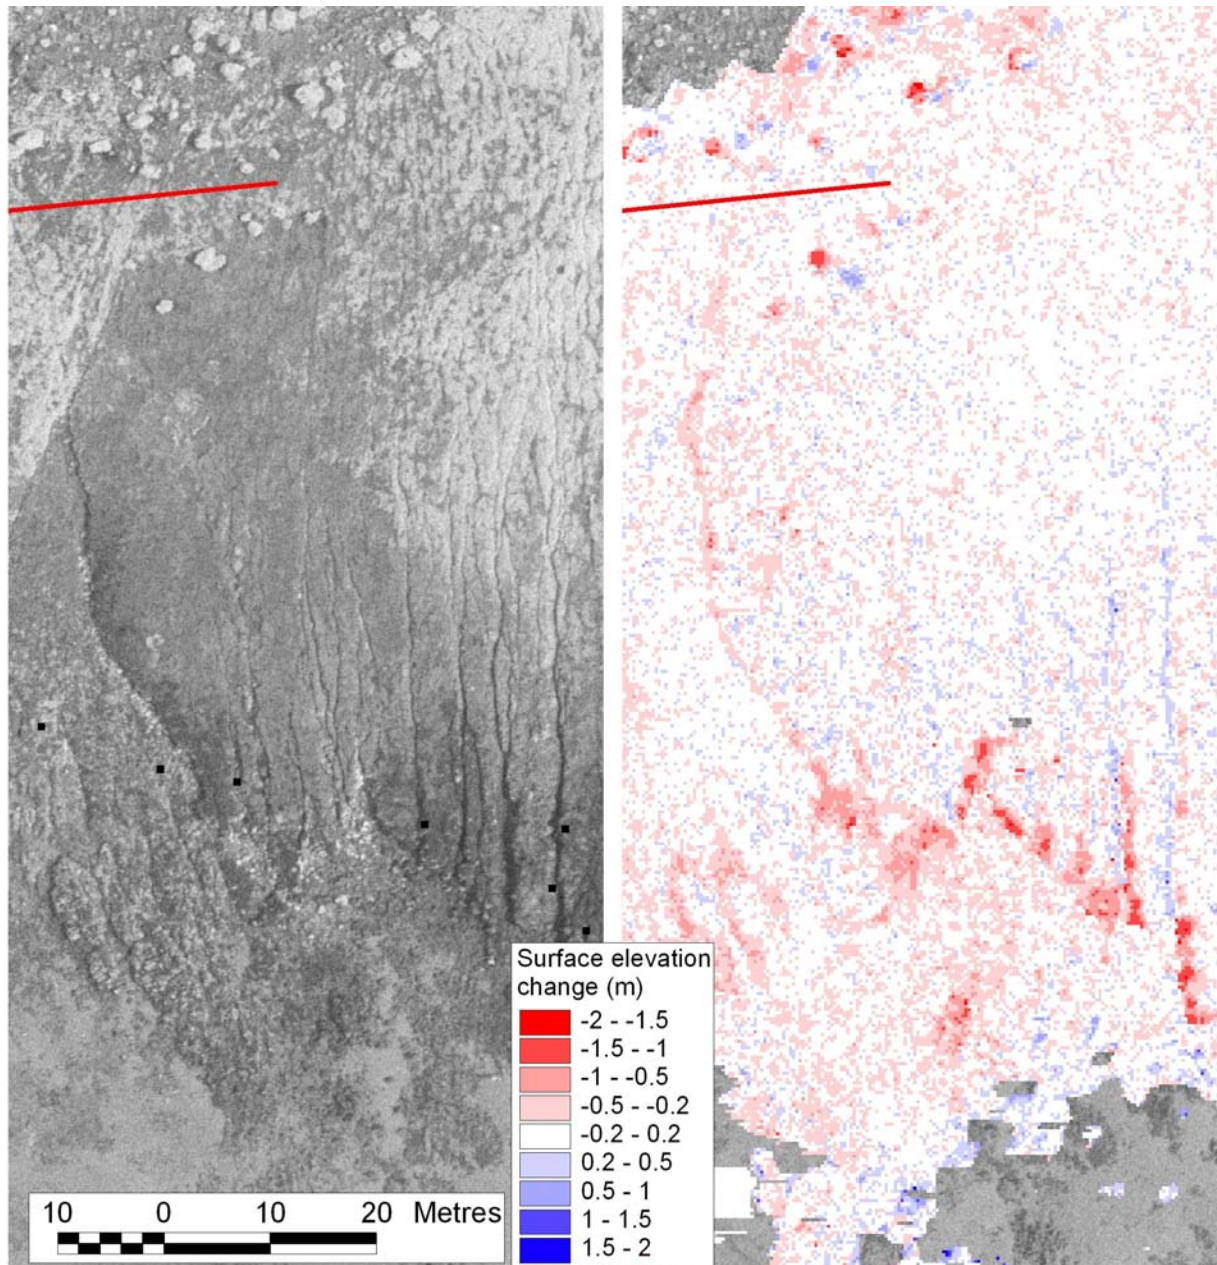
The concentration of erosion along steps and runnels can be seen in Figure 7.

Figure 7: Erosion along steps and runnels. Left: 1973 orthophoto. Right: Surface elevation differences.
