Water Leak Project

Background

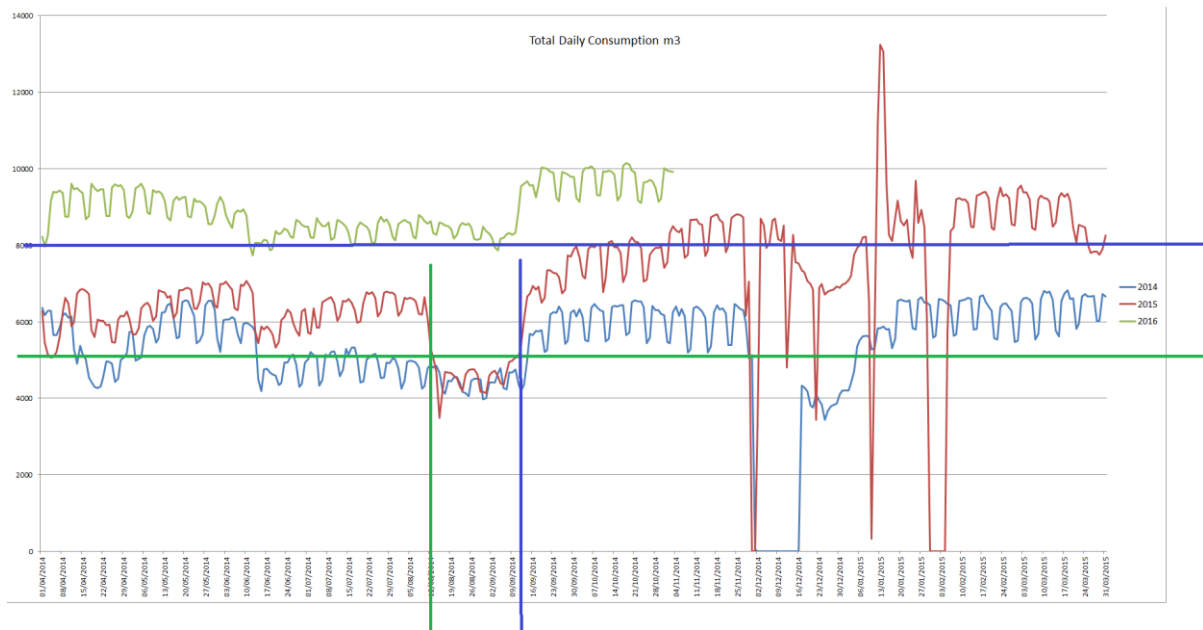
We have been fortunate to date with free access to water flow data, provided by Southern Water. This data is the instantaneous water flow every 15mins, which has been turned into a volumetric scale and presented below. On this graph I have overlaid the last 3 years of water usage from 2014 to date, which clearly shows an increase in usage.

Note: The green vertical line is the moment that the last sizable water leak broke ground at Aisin Seiki and the horizontal green line is the historic baseline consumption, during term time. The blue vertical line, whilst being the start of the academic year, it also shows the signs of increased leaks on the system. The blue horizontal line is the current baseline and the potentials for savings (potentially 3,000m3).

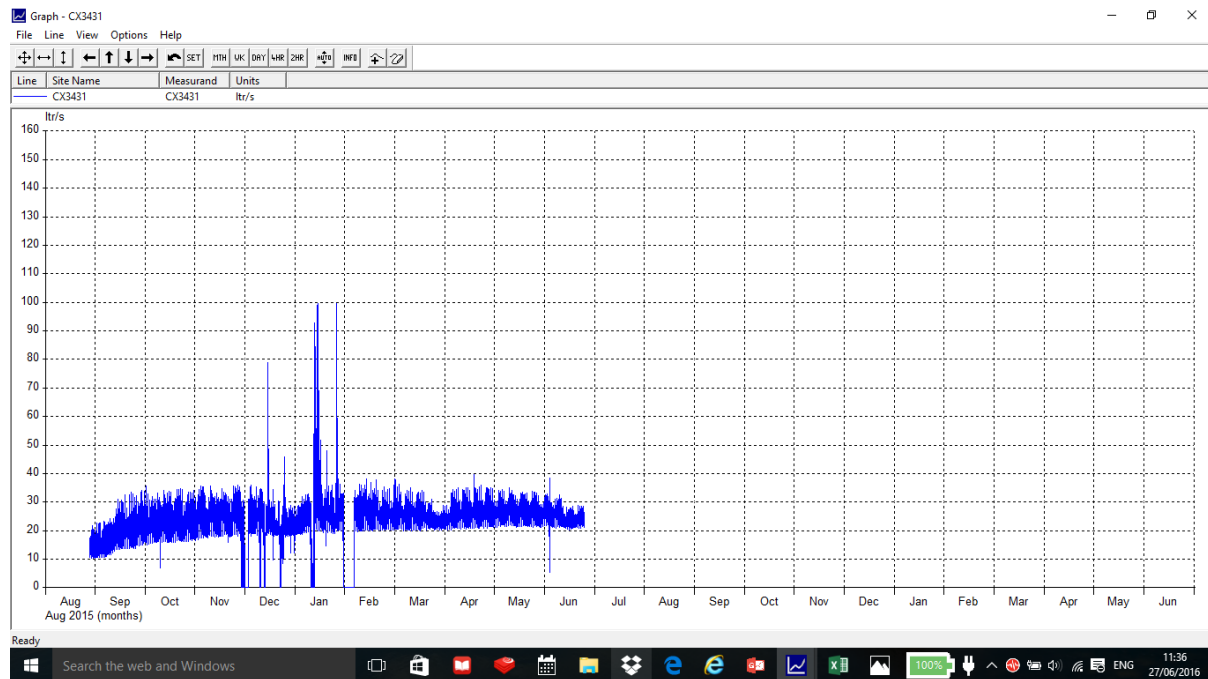
University of Sussex – Revenue flow meter – Graph of current flows (Litres / second) - 24th June 2016

This flow graph shows the growth in water use from August 2015 to the initial download in June 2016.

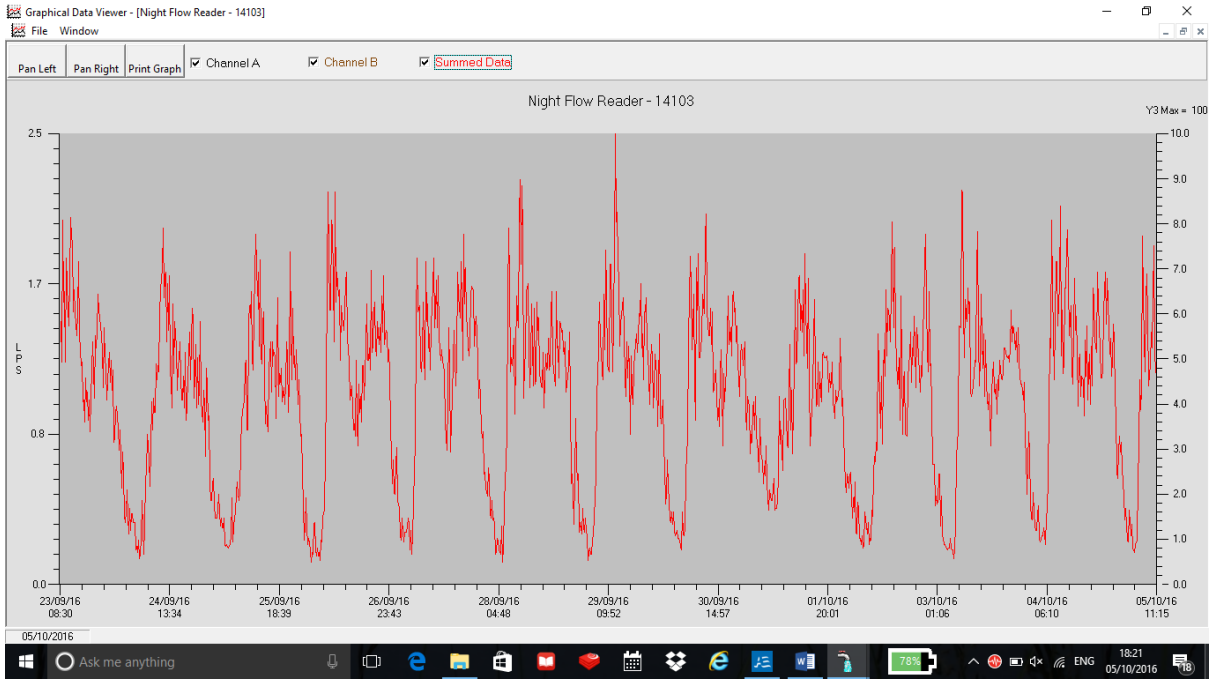
East Slope Residence Flow meter

One of the sub meter loggers was moved to the East slope residence meter, although this does show some night use, this is not the significant leakage that is occurring on site. This was in response to significant continuous flows observed in the drainage close to the meter location.

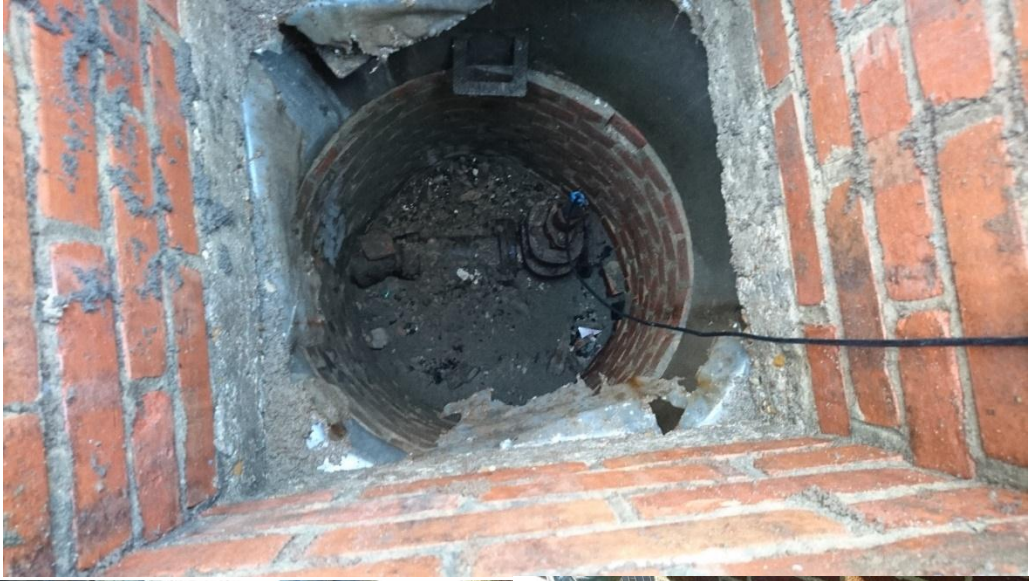
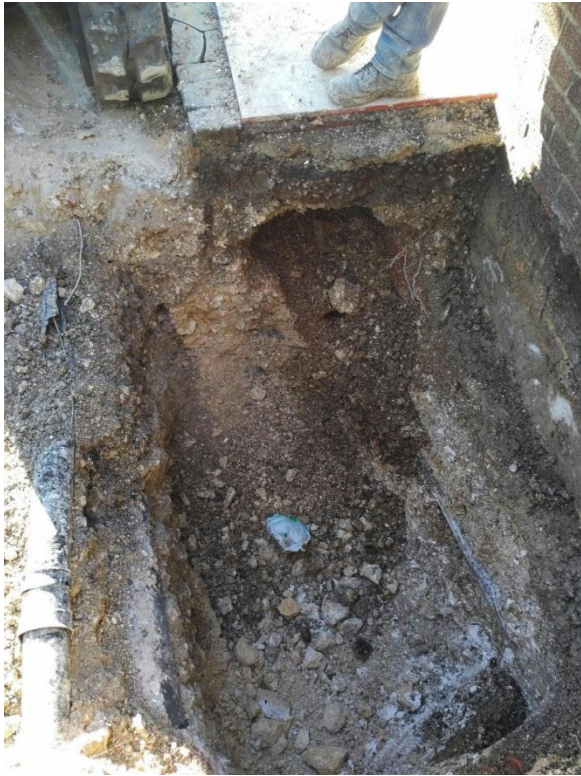
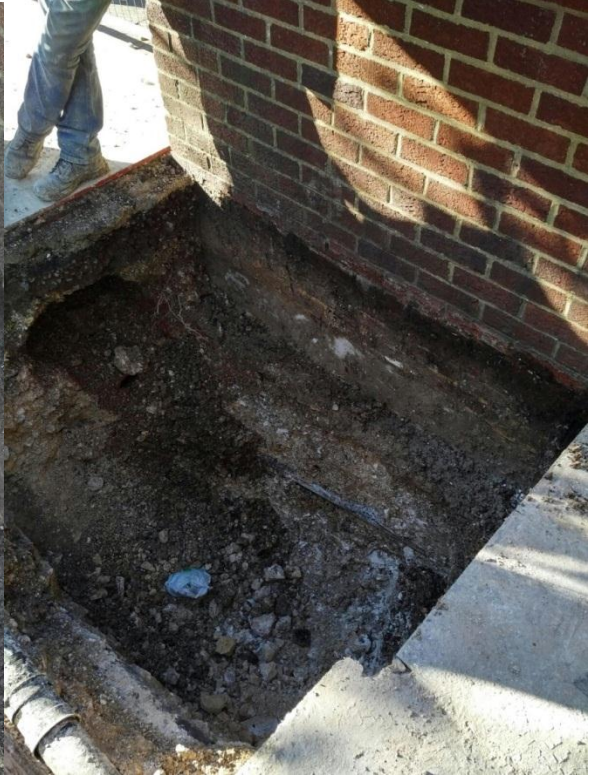
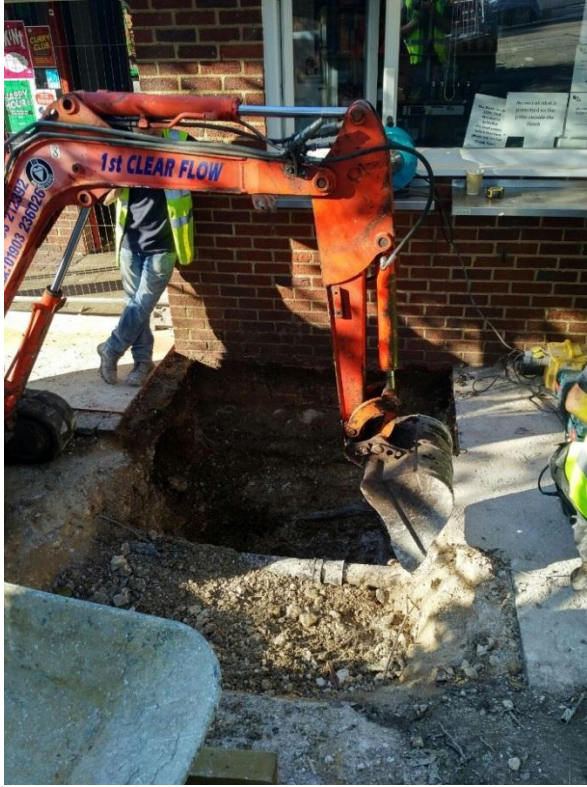
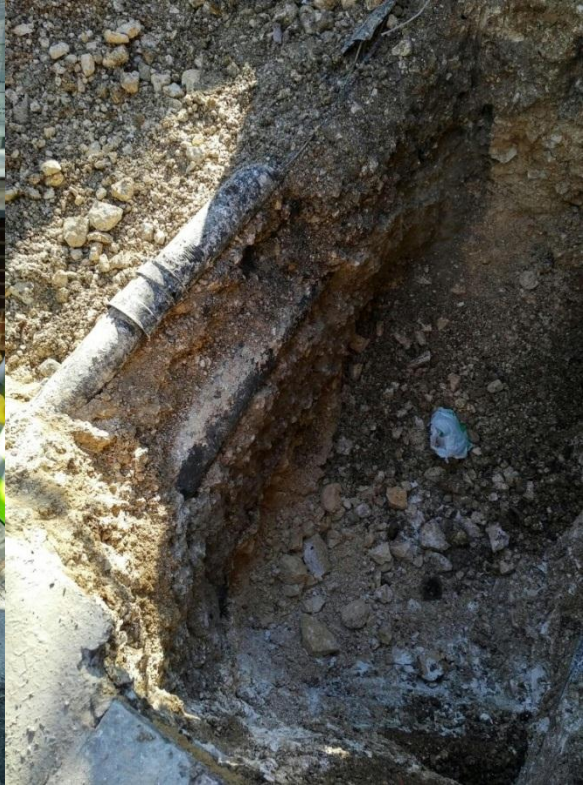
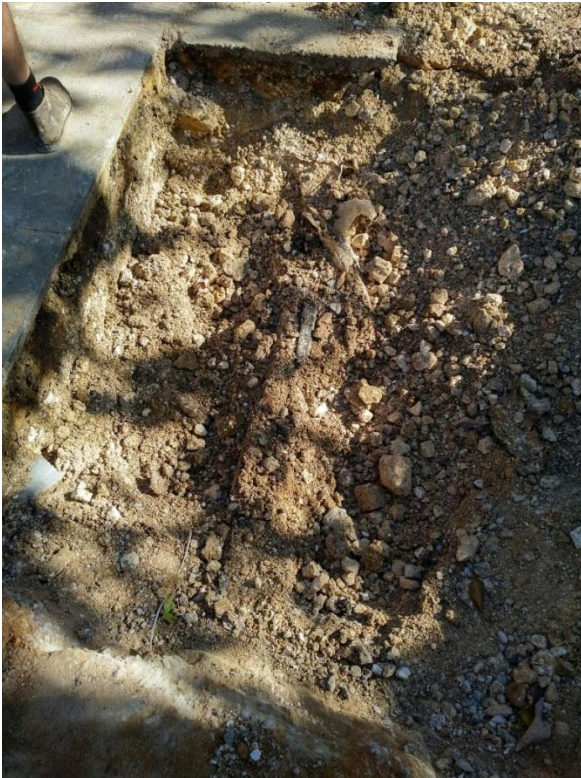
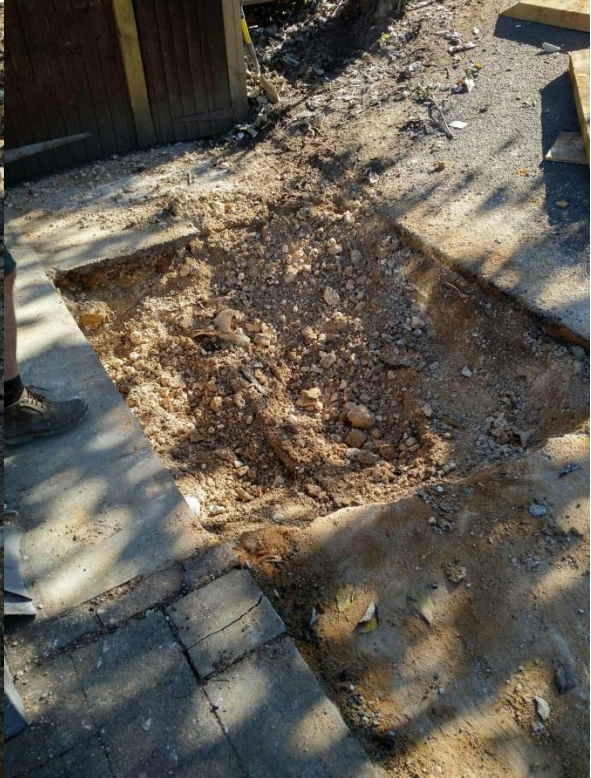
Appendix C – East slope mains leak location Photographs

From the leakage investigations undertaken these culminating in the leak noise correlations, a leak was discovered on the water main in the eastern verge of Refectory Road / East Slope car park and up to the East Slope residence meter.

This main is shown in different locations (under the East slope bar (not normal practice), alongside the bar to the southern side and in the East Slope car park). Following the attempted repair of this leak, it has been subsequently determined that the main is under the East Slope bar.

Re-excavation in this area to a greater depth confirmed that the main and location of the leak is underneath the East Slope bar and thus cannot be repaired in the conventional manner. Relaying of the section of the main from valve chamber at the East Slope bar up to the current residences meter location is required to repair this main.

The relocation of the meter on this main should also be made to the bar area to allow complete monitoring of this leg for future system management.

- Relay the East Slope main to remove leakage on this leg.
- Relocate the meter on this main to the bottom of the hill (East Slope bar area) to improve system flow monitoring.

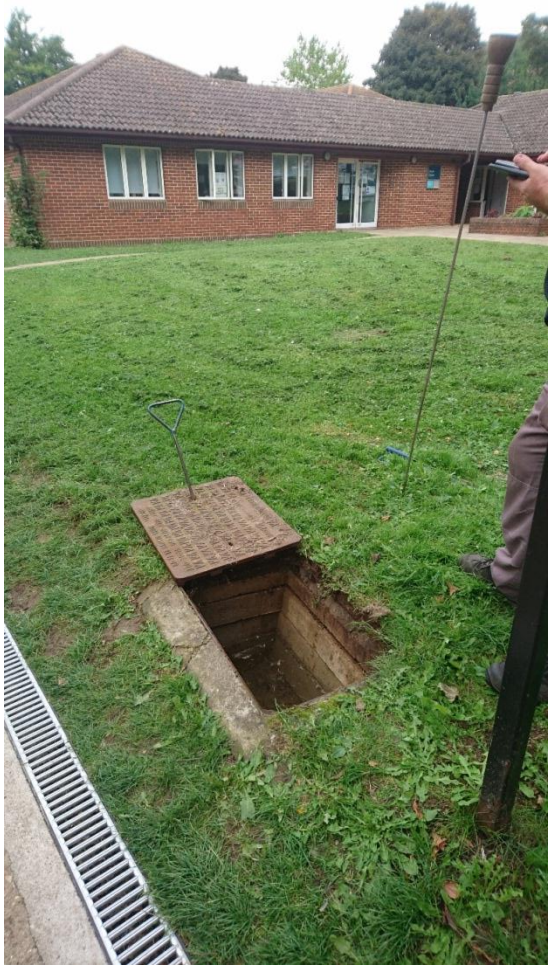
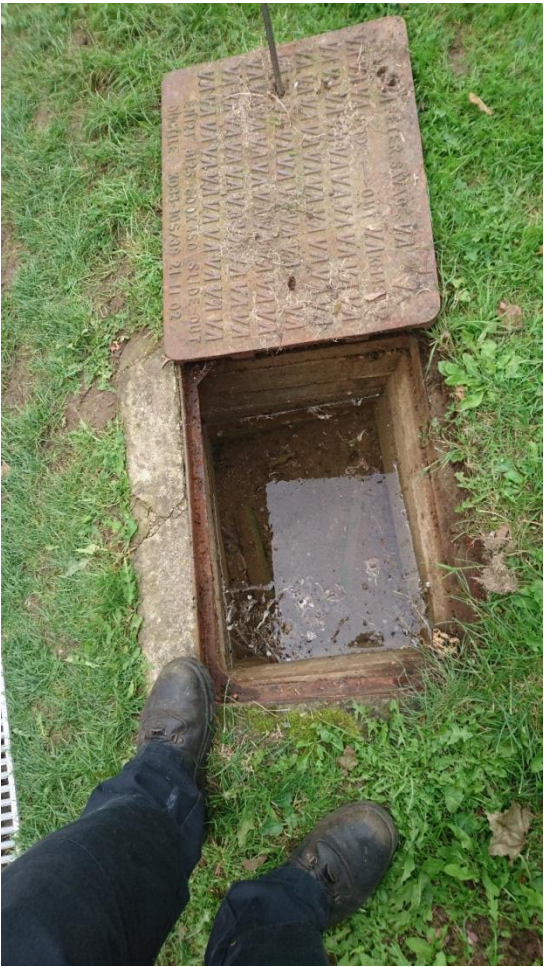
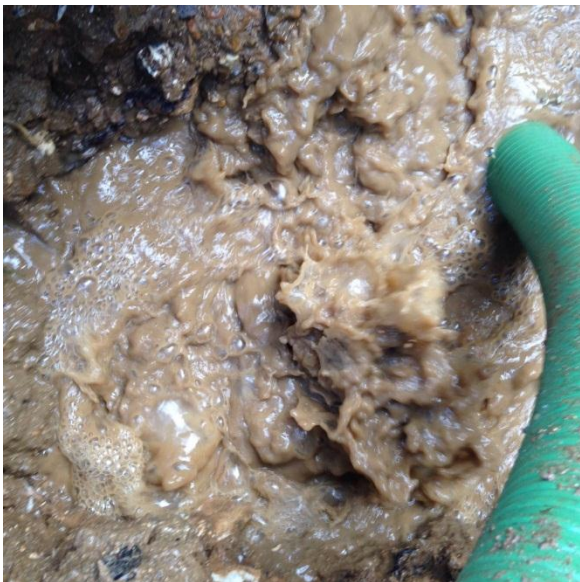
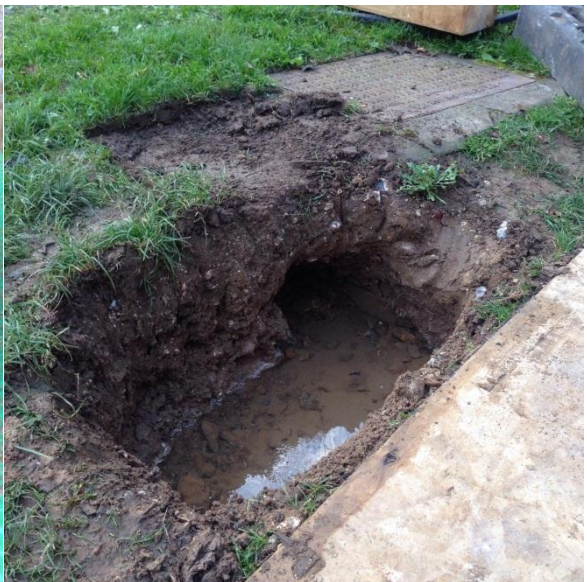
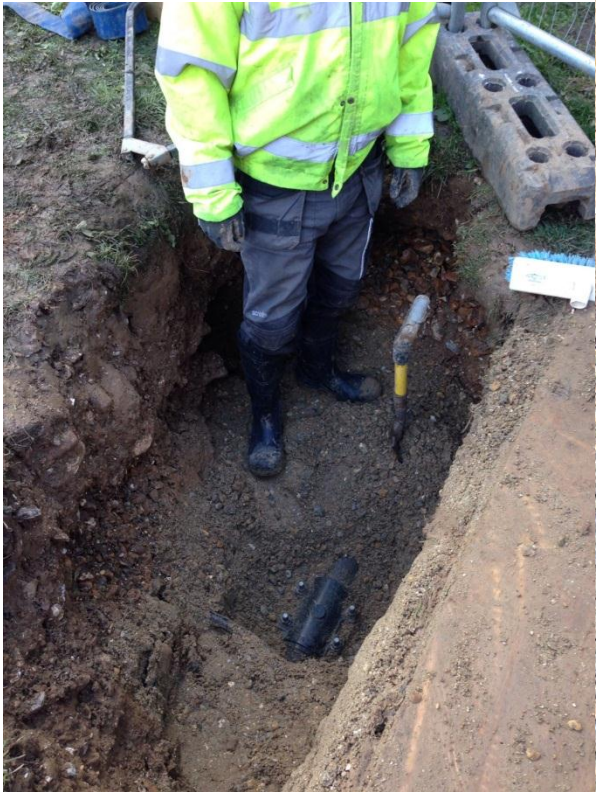
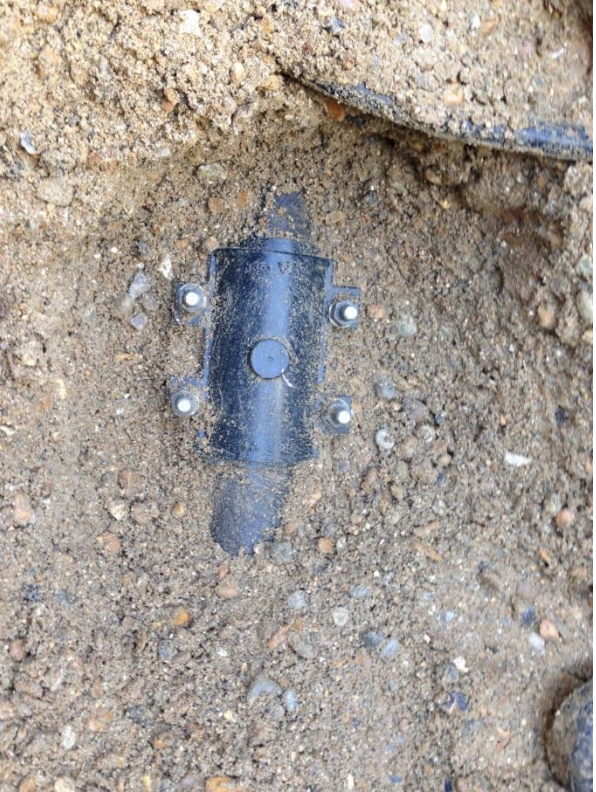
Appendix D – Lancaster House/ Health centre Leak Photographs

Another water leak, which was on the fire main system, was found through sounding equipment and thorough investigation under manhole covers. The located of this leak was at the edge of a chamber housing valves between Lancaster House and the Health Centre, adjacent to a recently replaced Fire Hydrant. This leak was found to be at a shallow depth (approximately 1m) and a conventional leak repair clamp was attached to affect the repair, Photographs are attached in appendix D. The repair to this leak was undertaken on the 11/12th October 2016 and was completed on a live supply because the valves leading up to the leak couldn't be isolated.

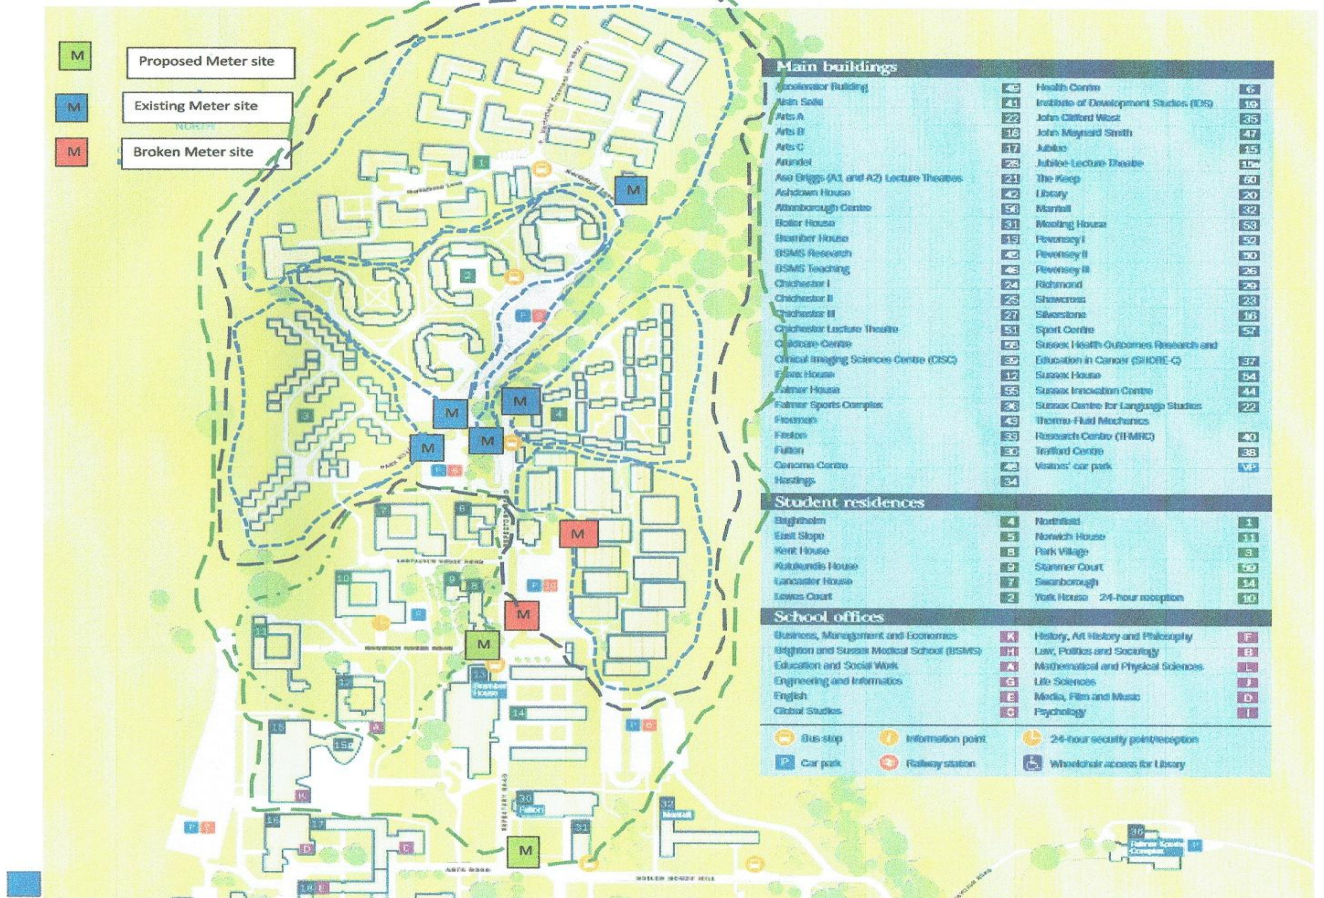
University of Sussex – Falmer Campus – Location of existing meters and proposed meter locations

Further inter system flow meters have been suggested, some are new installations, but some are the replacement of pre-existing meters that are not working. See attached plan in Appendix E

Due to the age and water quality the accuracy and competence of the existing mechanical sub meters is suspect. A good suggest could be the full bore fixed Ultra sonic (Arad Octave units) for the inter system flow meters as they are less susceptible to fouling than mechanical meters.

- Re sweep the feeder mains system to current sub meters to confirm no further leakage on these elements.
- Undertake Leakage control within the residence areas served by the various sub meters to further reduce known leakage - link these to the new installed monitoring system to allow flow balancing. Refer plan in appendix E.
