The University of Sussex

**Geography BSc
Third Year Project
May 2001**

Past and Present Rates of Coastal Chalk Erosion at Peacehaven, Sussex

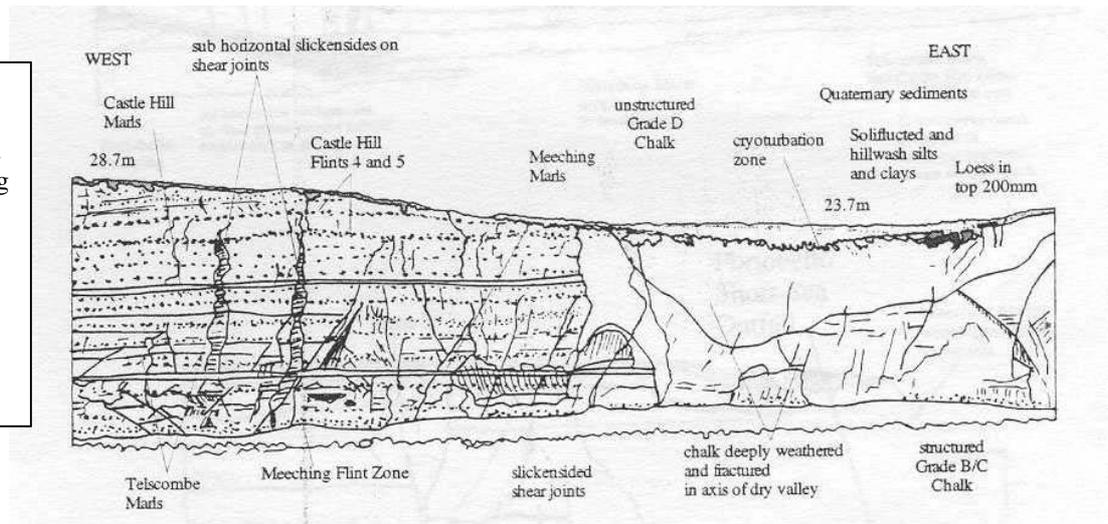
Sketch cross-section of typical weathering profile beneath a small chalk dry-valley west of Bastion Steps.

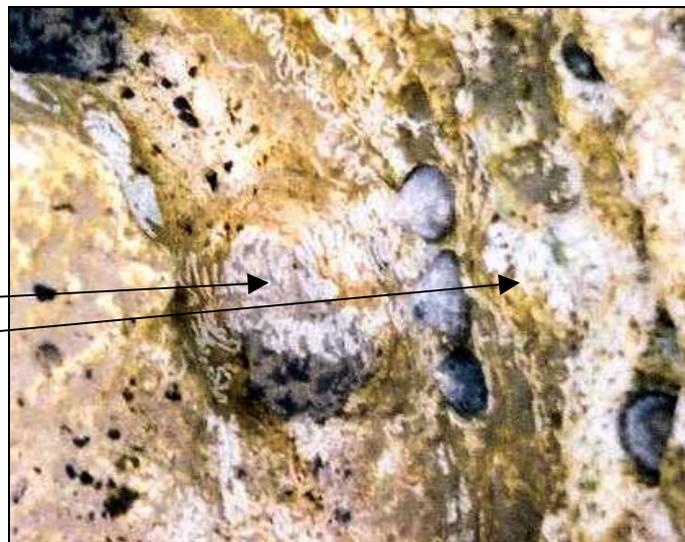
Photograph showing the grazing by a cluster of limpets.

White marks left
by limpets

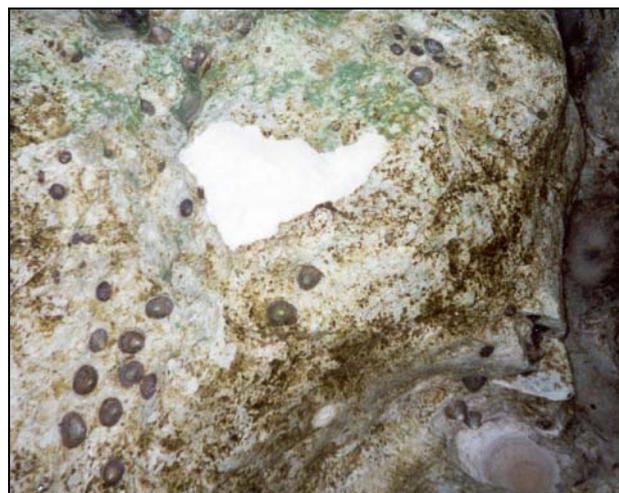
Figure 7:

Photograph showing fresh chalk exposed by 'spalling' in cold, frosty conditions.

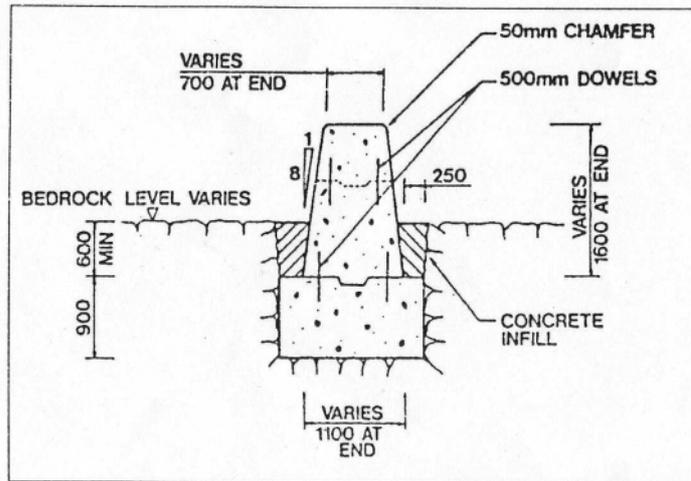
Diagram showing a typical section through a mass concrete groyne at Peacehaven.

The concrete groynes, installed in the three phases have blocked the denudation beneath them, creating pinnacles. Most are between 35 and 50 meters long and have concrete plinths on top of their foundations. These plinths were originally at the same level as the chalk surface (figure 8). However, the chalk has denuded, slowly exposing the foundations and in some place has gone further, beginning to eat under the concrete, leaving overhanging and unsupported ledges (figure 9).

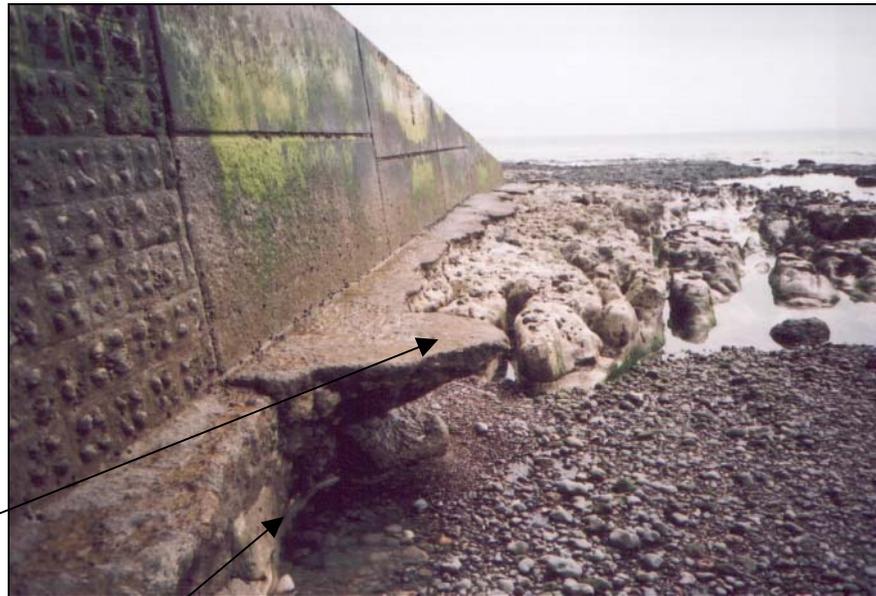
Figure 9:

Photograph of a phase 2 (1980) groyne showing the way erosion is now taking place underneath the concrete base.

Part of the concrete plinth is left hanging in mid-air - level of platform would have originally been at this height.

Severely exposed foundations

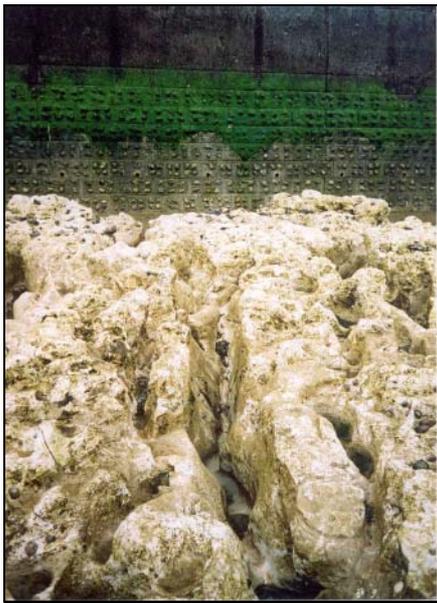
Figure 10:

Photograph showing some of the deeper runnels. These were located to the west of a groyne near the base of the sea defences.

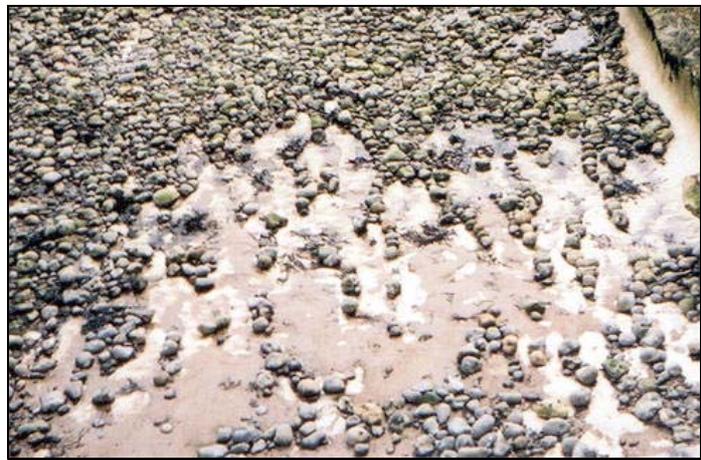
Figure 11:

Photograph showing some of the shallower runnels. Here coarse beach material moves frequently, 'smoothing' the surface. Marks can be seen (but not in this photograph) where this occurs.

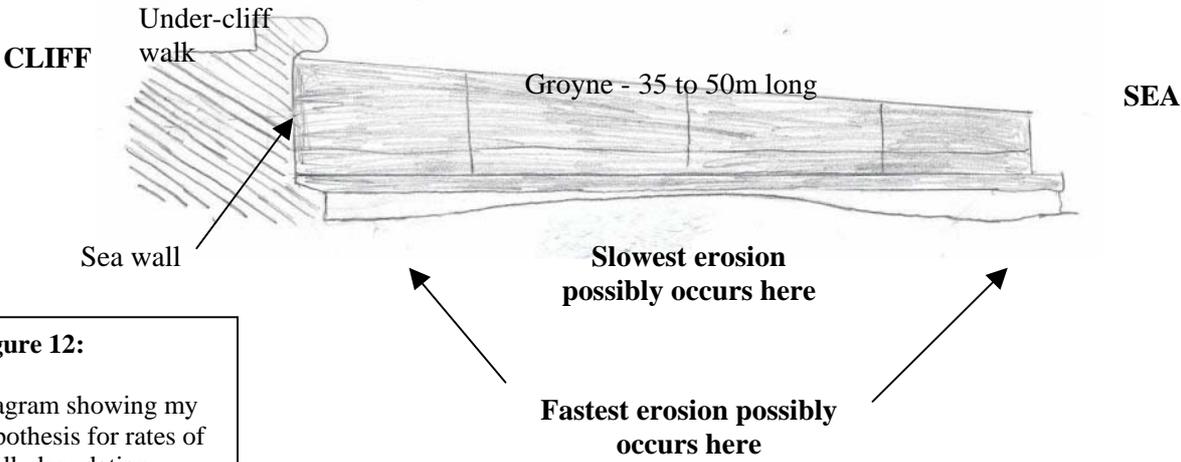
Figure 12:
Diagram showing my hypothesis for rates of chalk denudation around the groyne structures on the shore platform.

occur in two places: at the ends of the groynes, which are the first concrete obstacles to the oncoming waves and at the base of the sea walls. As a result, it is likely that denudation will be fast at the two extremes: high up the platform, close to the sea wall and lower down the platform, near the ends of the groynes. In the middle, it is logical to hypothesize that erosion will be slowest (figure 12).

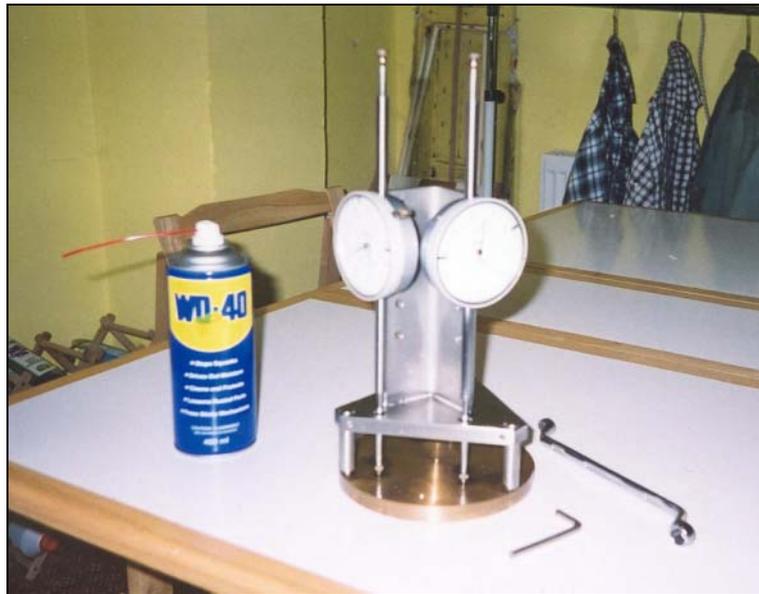
Figure 13:

Photograph showing the MEM on its calibration base plate with some of the equipment used with it alongside.

In an effort to design an MEM that is easier to use in runnels, each of the two probes has 4 positions on the frame, of varying heights. In their lowest position, the legs of the MEM could essentially sit high up in the runnel (almost on the ridges) and the probes would reach down to the base of the runnel. This allows it to be used in areas much narrower than the actual width of the MEM as the bulk of the frame is higher up where the runnel is wider. In addition, it helps keep the bulk of the frame out of any salty, corrosive water. However, the probes were kept at their highest position for the entire use of the MEM as the base proved small enough to fit into the most narrow of runnels. If the probes had been changed position in the field for use on various sites, then readings would have been more inaccurate. Also made with the MEM was a brass base plate that is used for calibration purposes. See figure 13 for a photograph of the MEM on its base plate.

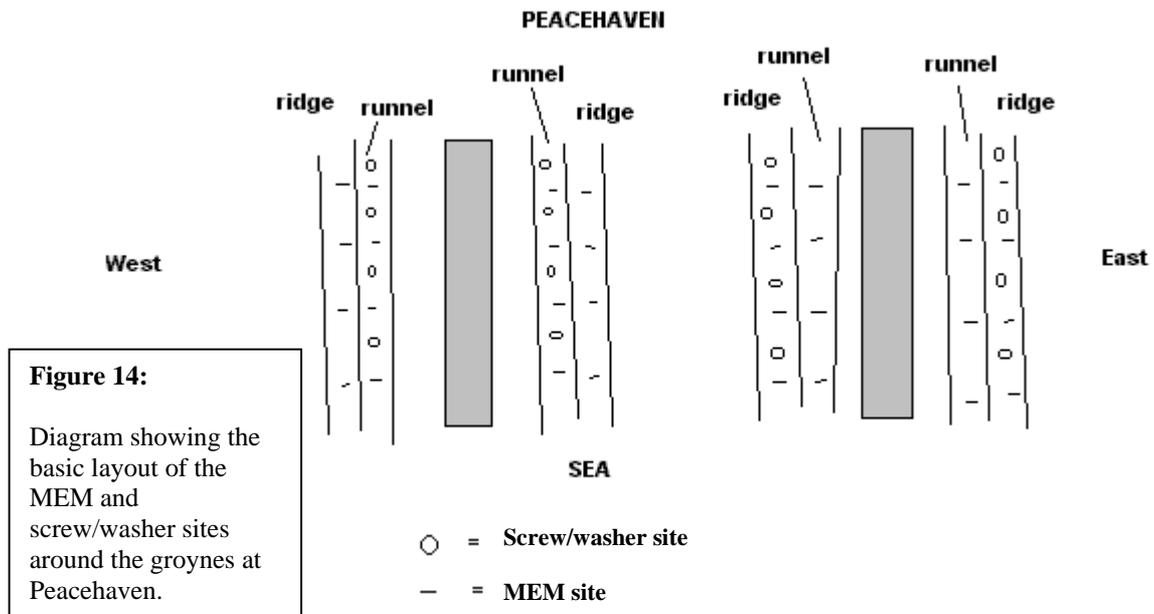
After careful consideration, it was decided that there would be a total of 4 MEM sites along each runnel transect and on the accompanying ridges, a corresponding MEM site (making a total of 8). On the western groyne, there will also be screw/washer sites in-between the MEM runnel sites and on the eastern groyne there will be screw/washer sites in-between the MEM ridge sites. Therefore there will be 12 sites on either side of the groyne (making 24 sites at each groyne and a total of 48 sites overall). There are less screw/washer sites as these are likely to be more unreliable. Figure 14 shows the basic layout of the sites.

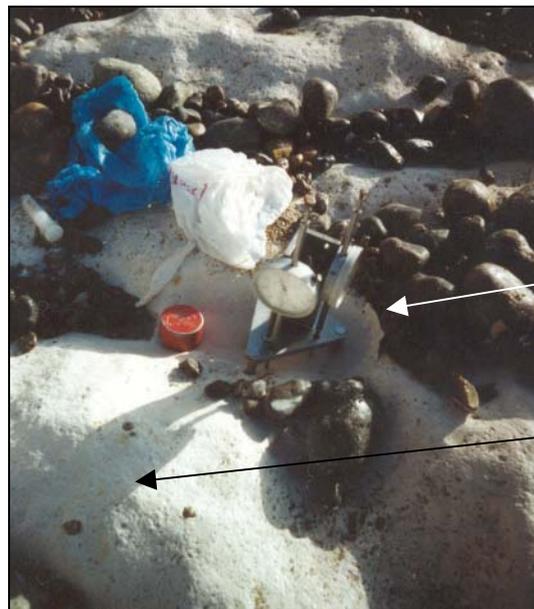
Photograph showing the use of white tack to try and stem the flow of water through this shallow runnel.

Not surprisingly the screws at this site began to move within a couple of months of construction.

White tack

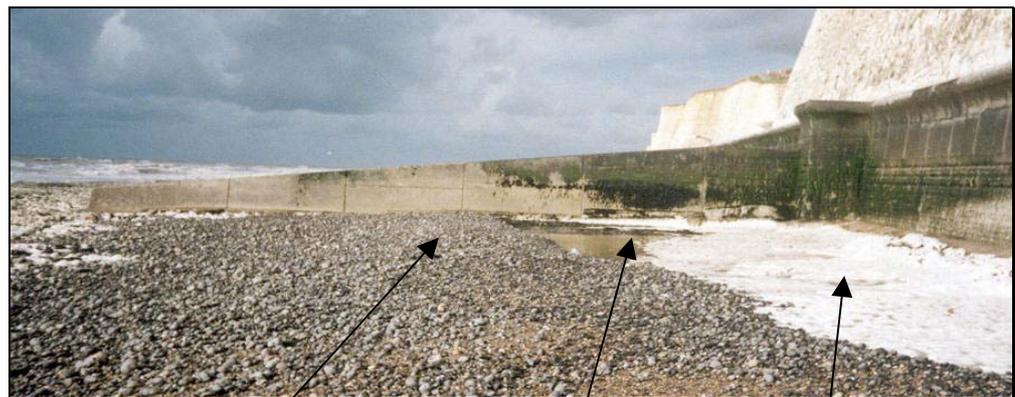
Figure 16:

Photograph showing the build-up of shingle in the middle of the eastern side of the western groyne. Water has been dammed behind it.

Bank of shingle

Pool of water

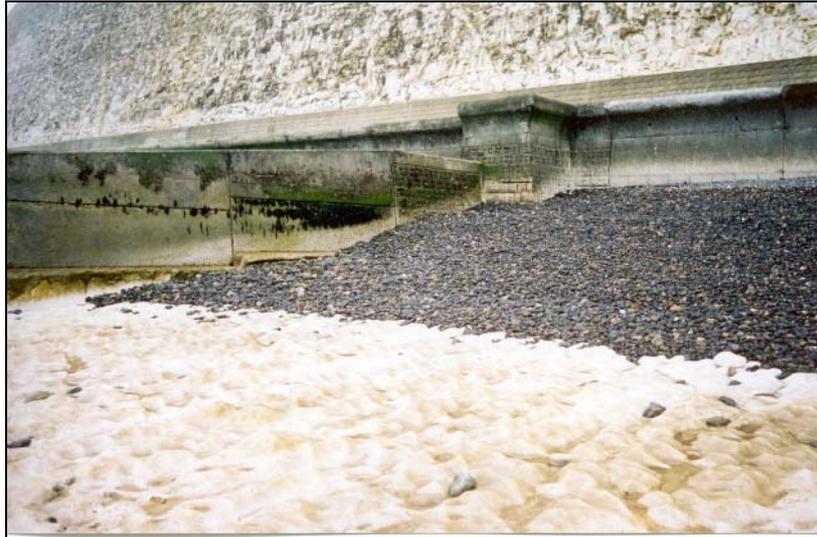
Figure 17:

Photograph showing the build-up of shingle at the back of the east side of the western groyne.

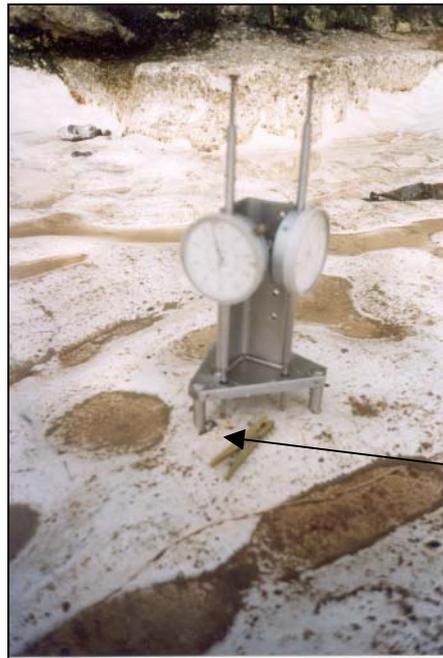
Figure 18:

Photograph showing MEM site 20. Denudation has been so fast that the chalk surface is now far beneath the tops of the screws, exposing them. As a result the screws have moved and do not line up with the feet of the MEM at all.

Leg of MEM misses screw completely.

This continuous movement of shingle caused rapid downwearing and exposed a number of the MEM screws, which were then moved or bent. Site 20, the ridge MEM site located closest to the sea wall, was the first to be lost in November (figure 18), followed by 19 (also on a ridge) in March. Site 9 (20's runnel 'partner') may have been lost after November, but was never uncovered by the shingle again.

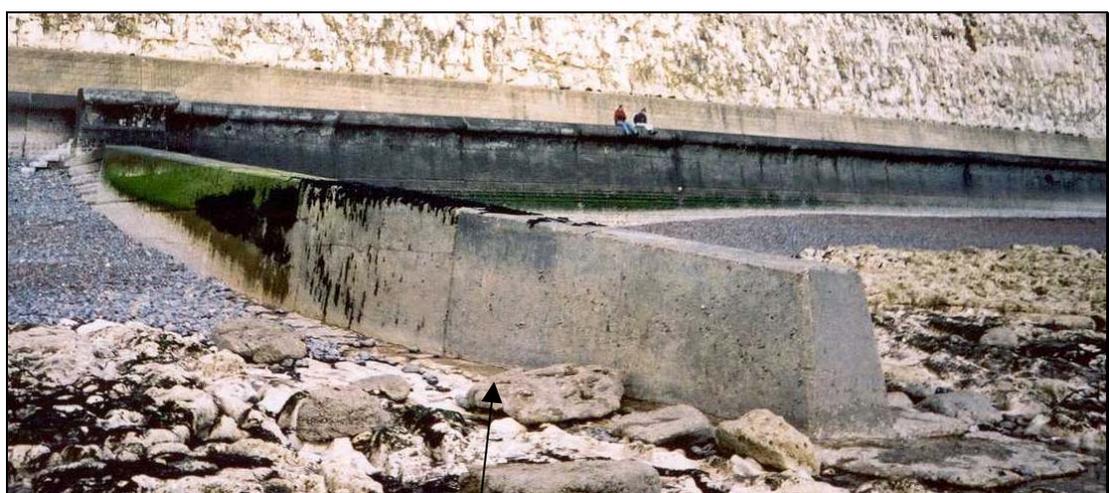
Photograph showing the west side of a phase 3 (1983) groyne.

Erosion is slower here as the build up of fine shingle protects the surface from downwearing.

Plinth is almost at the same level as the platform on this side.

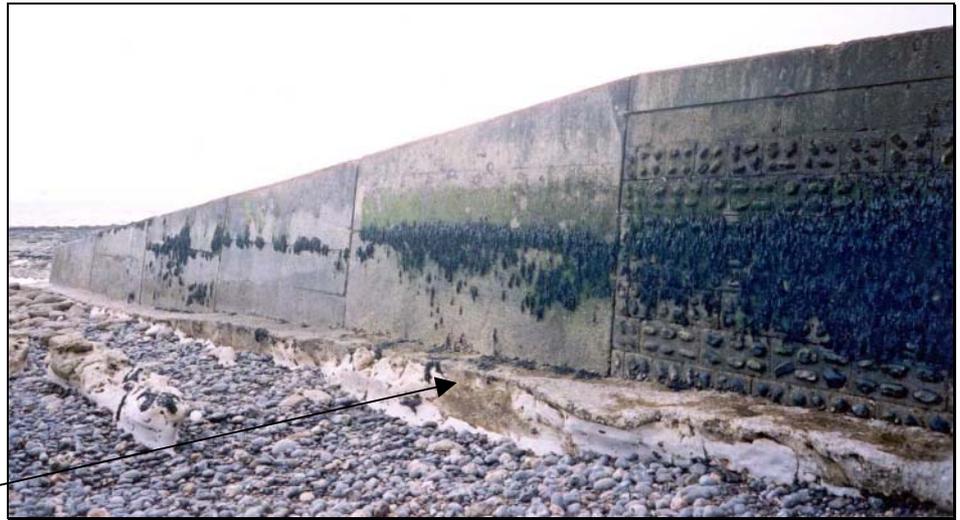
Figure 20:

Photograph showing the east side of the same groyne shown in figure 19.

Erosion here is much faster as there is less shingle protecting the chalk surface. Remaining shingle is coarse and actually scours the surface.

Plinth is a lot further above platform surface than in figure 10.

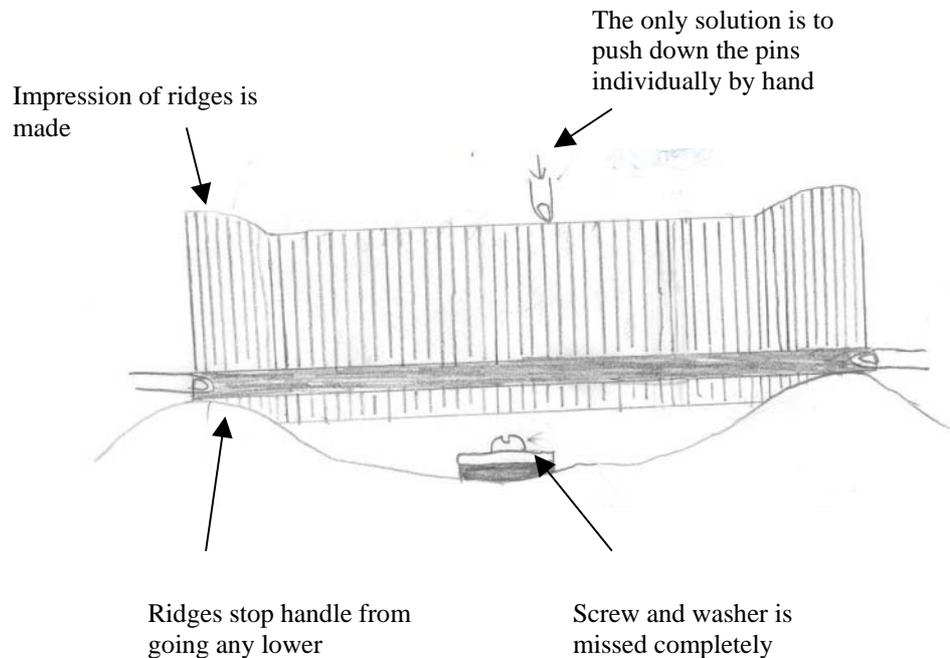
Diagram showing how the intended use of the contour gauge across even fairly shallow hollows is impossible.

Measurement is still possible when used parallel to the flow of a fairly flat-bottomed runnel. Most problems like this were encountered on ridges (eastern groyne).

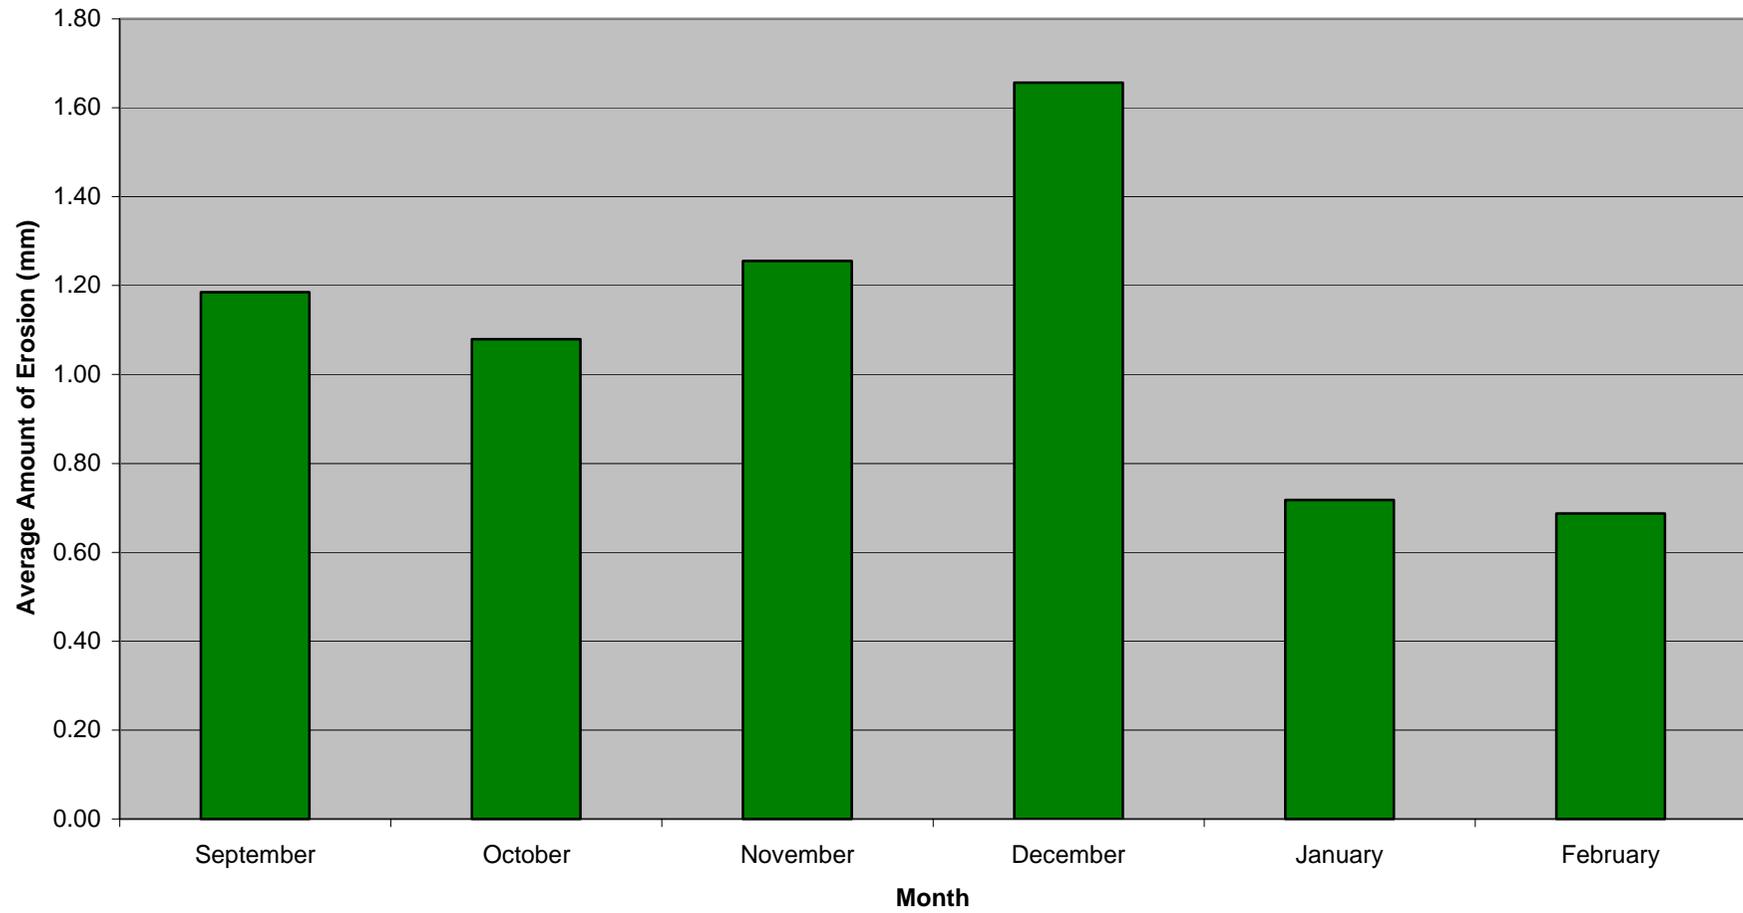
MEM Data:
Bar Chart Showing the Average Amount of Erosion Across the Months

As can be seen from the MEM data (appendix 20), the greatest rate of erosion occurred during November and December, when some of the worst storms occurred and the most shingle was moved around, scouring the platform. This high rate in November is supported by the screw/washer data. However, in contrast it shows that in December the surface supposedly raised more than it eroded. The MEM data shows that the least occurred in January and February, despite this being the middle of the winter and the occurrence of frost action. This may be partly due to the expansion of the chalk as explained before. It must be also noted that these averages are taken from the sites that were found at the time and that hadn't been lost. Sites that experienced the greatest erosion were thus lost towards the end and therefore these averages are perhaps smaller than they should be. The screw/washer data indicates that the greatest erosion occurred in January, which does tie in with the frost action. However, again, I would trust the MEM data more than the screw/washer.

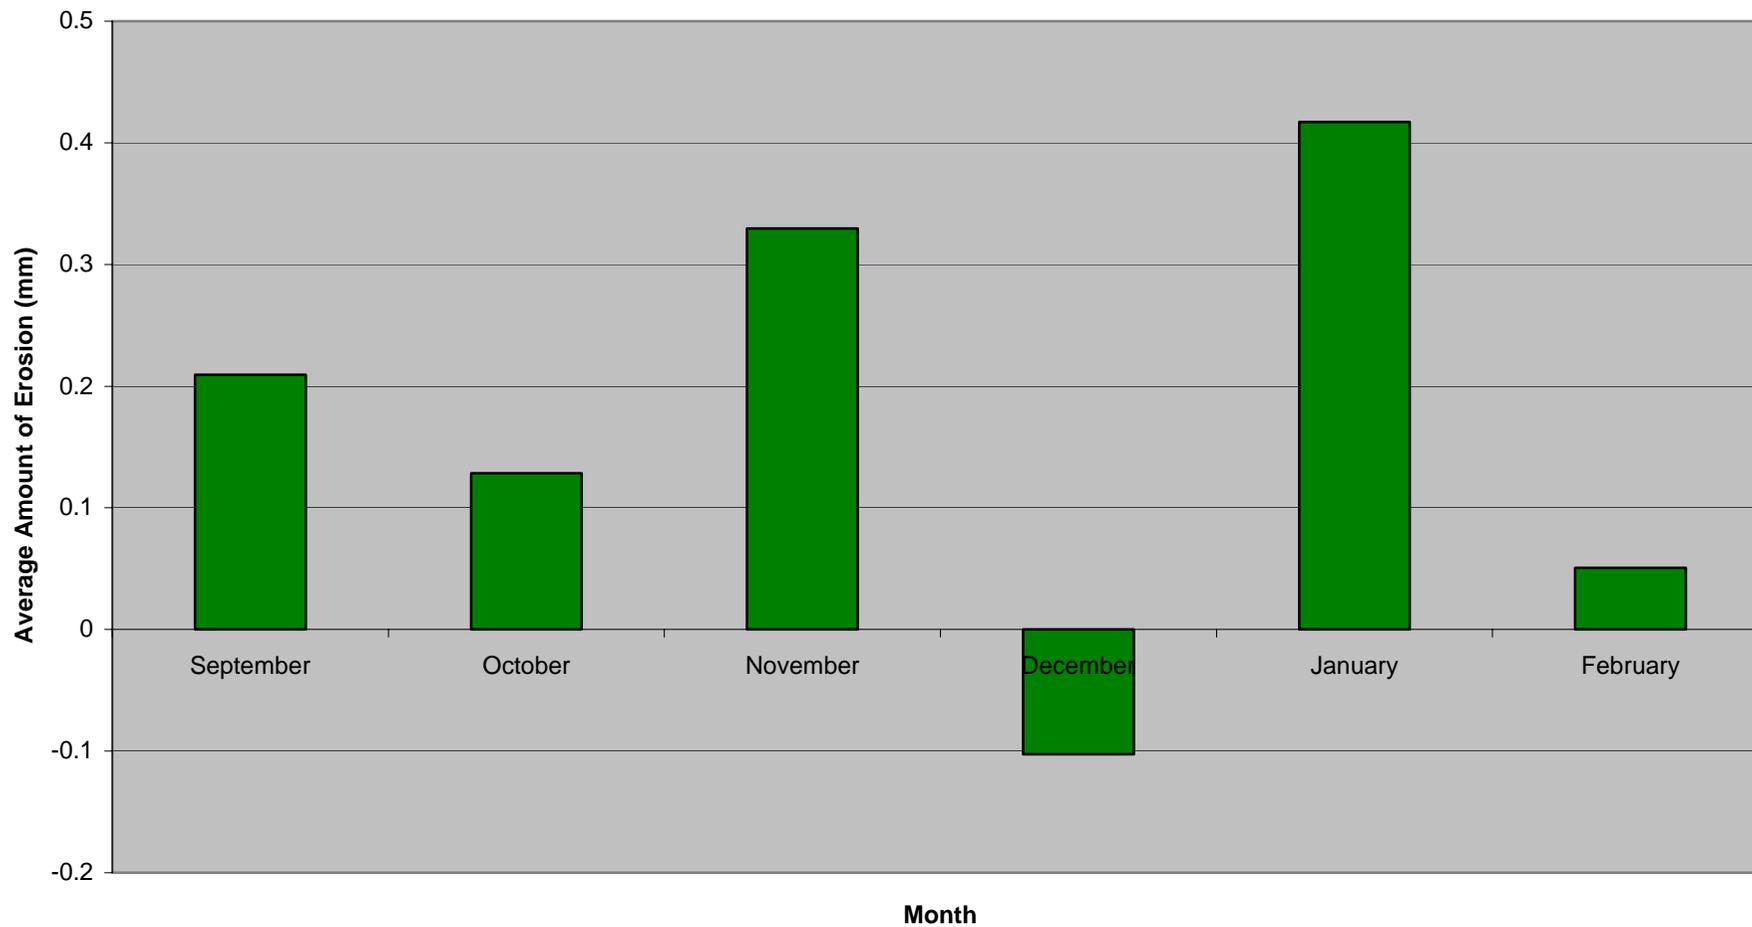
Screw/Washer Data:
Bar Chart Showing the Average Amount of Erosion Across the Months

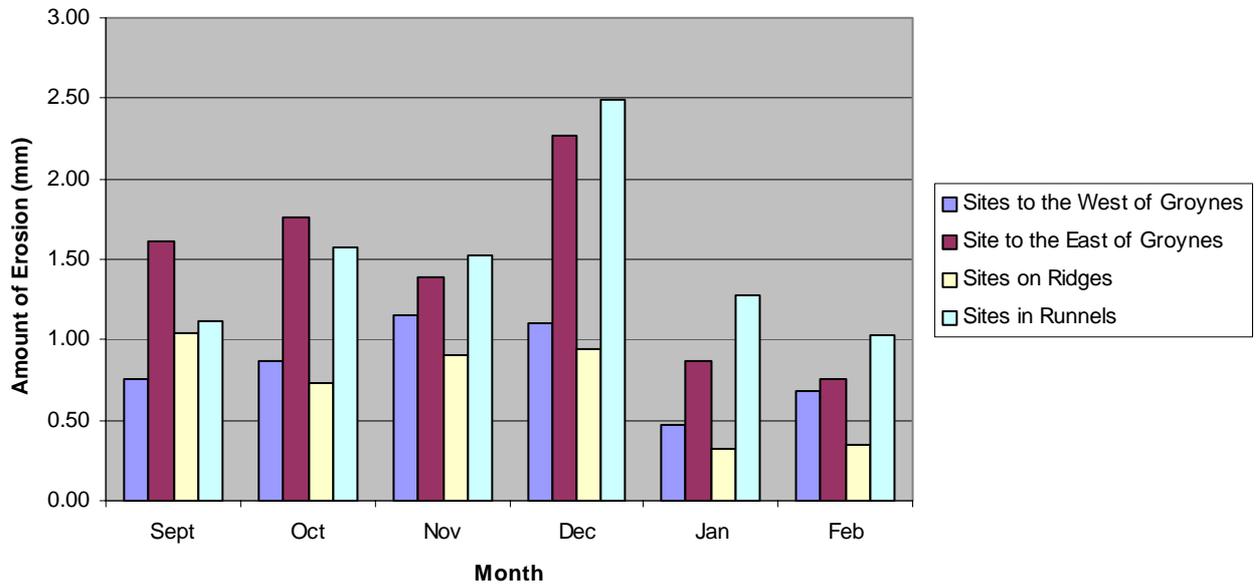
Appendix 32

MEM Data:
Histogram Showing Erosion Rates Across the Months Distinguishing between West and East of Groynes and Ridges and Runnels

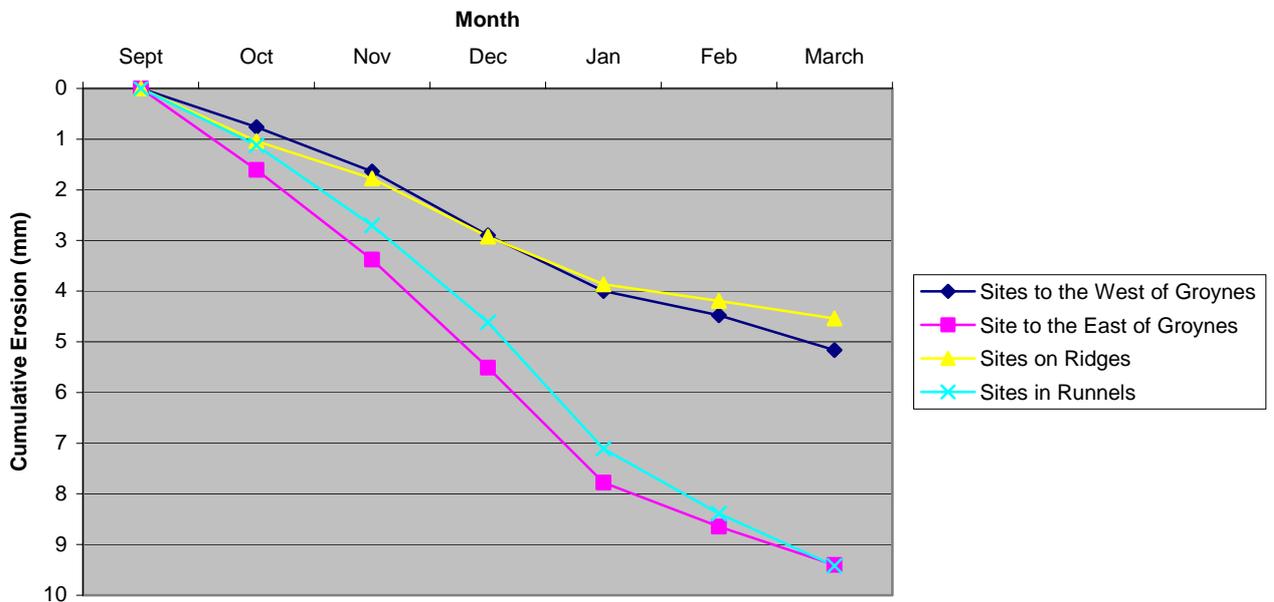
Appendix 33

MEM Data:
Graph Showing Cumulative Erosion Across the Months Distinguishing between West and East of Groynes and Ridges and Runnels

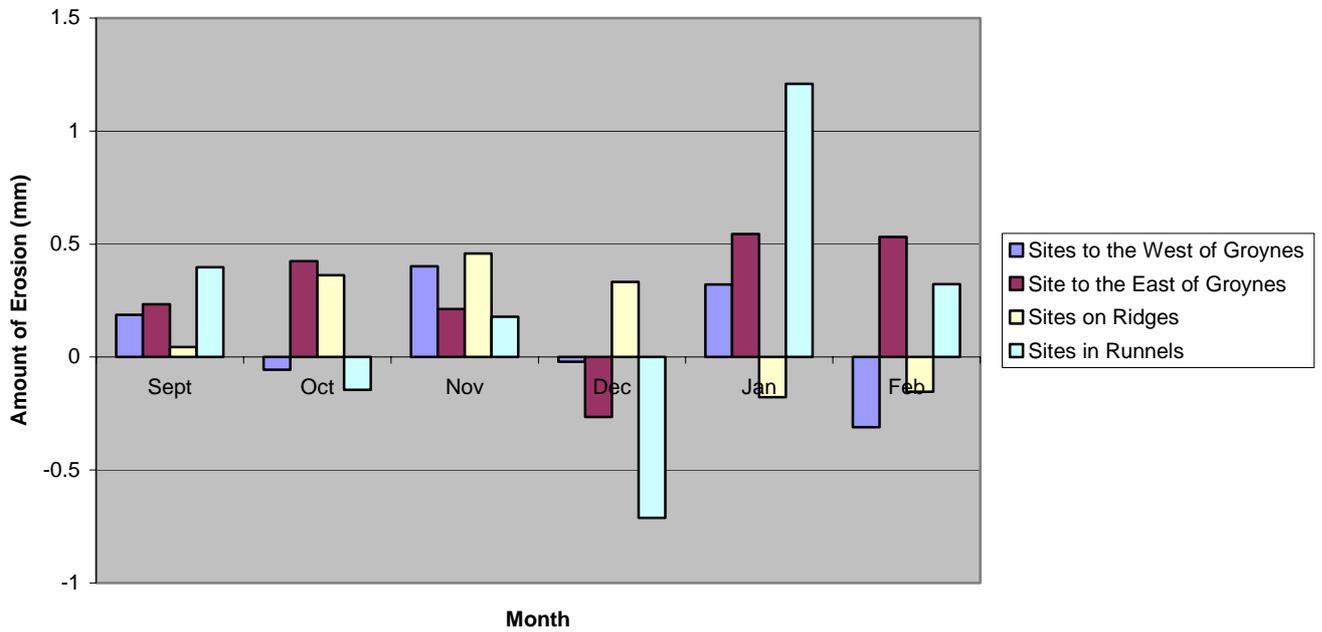
Appendix 34

Screw/Washer Data:
Histogram Showing Erosion Rates Across the Months Distinguishing between West and East of Groyne and Ridges and Runnels

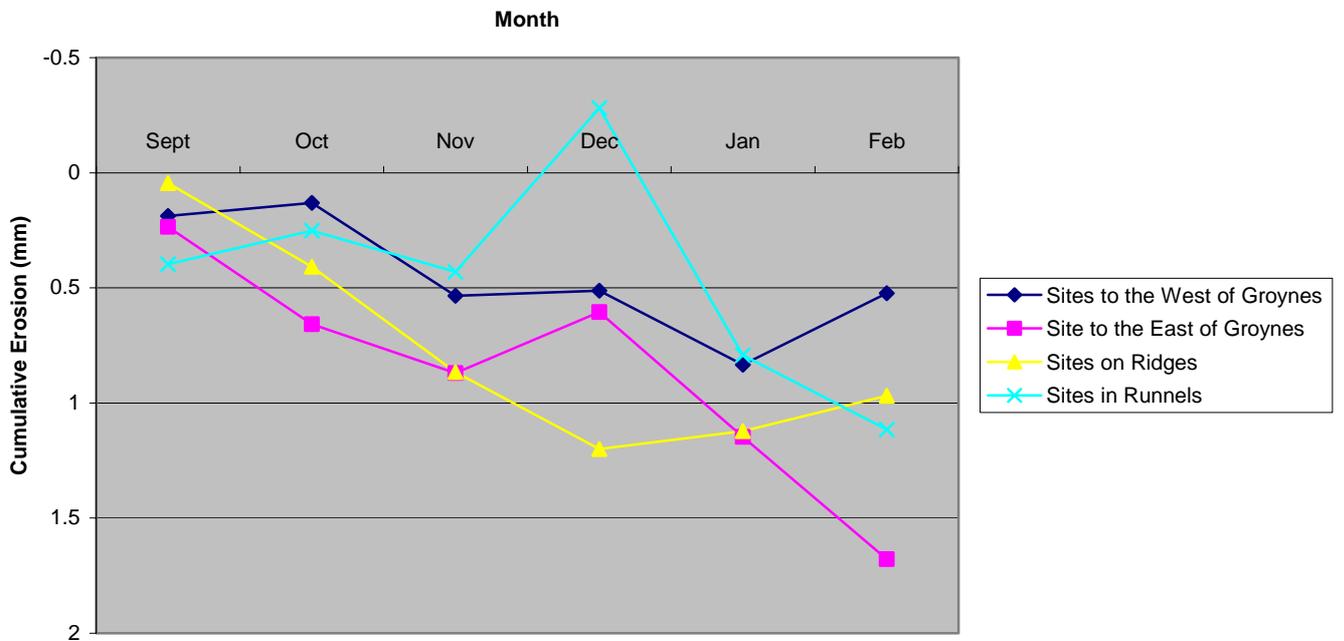
Appendix 35

Screw/Washer Data:
Graph Showing Cumulative Erosion Across the Months Distinguishing between West and East of Groyne and Ridges and Runnels
