Vuggles and Buckham Hill: Sutton Hall, East Sussex

River Ouse Project Report No. 4

Centre for Community Engagement
University of Sussex

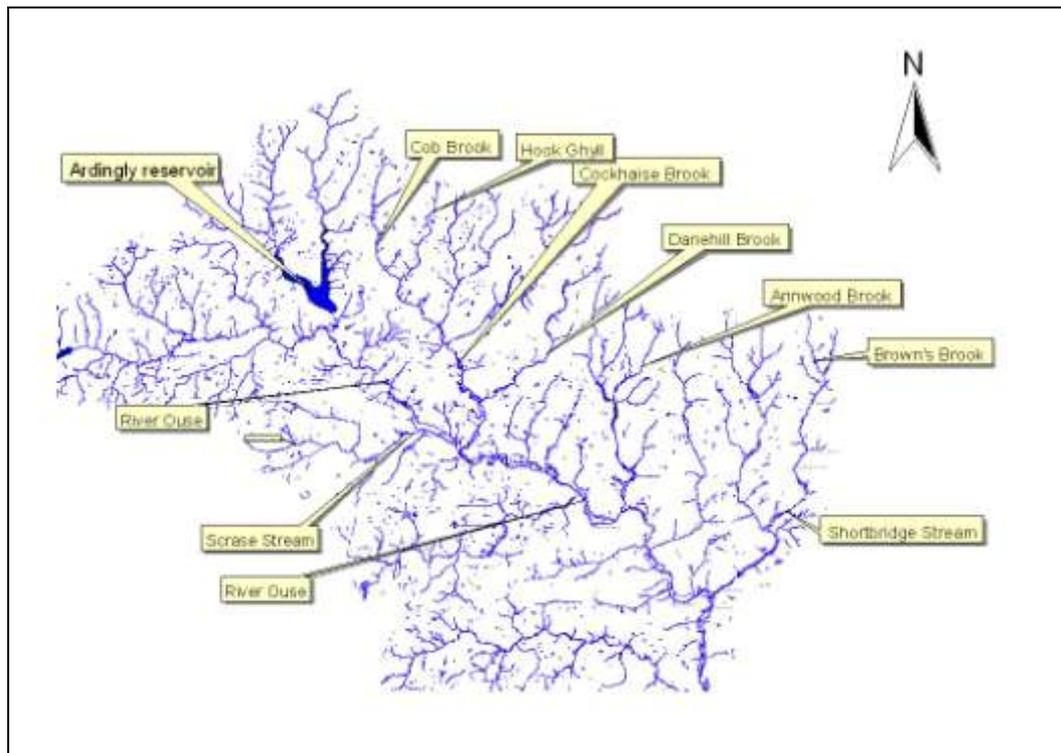
Figure 1. The stream system that feeds into the upper reaches of the river Ouse.

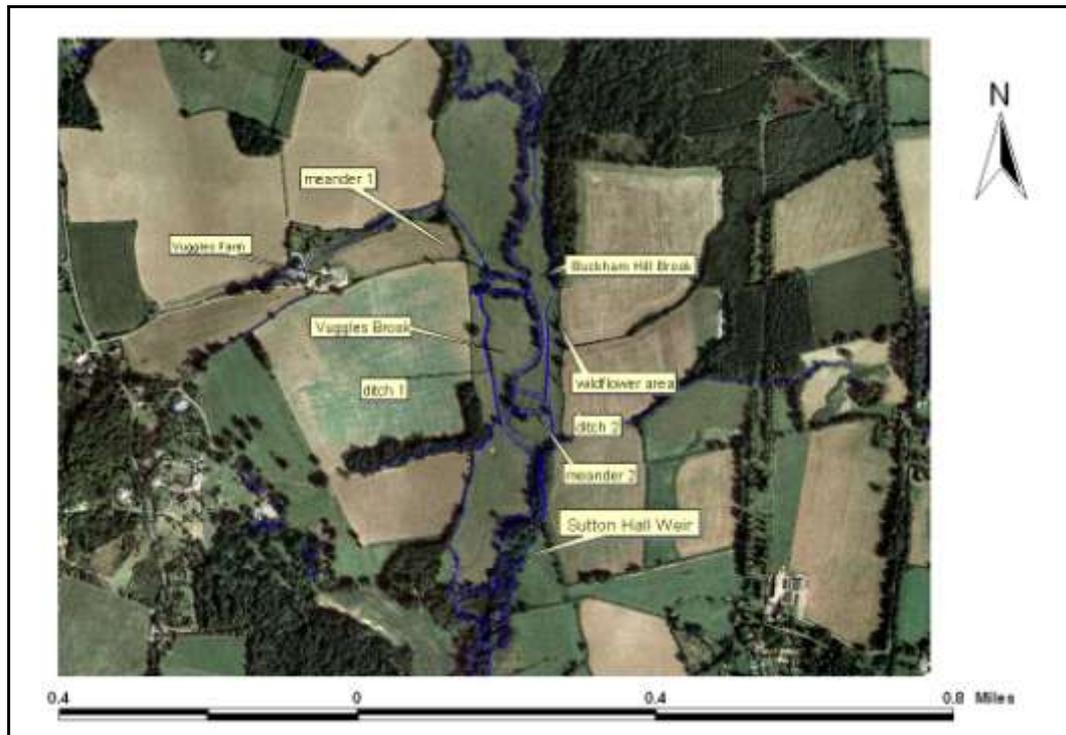
Figure 2 Location of Vuggles and Buckham Hill Brooks.

Buckham Hill Brook is a long thin meadow lying along the east bank of the main Ouse from TQ441196 to TQ441190. Most of the meadow is bounded on the eastern side by woodland, but the southern tip is bisected longitudinally by a ditch (Figure 2). In

There is a former meander in Vuggles Brook, which contains wetland vegetation, and another in Four Acre Brook (Figure 3), which was not surveyed. In both Vuggles Brook and Buckham Hill Brook there are extensive ditches. These are fed by local woodland springs (Figure 2) and contain wetland vegetation.

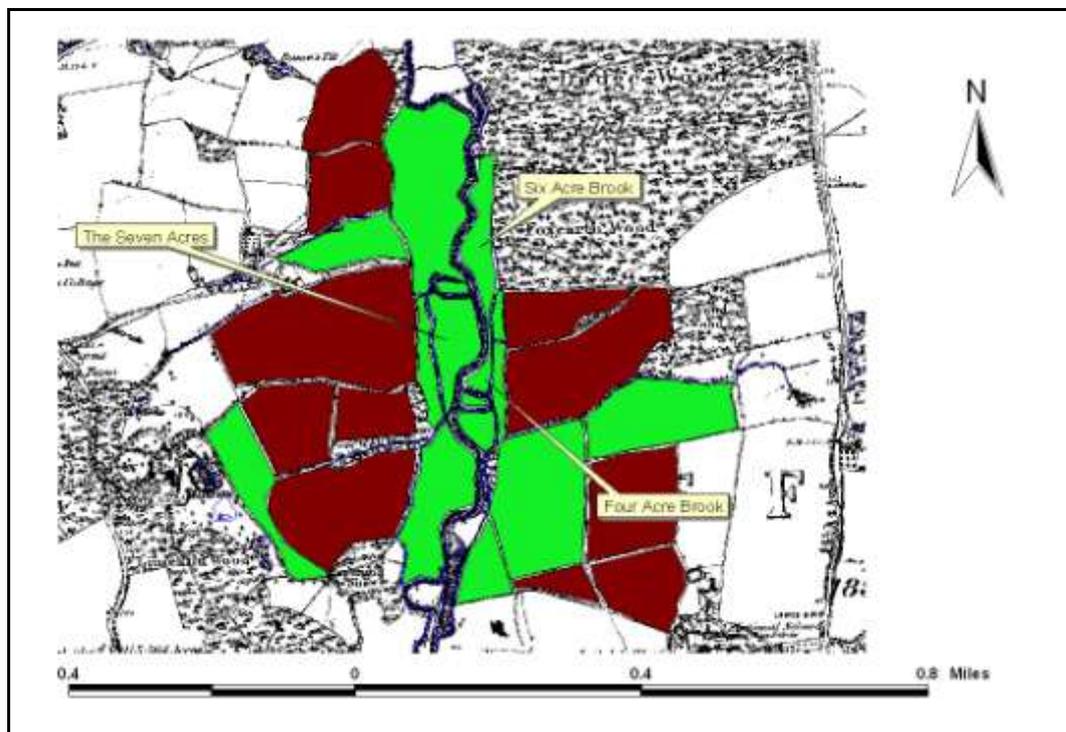
Figure 3 Map showing land use and field names compiled from the 1839-40 Tithe Map and apportionment data by Peter Heeley. The Seven Acres is now known as Vuggles and Six Acre Brook is now known as Buckham Hill Brook. Use as pasture is shown as green and arable as brown. Source: Tithe maps for Barcombe, Isfield and Newick: East Sussex Record Office: ESRO TD/E42, ESRO TD/54 and ESRO TD/134.

1839 it was known as Six Acre Brook (Figure 3). The shape of these Brooks is the same today as it was in 1879 (Figure 4).

These Brooks are part of an extensive band of permanent grassland lying alongside the river Ouse. At the time of the Tithe survey, they were being managed as pasture (Figure 3) and in 1970 they were still being grazed as part of a low input system of farming.

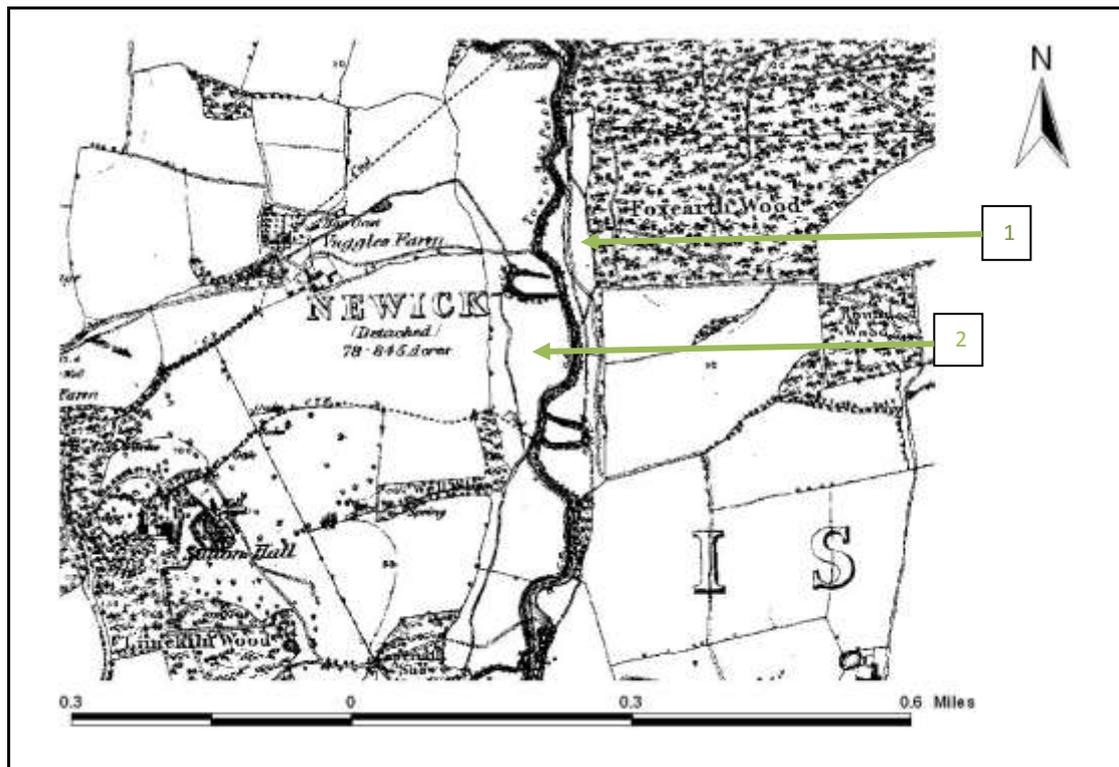
Figure 4 Ordnance Survey 1:10,560 map of 1879. 1 indicates Buckham Hill Brook and 2 Vuggles Brook.

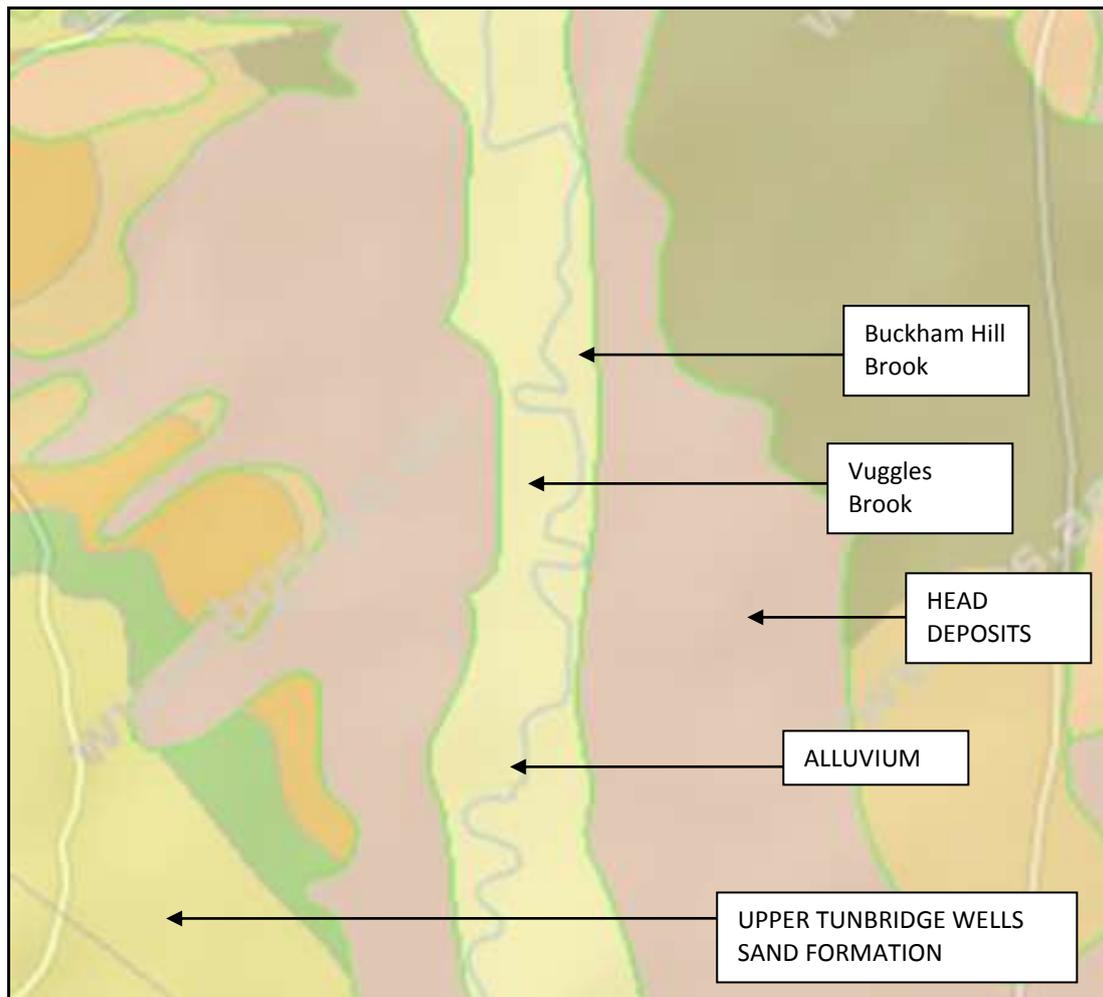
Figure 5 Map showing the geology of the area around Vuggles Brook and Buckham Hill Brooks.
 Source: British Geology Survey, Newick at Geology of Britain
<http://mapapps.bgs.ac.uk/geologyofbritain/home.html>

The soil is Alluvium, flanked by sand and silt deposits known as 'Head', and lying more generally within the Upper Tunbridge Wells Sand formation (Figure 5). The soil pH is 7.0 for Vuggles Brook and 6.0 for Buckham Hill Brook. The soil is free-draining as the current farm manager, James Wallis, explained:

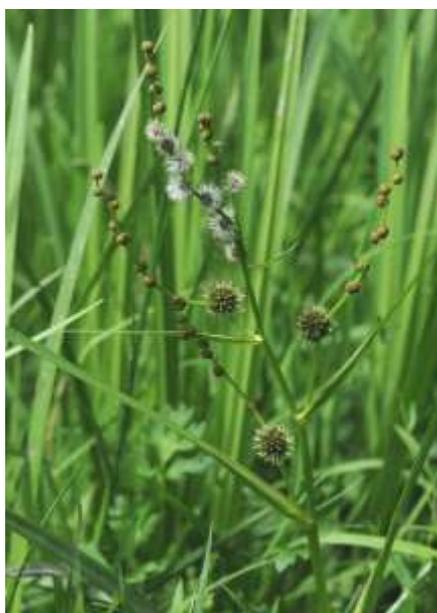
Figure 6 Branched bur-reed found in Ditch 2.

There were a number of attractive wetland plants growing in Ditch 2: water plantain; lady's-smock, marsh bedstraw, greater bird's-foot-trefoil, gipsywort, purple-loosestrife, water mint, creeping forget-me-not, celery-leaved buttercup, branched bur-reed (Figure 6) and brooklime. Meadow vetchling, which is characteristic of hay meadows, was growing beside the ditch.

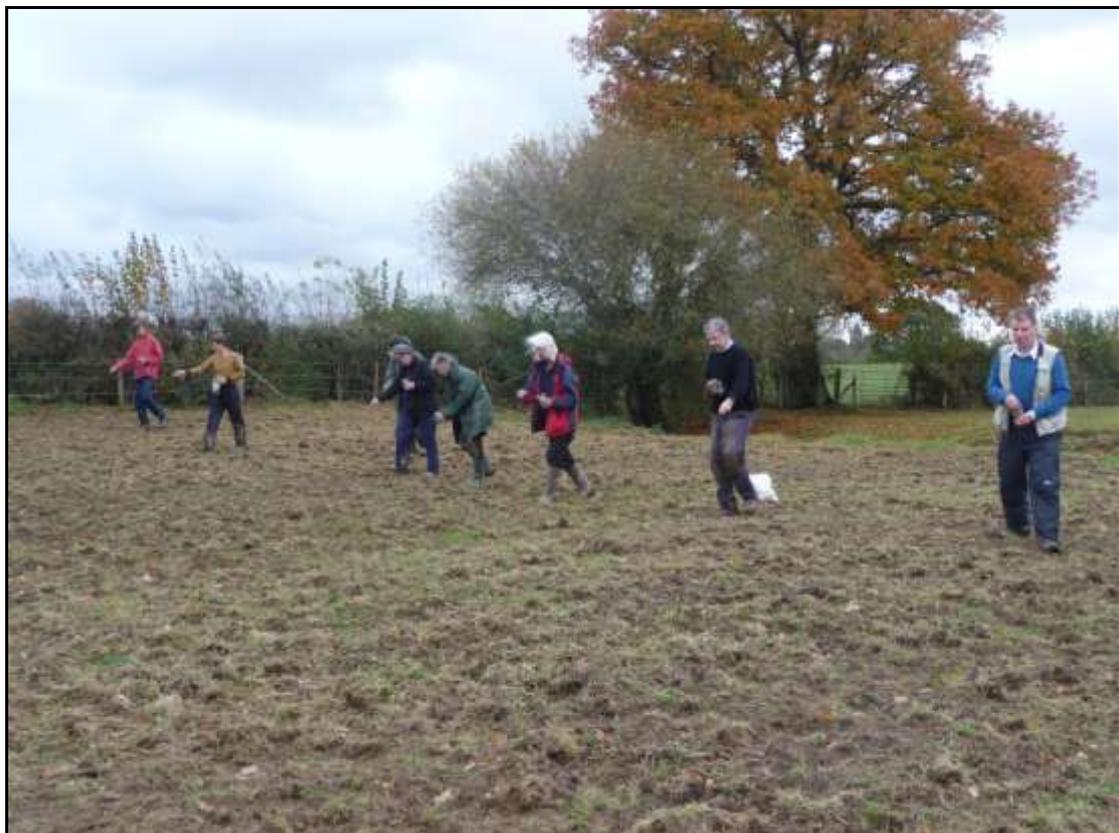
Figure 7 Volunteers sowing wildflower seed in Buckham Hill Brook.

We would recommend sowing with a wildflower seed mix, which would include indigenous grasses and attractive hay-meadow flowers to encourage butterflies and bumblebees.
