Understanding and Predicting Beach Morphological Change Associated with the Erosion of Cohesive Shore Platforms

R&D Technical Report FD1926/TR

Produced: December 2007

Author(s): Royal Haskoning, British Geological
Survey, University of Sussex, Newcastle University

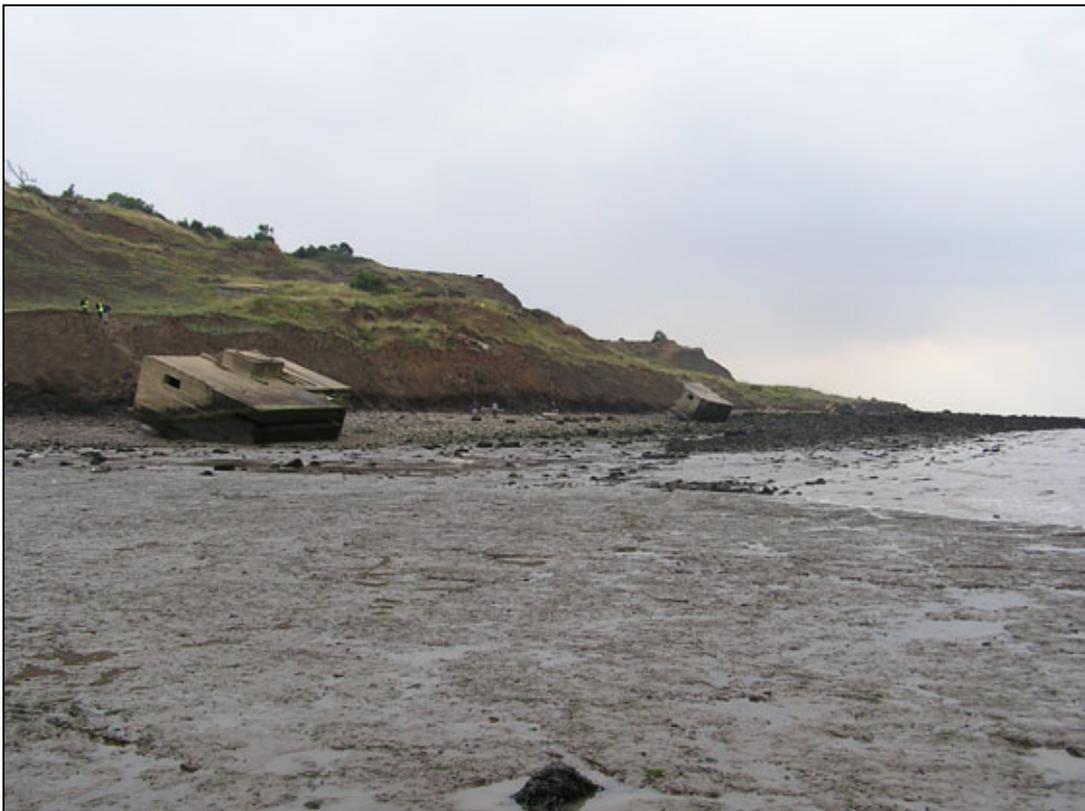
Figure 1.2. Warden Point: General view of exposed London Clay platform with thin, narrow beach at foot of slipped London Clay sea cliff (July 2005).

The site at Warden Point on the Isle of Sheppey lies at the foot of landslipped London Clay sea cliff. The cliff edge lies at approximately 48 metres OD. Cliff recession rates have averaged 1.93m/year (Nicholls et al., 2000). The tidal range on this section of coast is approximately 5.2 metres at mean spring tides. A broad, exposed, platform of London Clay is located in the intertidal zone at this point (Figure 1.2) which has been observed to have been continually exposed over several years prior to the commencement of this project. Adjacent coastlines also have an intermittently exposed platform, extending for several hundred metres southwards towards Leysdown and for more than a kilometre westwards towards Minster. A narrow beach exists at the cliff toe which ranged from 14 to 18 metres wide during the survey period.

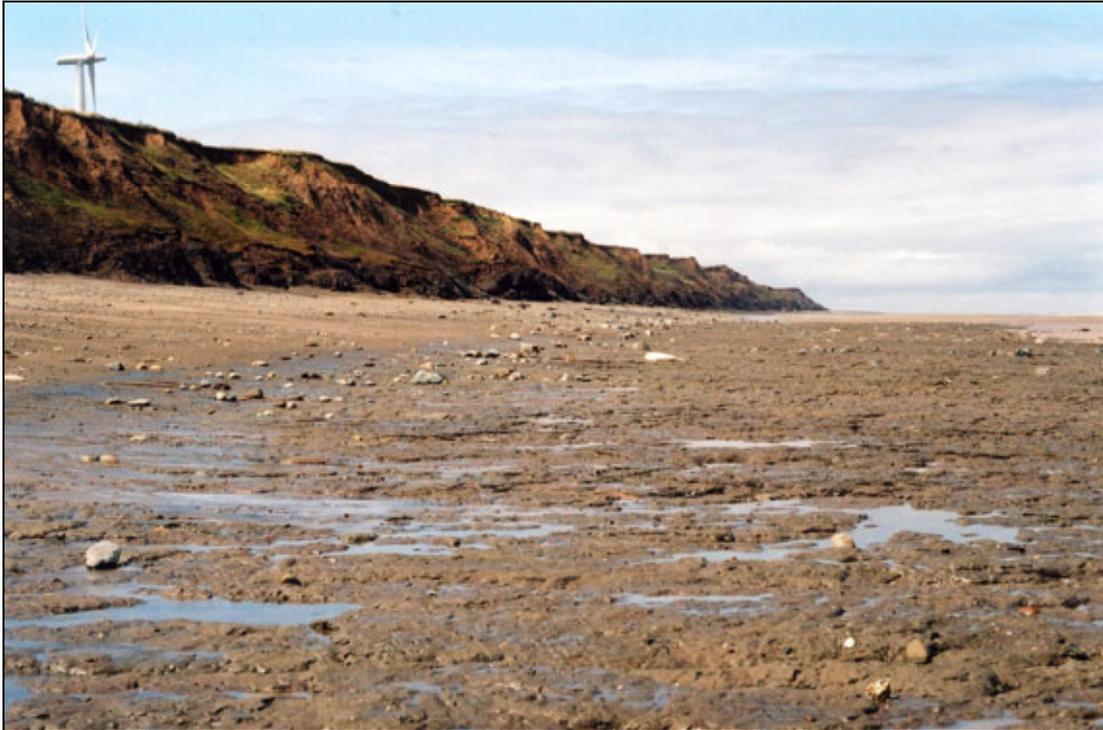
Figure 1.3. Easington: General view of study site showing glacial till platform (July 2005). Oblique sand bar visible at extreme right of picture.

The site at Easington lies at the foot of a section of unbroken cliffs just north of the Easington Gas Terminals. The cliff edge lies at approximately 20 metres OD. Cliff recession rates at this location have averaged 1.97m/year (East Riding Yorkshire Council data). The tidal range on this section of coast is approximately 5.7 metres at mean spring tides. An exposed platform of glacial till is located in the intertidal zone at this point (Figure 1.3) landward of a low sand bar which is slightly oblique to the line of the beach. A substantial mixed sand and gravel beach between 60 and 100 metres wide existed between the platform and the cliff toe during the survey period.

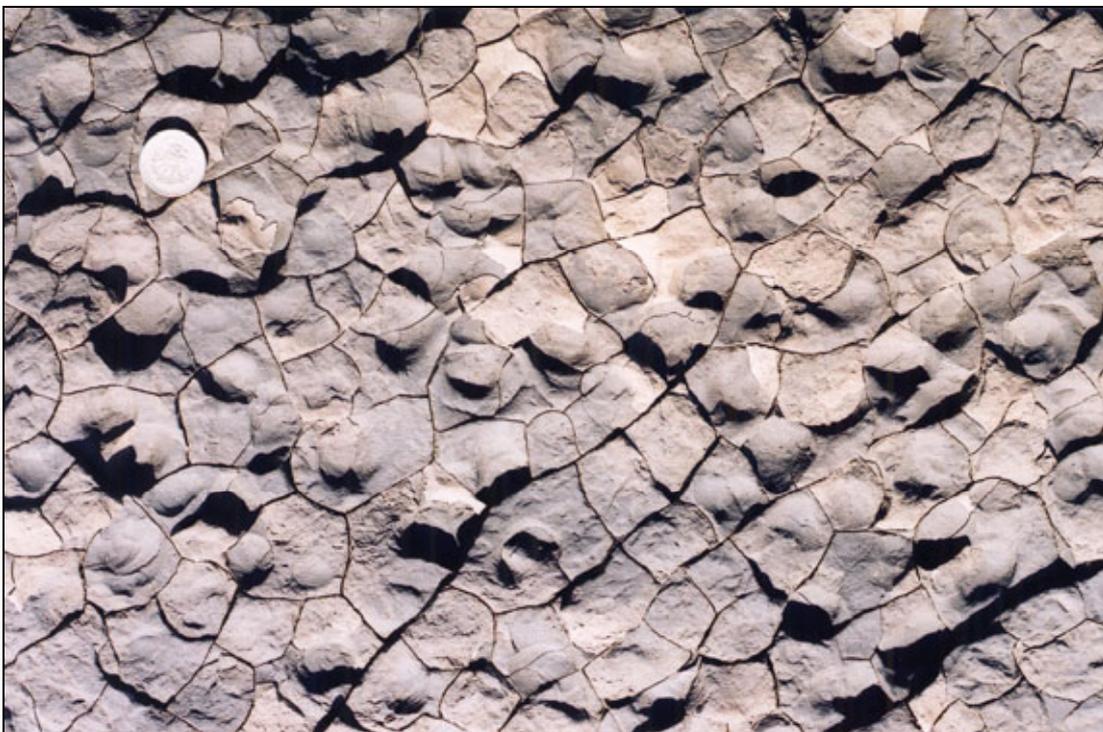
Figure 2.3. Polygons on the surface of the cohesive shore platform on the Isle of Sheppey, north Kent.

Alternating phases of desiccation and wetting result in the thin upper layers of the cohesive sediment being cracked into polygons (10s of millimetres across, Figure 2.3).

The surface of these polygons may then be removed as flakes by the sea. This process is probably confined to the intertidal zone, and is probably most active in well-drained areas and greater in summer than in winter. Wetting and drying can also occur as a result of rainfall episodes, although the erosive effect will be different to that caused by tidal cycles since there is an absence of salts.

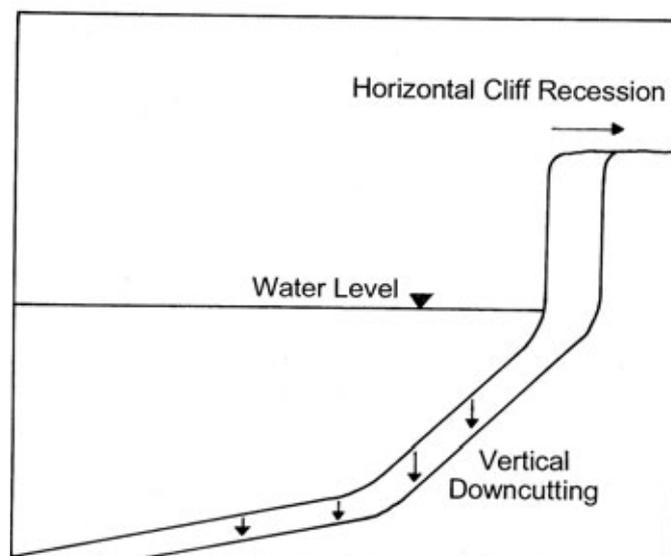
Figure 2.4. Platform downwearing-cliff recession relationship.

It is generally agreed that the primary control on the long-term rate of cliff toe erosion is the rate of vertical lowering of the beach and platform (Davidson-Arnott and Askin, 1980; Philpott, 1984; Hutchinson, 1986; Kamphuis, 1987; Davidson-Arnott et al., 1999). Hutchinson (1986) suggested that cliff erosion follows at a rate that the platform erosion permits (Figure 2.4). While subaerial processes may dictate when and where a slope failure will occur, the frequency of failures over the long-term is strongly determined by the rate at which the platform is eroded.

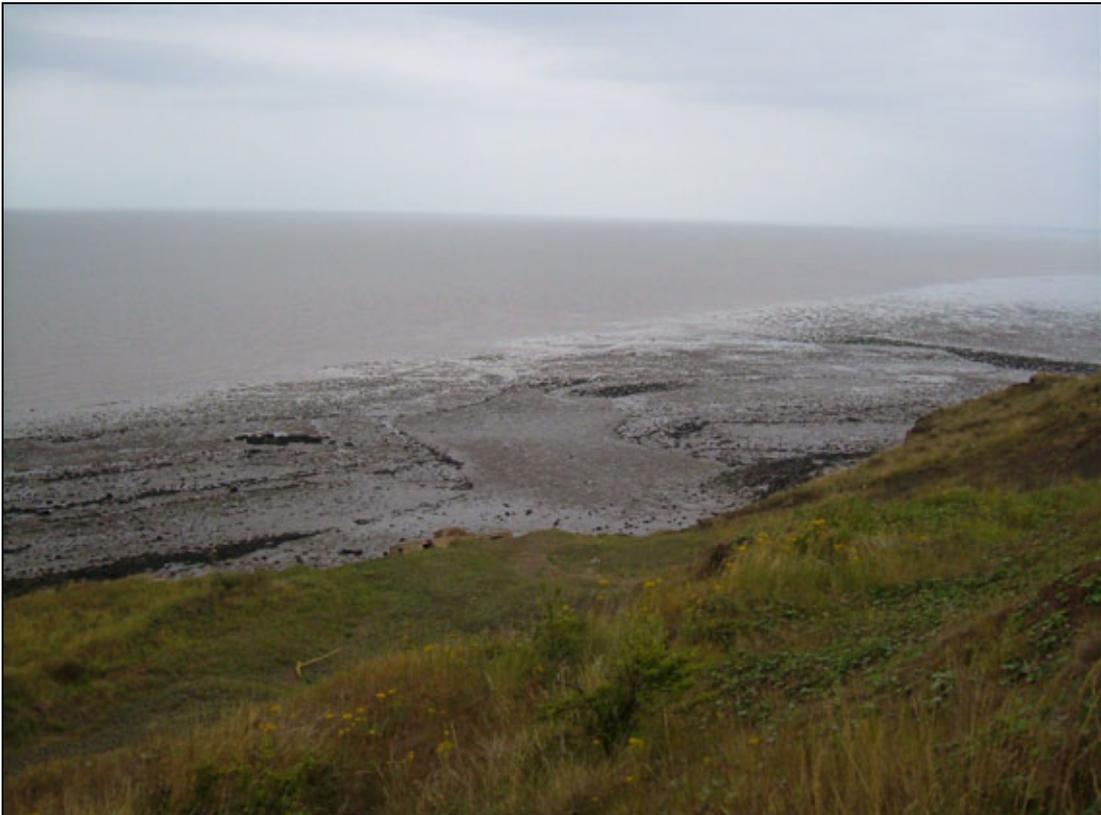
Figure 3.1. Shore platform at Warden Point, 22nd July 2005. Study site is in the centre of photograph with disturbed landslides exposed to either side.

The cliffs and platform at the Warden Point study site consist of London Clay. The intertidal zone predominantly comprises a wide (100-500 m), low gradient (0.5° - 2°) undisturbed shore platform flanked by areas of disturbed deep-seated landslides (Figure 3.1). Seaward of low water is believed to be a wide shallow platform covered by sand.

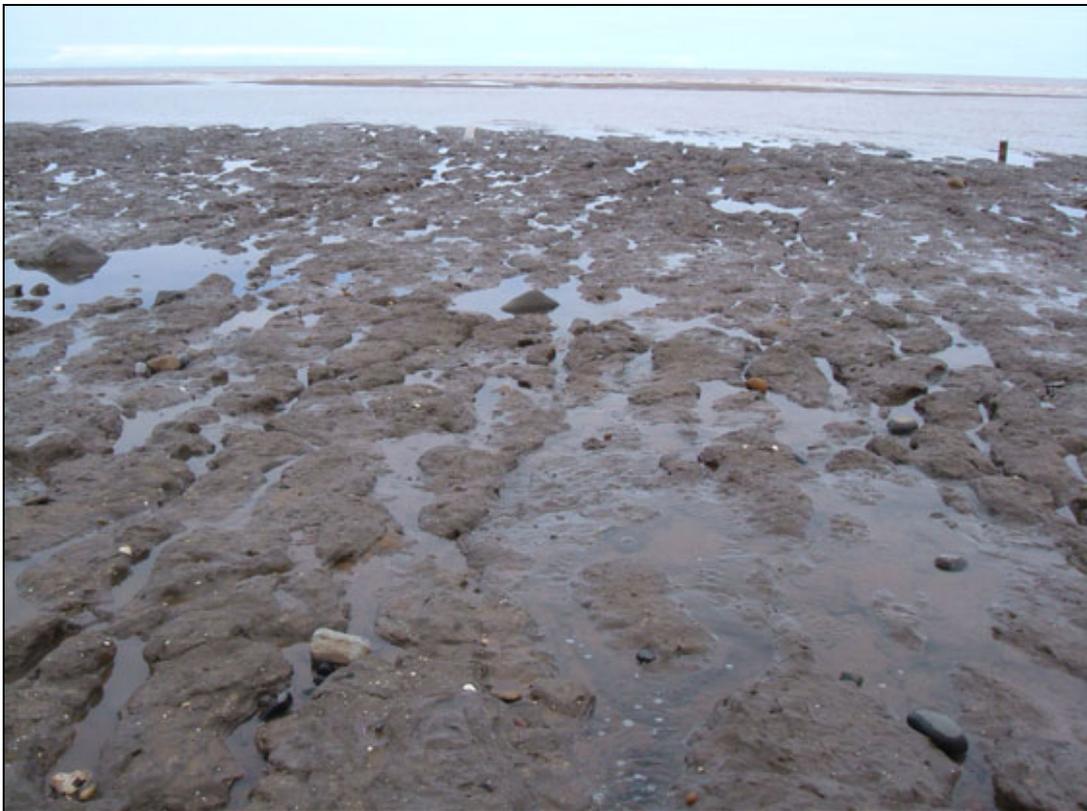
Figure 3.3. Shore platform at Easington, 25th July 2005. 'Lagoon' and sand bar in background. Exposed platform is about 30 m wide.

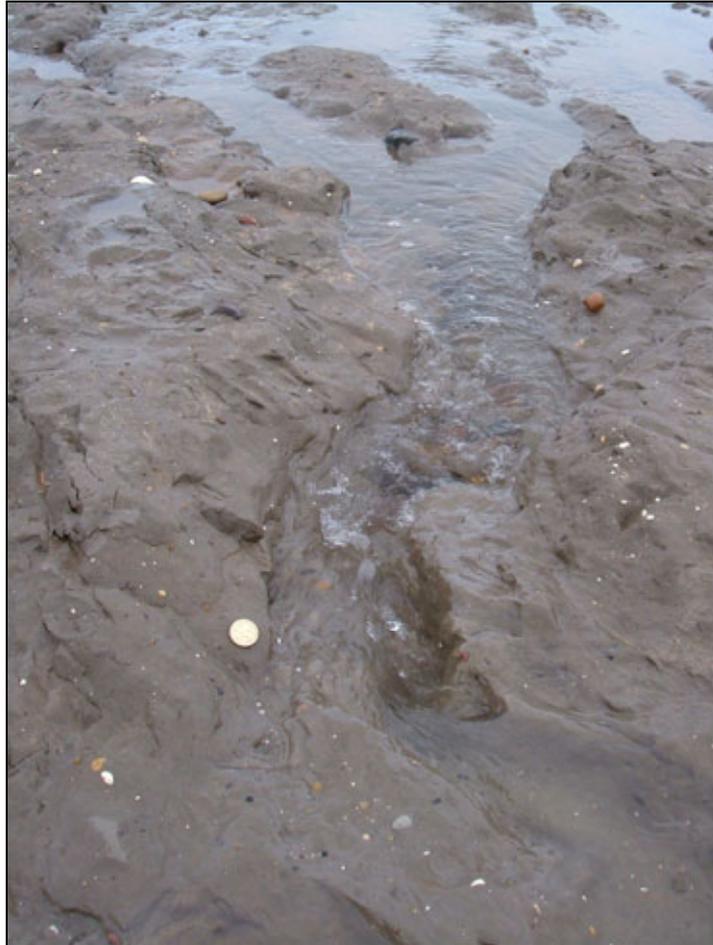
Figure 3.5. Gully erosion at Easington, 26th July 2005.

Erosion of the Easington platform may be partly controlled by features within the till. Closely spaced gullies perpendicular to the shoreline and to a depth of 0.5 m are common on the studied platform (Figure 3.5). As the tide ebbs, water exits the base of the beach and flows across the platform cutting gullies into it. This appears to be a significant process of erosion. Where the gullies are absent the till surface is smooth or irregularly undulating. However, some larger gullies are cut oblique to the general shore-perpendicular smaller gullies and are located along planes of weakness (disturbed areas of till). As the beach becomes thinner and narrower to the north of the study site, the gullying becomes less frequent and less deep. This may be related to the amount of water that can be released from storage in the beach.

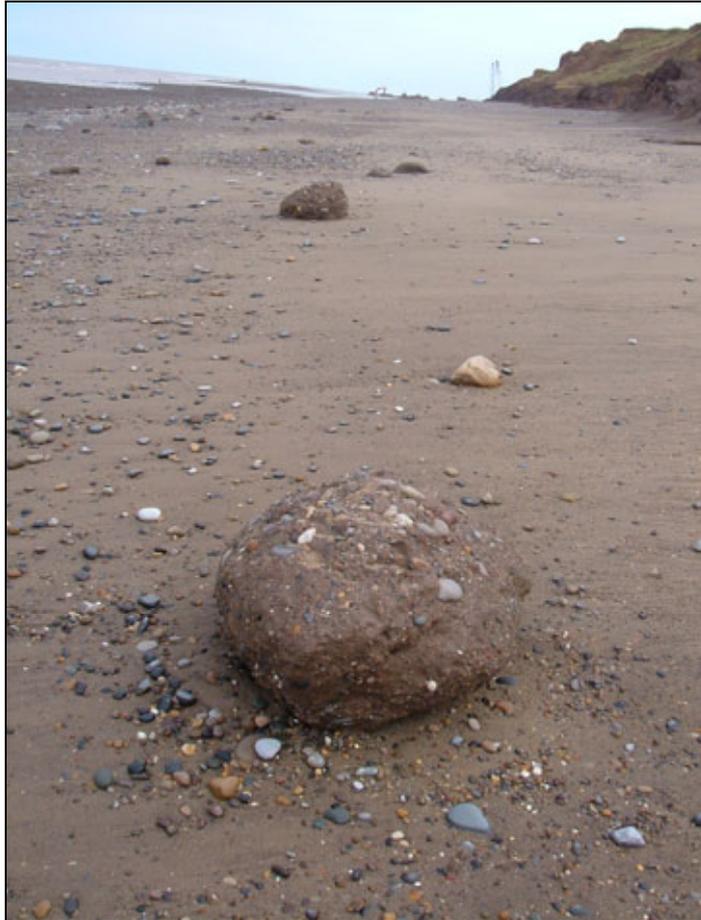
Figure 3.6. Armoured mud balls at Easington, 26th July 2005. Mud ball in foreground is about 50 cm across.

Armoured mud balls often lie on the exposed till surface (Figure 3.6). They derive entirely from cliff fall debris, and concentrations of them indicate a period of local rapid cliff erosion.

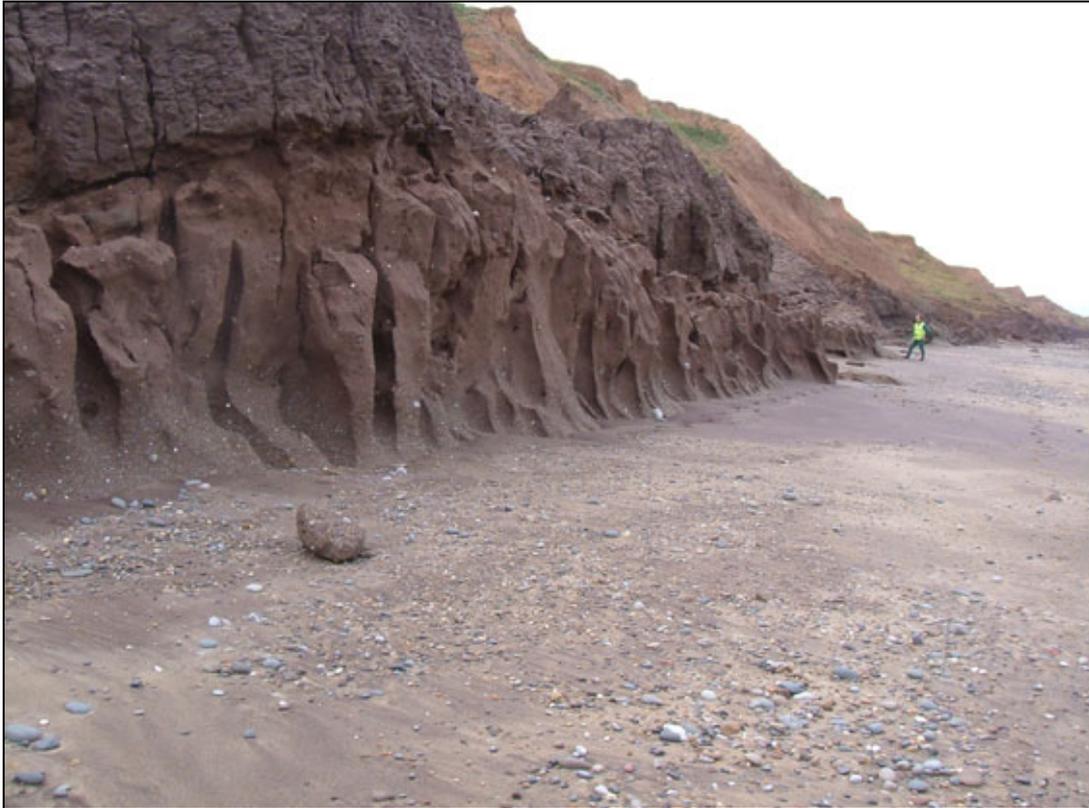
Figure 3.7. Morphology indicating direct erosion of the cliffs by waves at Easington, 26th July 2005.

There appears to be some support for Pringle (1981, 1985) at the Easington study site. It is likely that the water in the 'lagoon' covers part of an ord. The lagoon is therefore part of the ord system, along with the exposed shore platform at the study site, between the sand bar and the beach. Also, the backing cliffs where the beach is thinner have a morphology that indicates direct attack and erosion by waves in the form of 'fluting' up the cliff face (Figure 3.7). Where the beach is thicker the backing cliffs do not show such a distinct morphology.

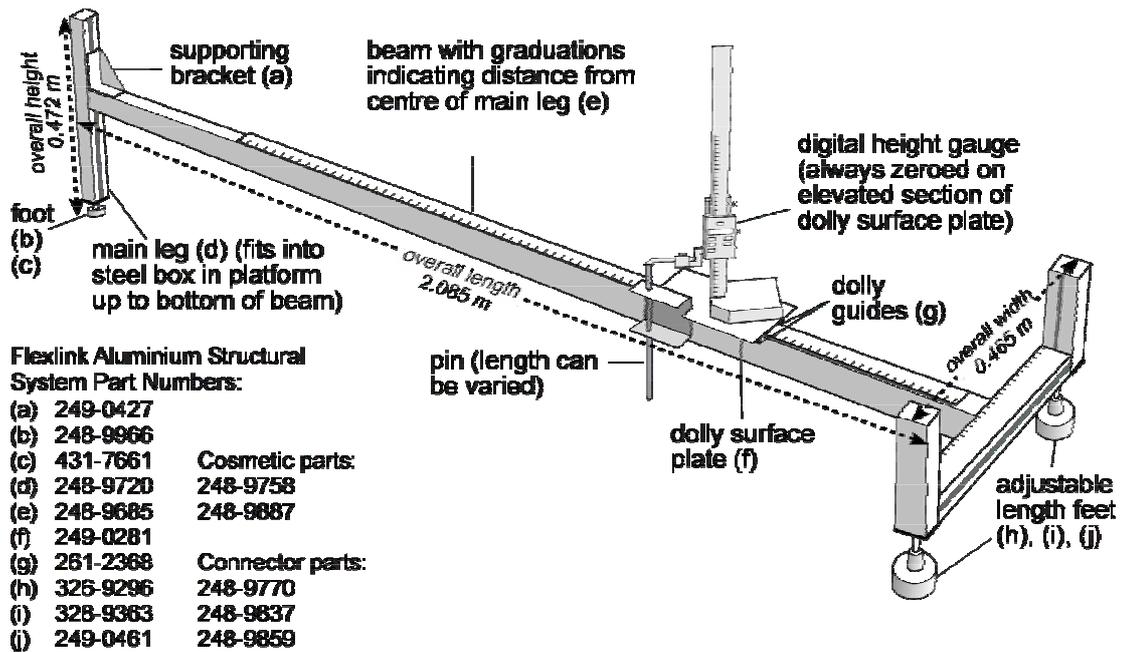
Figure 3.8. The Traversing Erosion Beam (TEB). Relevant Flexlink Aluminium Structural System part numbers are identified.

- (i) allow the instrument to be carried by one person;
- (ii) prevent any compaction/destruction of the platform material when the instrument is in position in the field; and
- (iii) retain high stability and considerable torsional strength.

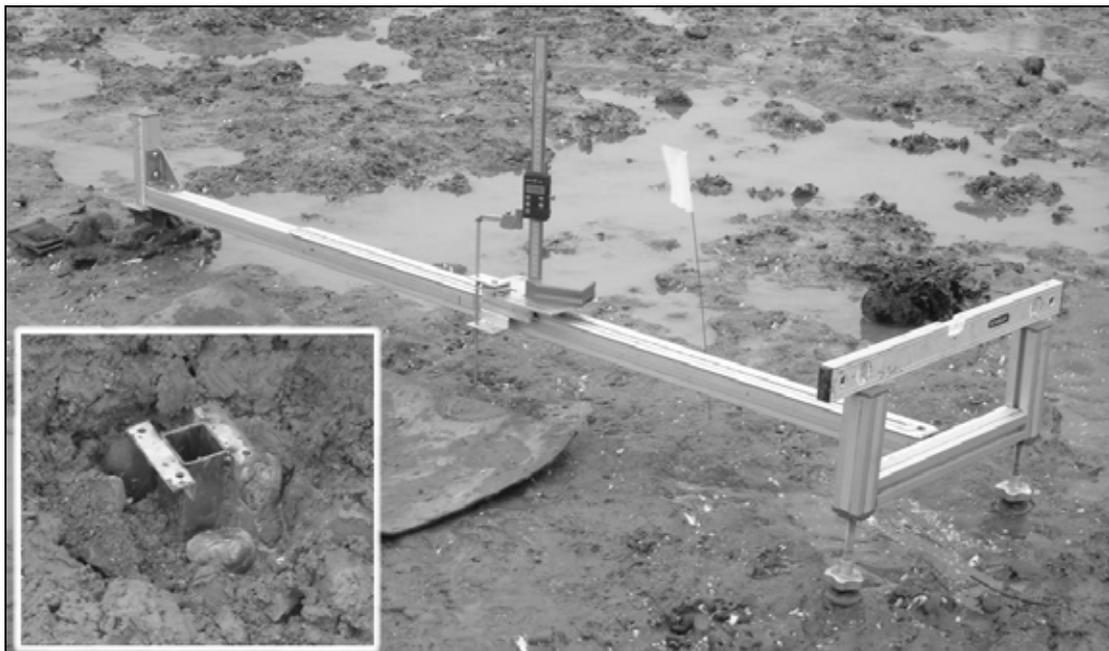
Figure 3.9. The Traversing Erosion Beam in use at Warden Point.

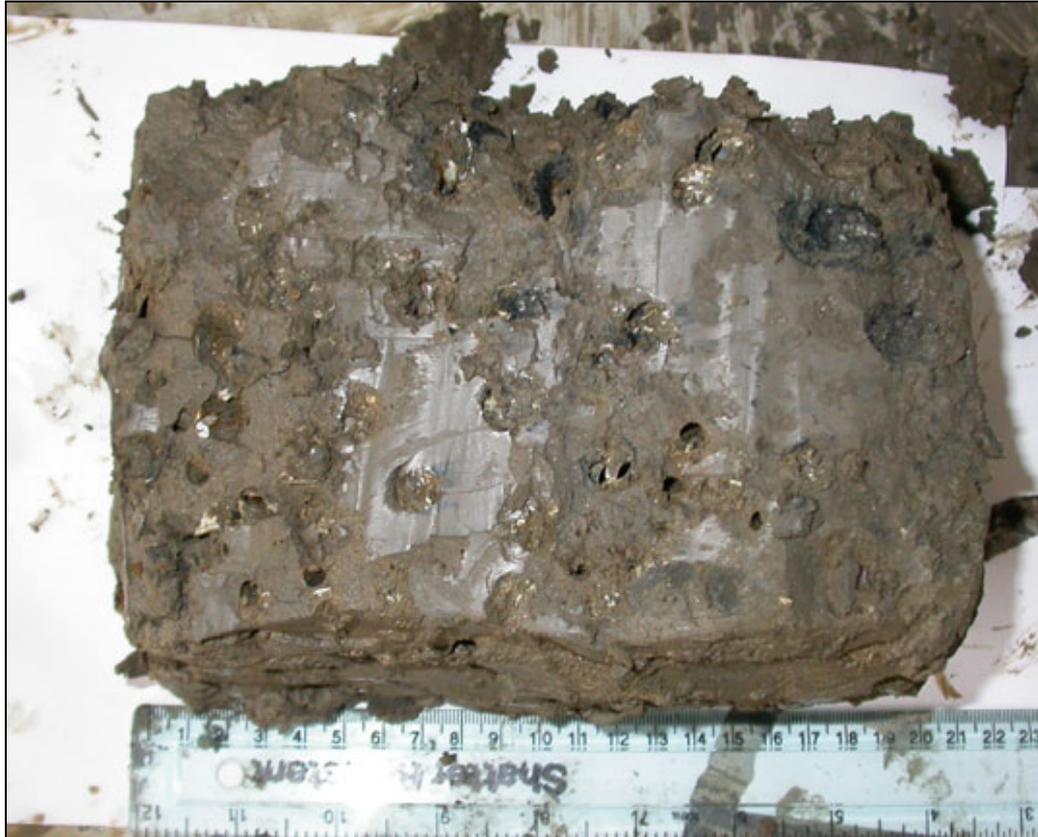
Figure 3.15. Dissected block of cohesive shore platform used to estimate piddock and borehole density.

Two blocks each, approximately 30 cm x 30 cm x 15 cm, were removed from the upper, middle (between sites B and C) and lower (between sites D and E) platform at Warden Point for laboratory analysis of the burrowing organisms. The density of piddocks in each block was estimated. In the laboratory the blocks were firstly trimmed and their precise dimensions measured. Each block was then examined by slicing 2 cm layers from the upper surface using a cheese wire (Figure 3.15). A scale diagram was made of each successive fresh surface and the following recorded: location and diameter of each live piddock, dead piddock, position of a former piddock's body (but now containing little to no shell material), open hole, infilled hole or back-filled plug or base of a hole. Complete shells were removed and their lengths measured. The depth of the bottoms of piddock boreholes was recorded. Volume calculations were based on the assumption that the blocks were perfectly rectangular. Piddock shells were assumed to be cylindrical and their volume calculated using their measured length. Infilled holes were assumed to be cylindrical and their volume calculated based on the assumption that they extended from one 2 centimetre slice to the next. The bottoms of the boreholes were assumed to be cone-shaped and their volume calculated using their measured depth.

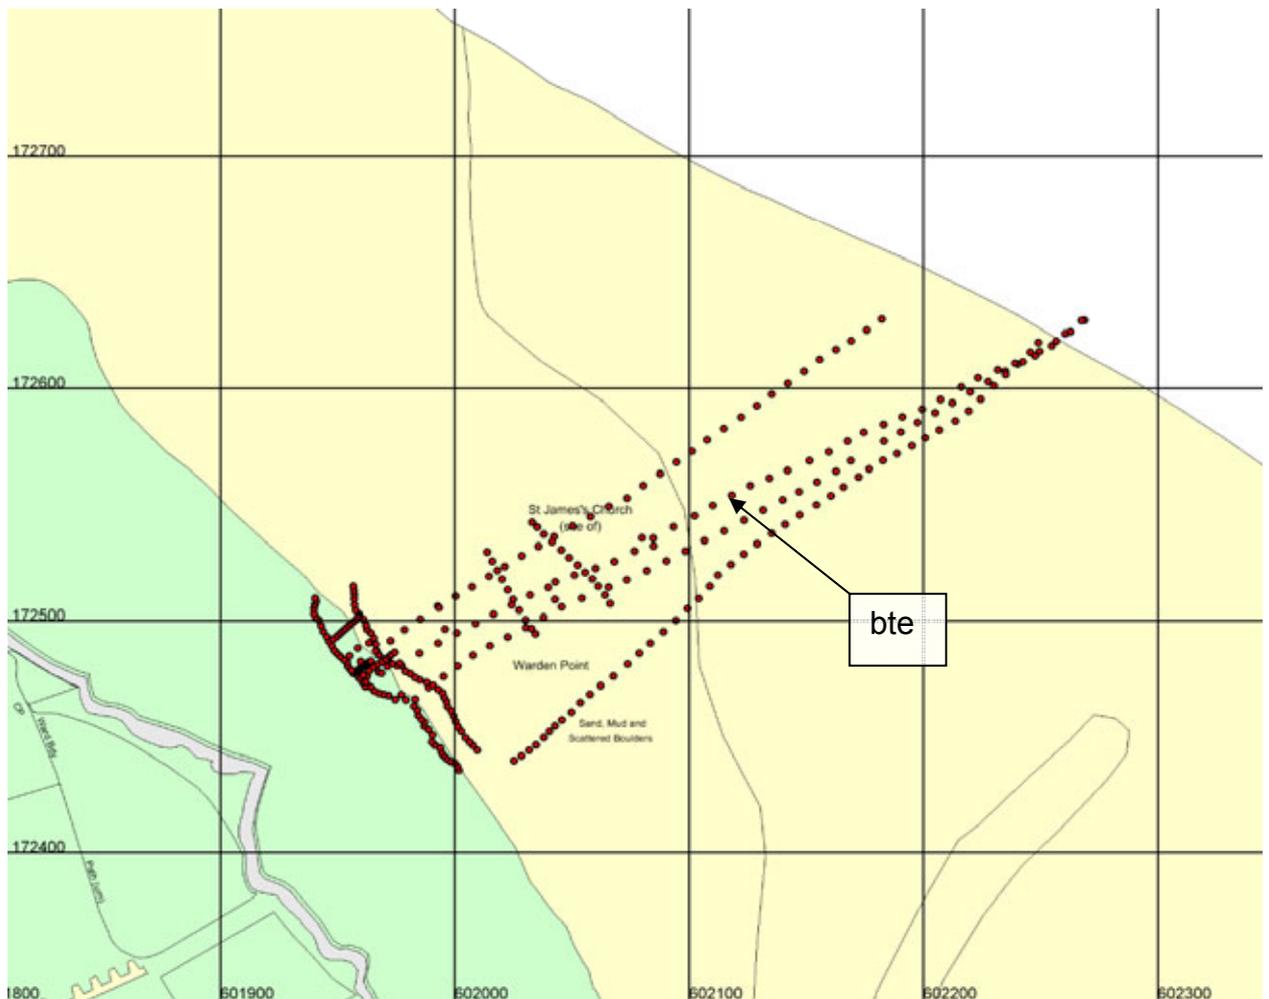
Figure 3.19. Warden Point: GPS survey profiles measured on 22-23rd July 2005. Profile 'bte' labelled (see Figure 3.45).

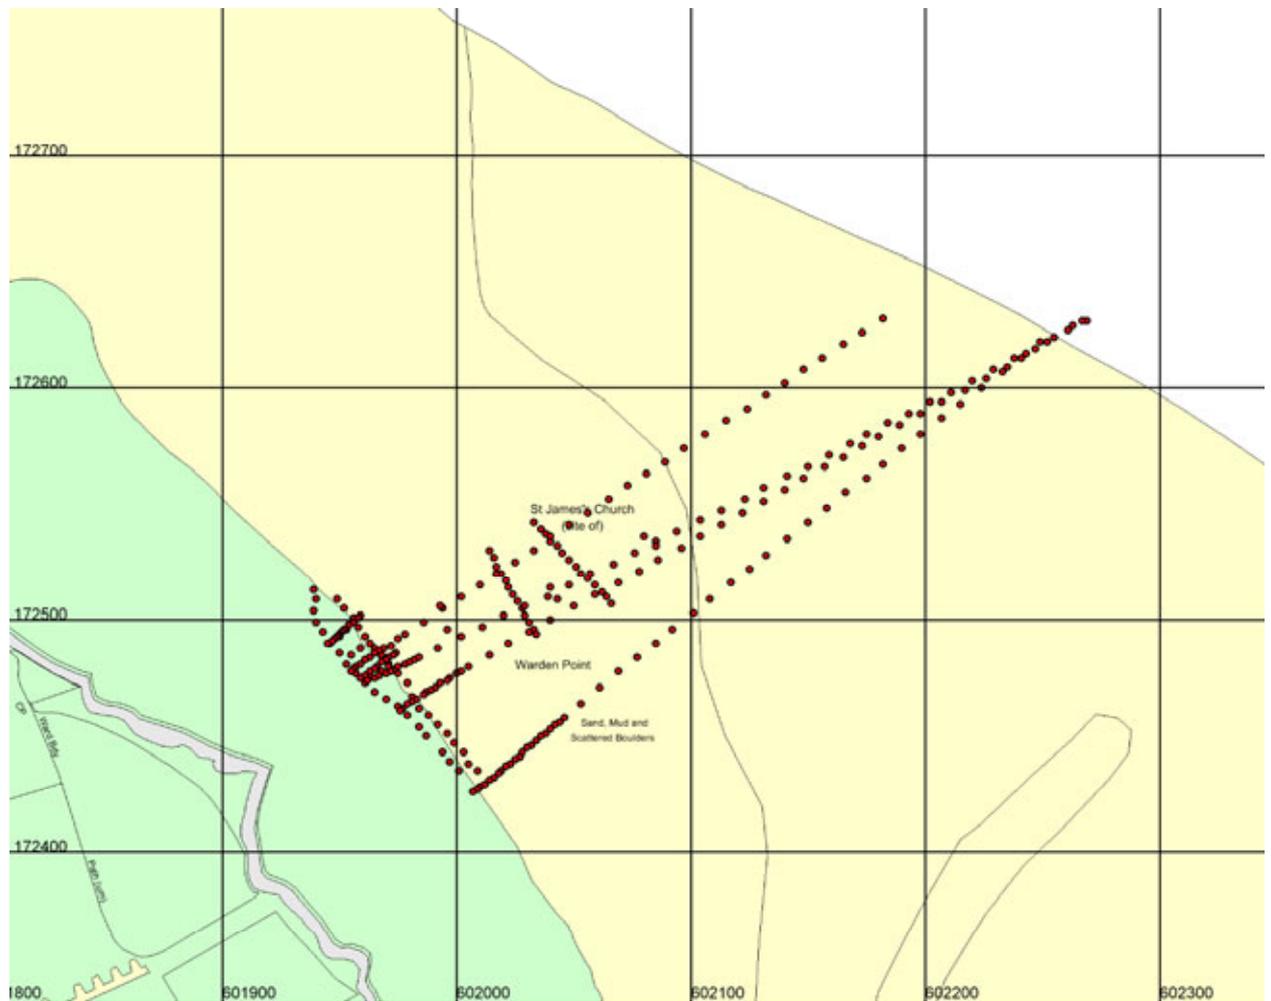
Figure 3.20. Warden Point: GPS survey profiles measured on 3-4th February 2006.

During the repeat surveys on 3-4th February 2006 the same profiles were measured as far as was practicable in order that any changes to the beach profile could be quantified (Figure 3.20).

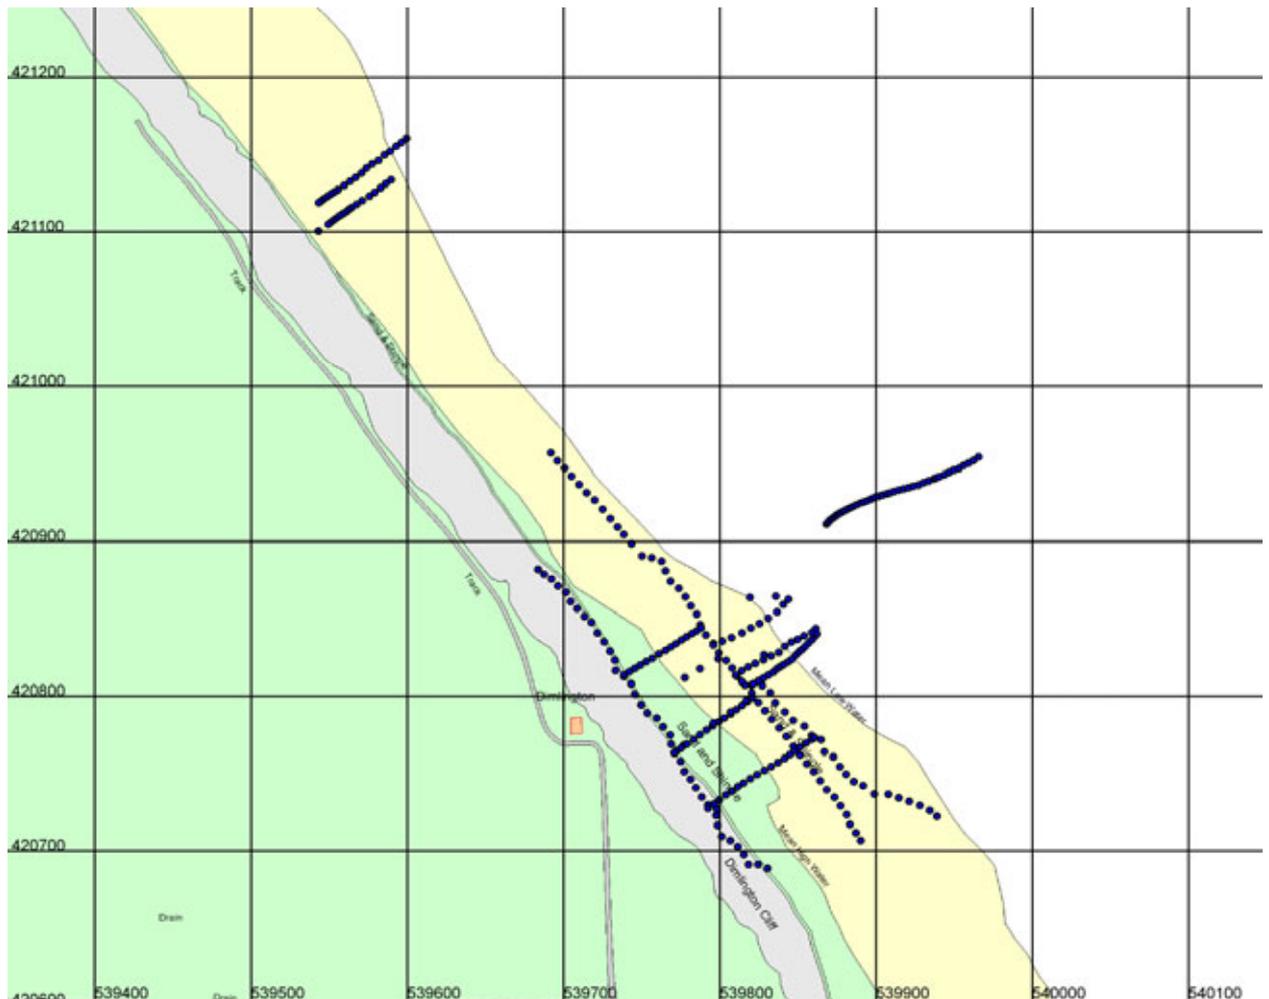
Figure 3.21. Easington: GPS survey profiles measured on 25th-26th July 2005.

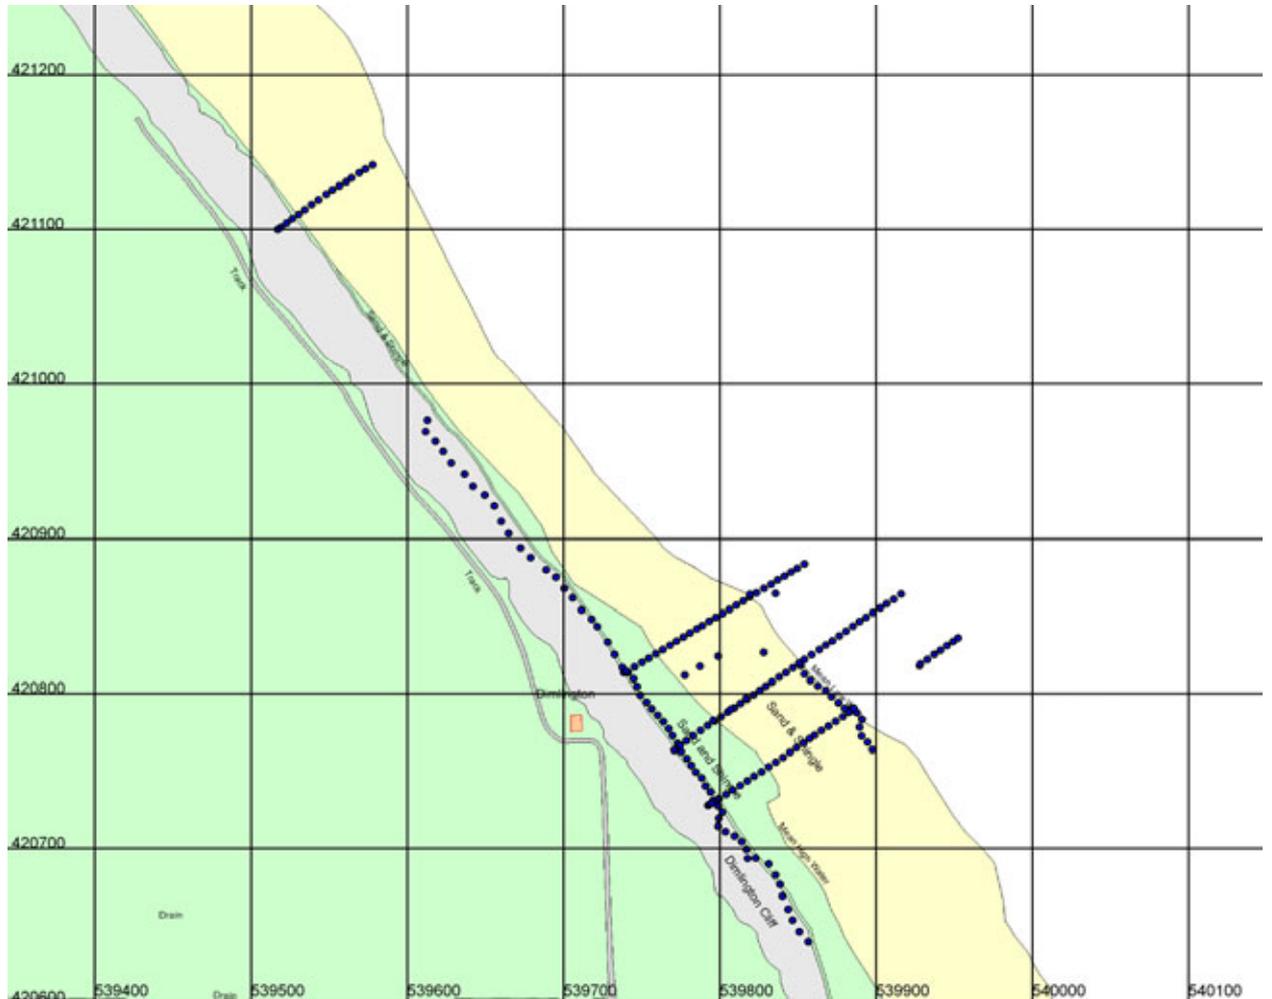
Figure 3.22. Easington: GPS survey profiles measured on 31st March 2006.

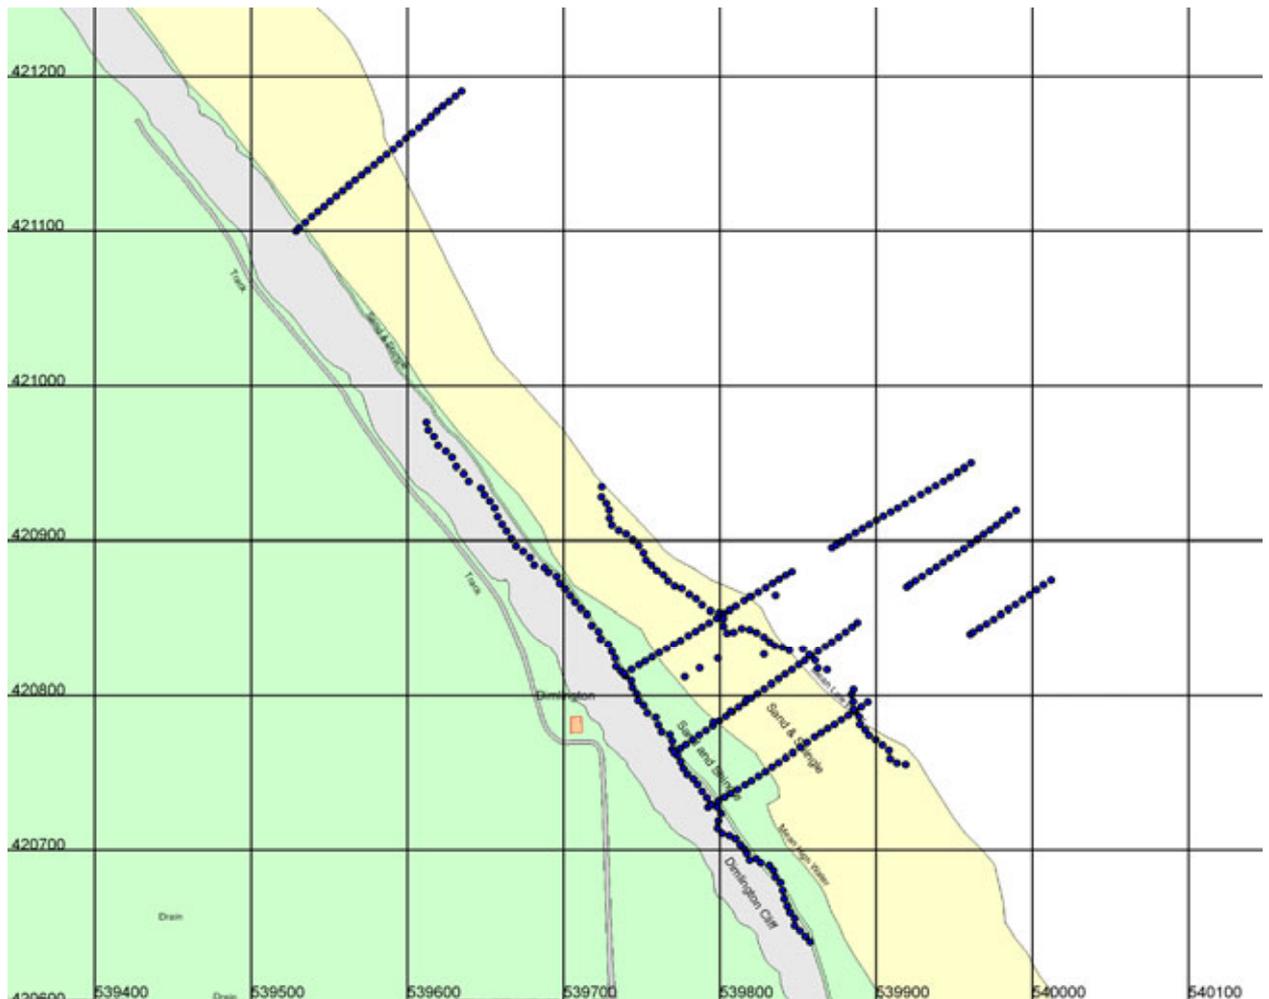
Figure 3.23. Easington: GPS survey profiles measured on 14th July 2006.

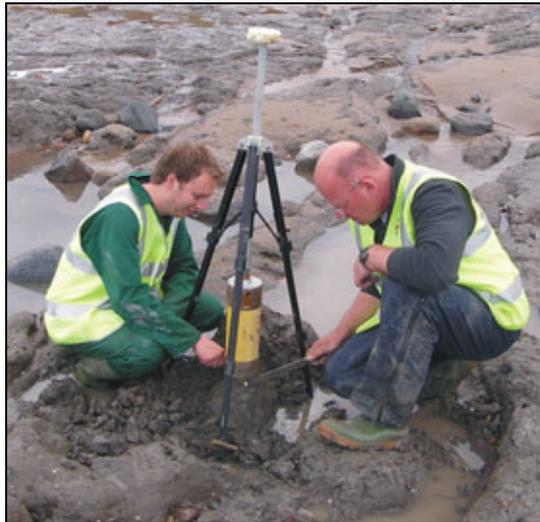
Figure 3.24. Preparation of U100 tube (triaxial) sample

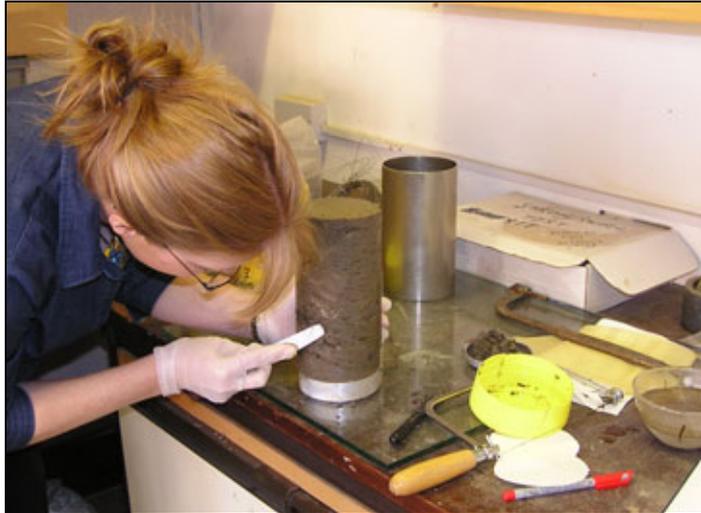
Figure 3.29. Making repairs to the triaxial test specimen.

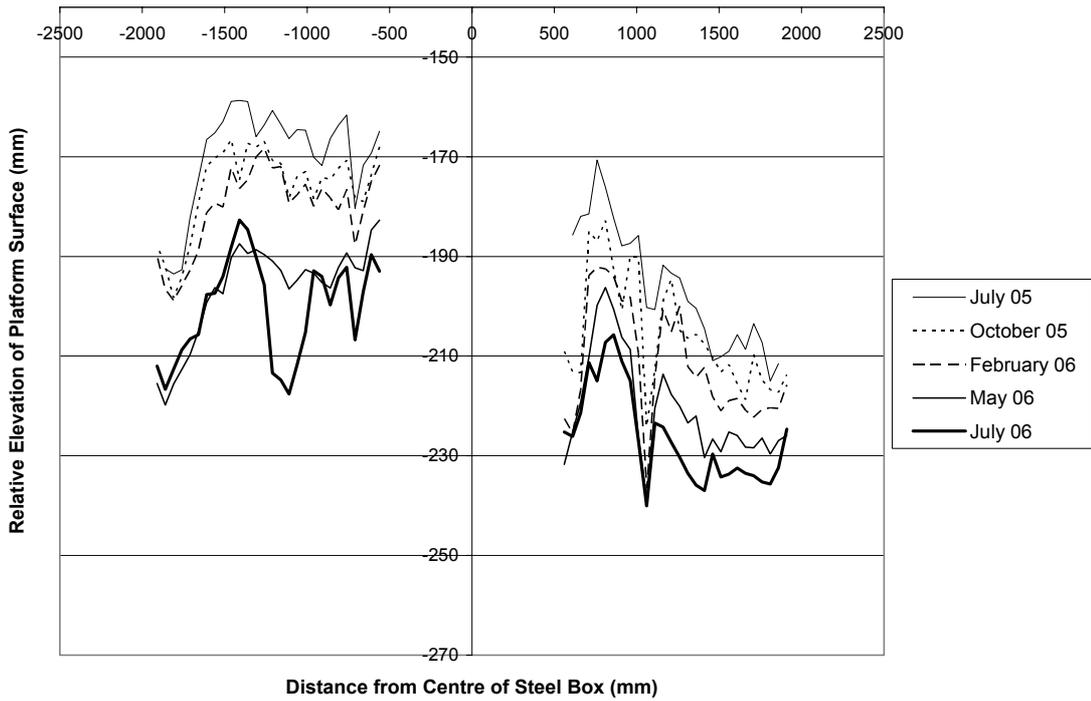
Figure 3.31. Warden Point, location A1: seasonal change in platform elevation, July 2005 to July 2006.

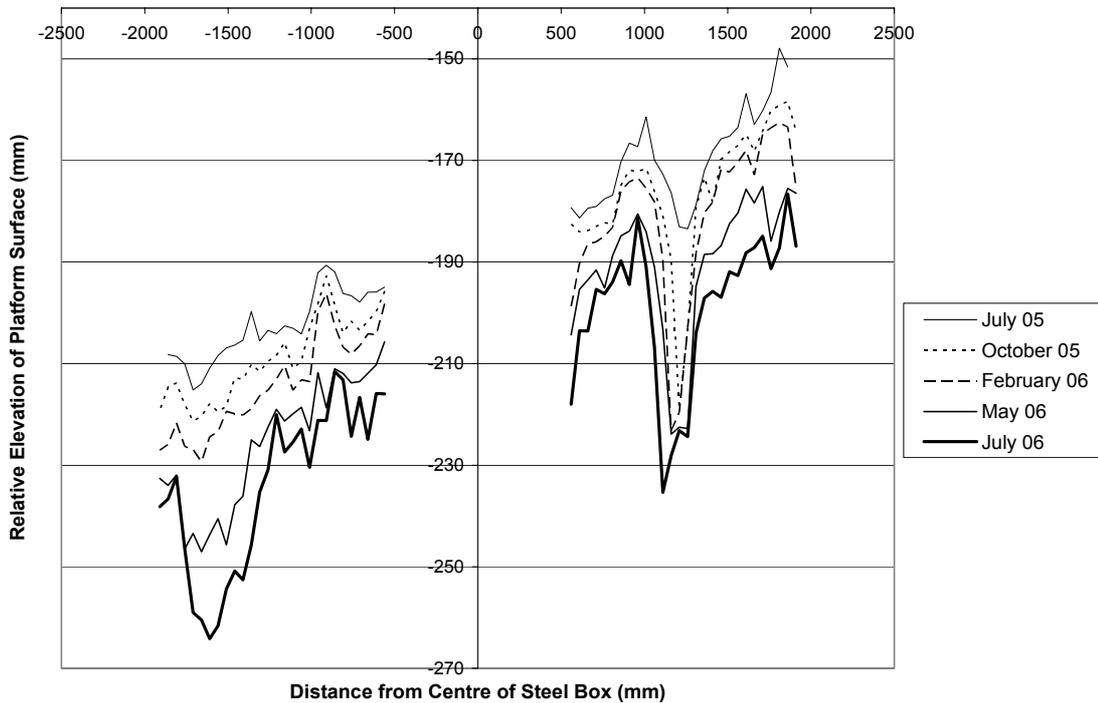
Figure 3.32. Warden Point, location A2: seasonal change in platform elevation, July 2005 to July 2006.

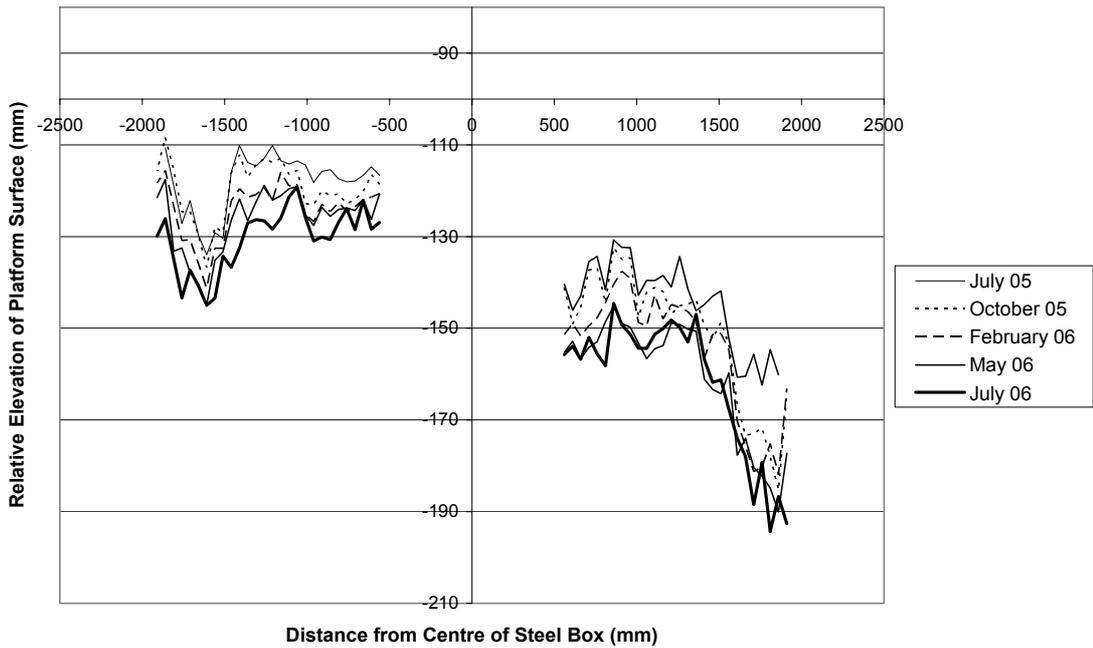
Figure 3.33. Warden Point, location B1: seasonal change in platform elevation, July 2005 to July 2006.

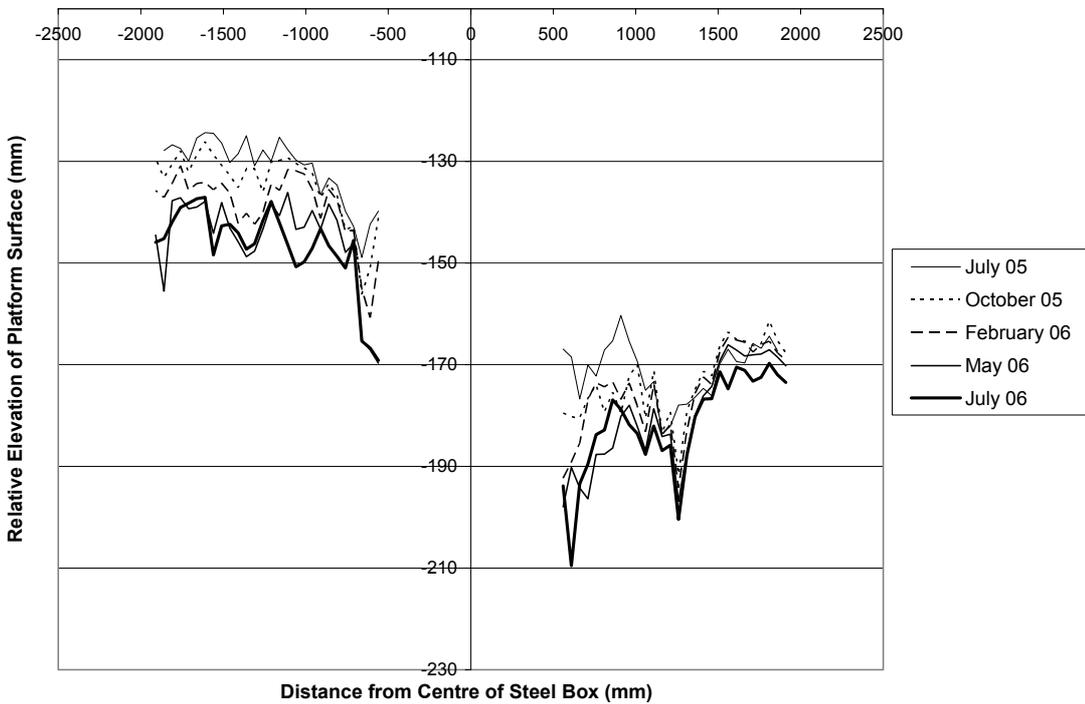
Figure 3.34. Warden Point, location B2: seasonal change in platform elevation, July 2005 to July 2006.

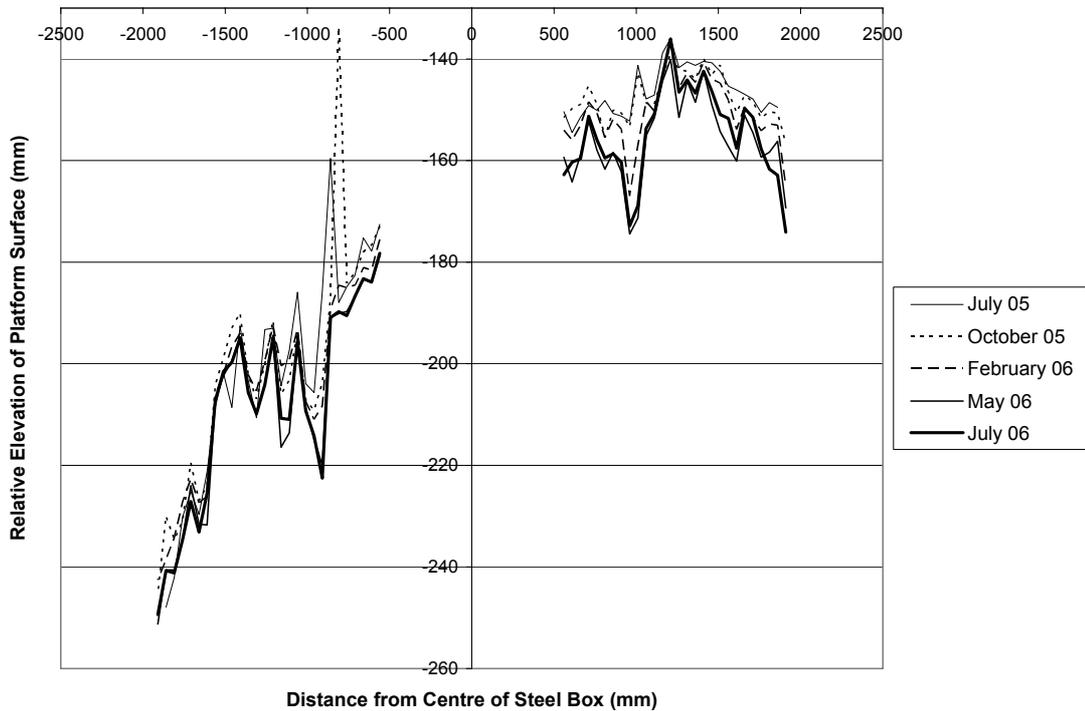
Figure 3.36. Warden Point, location C2: seasonal change in platform elevation, July 2005 to July 2006.
