Understanding and Predicting Beach Morphological Change Associated with the Erosion of Cohesive Shore Platforms

R&D Technical Report FD1926/TR

Produced: December 2007

Author(s): Royal Haskoning, British Geological
Survey, University of Sussex, Newcastle University

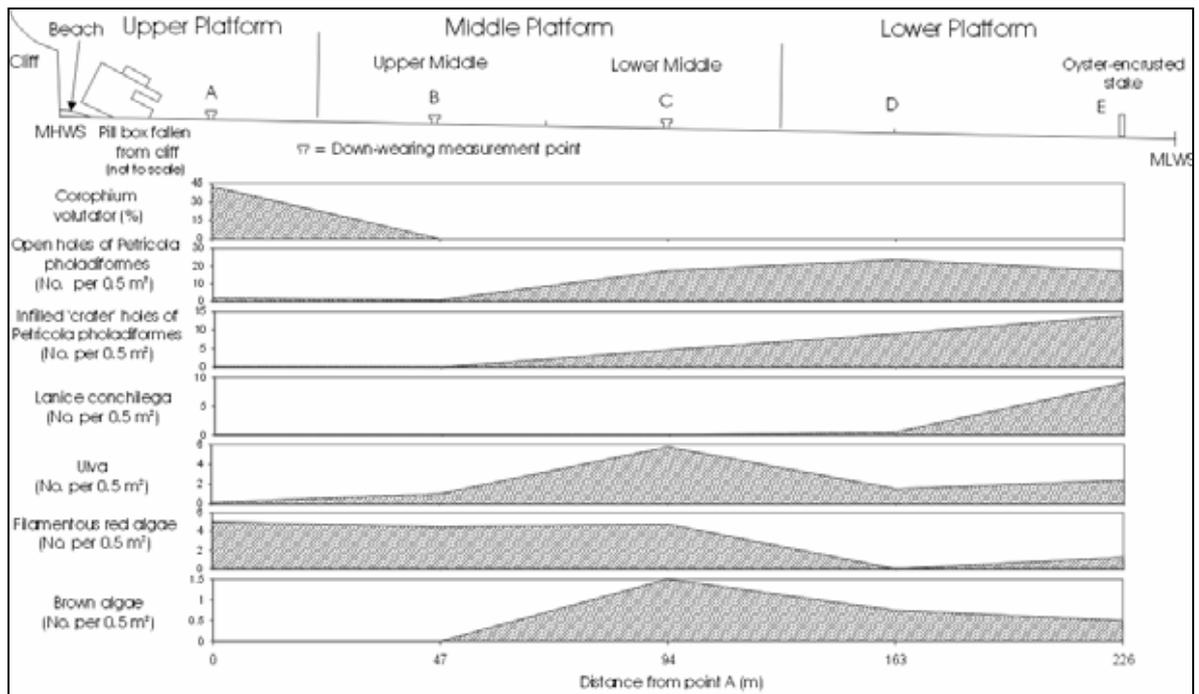
Figure 3.44. Summer distribution of organisms across the platform at Warden Point. Note the differences in the density (Y axis) scales. Percentages are the number of 1 cm² within 100 cm² quadrats containing that organism.

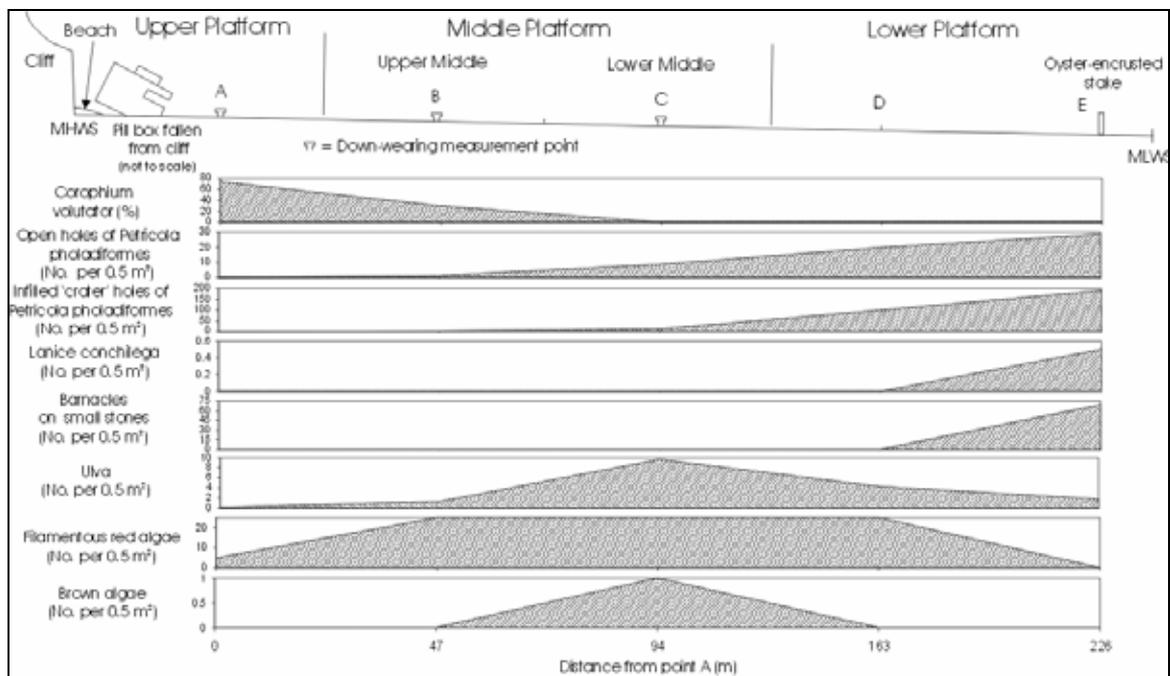
Figure 3.45. Winter distribution of organisms across the platform at Warden Point. Note the differences in the density (Y axis) scales and the addition of Barnacles which were not counted in the summer (Figure 3.43).

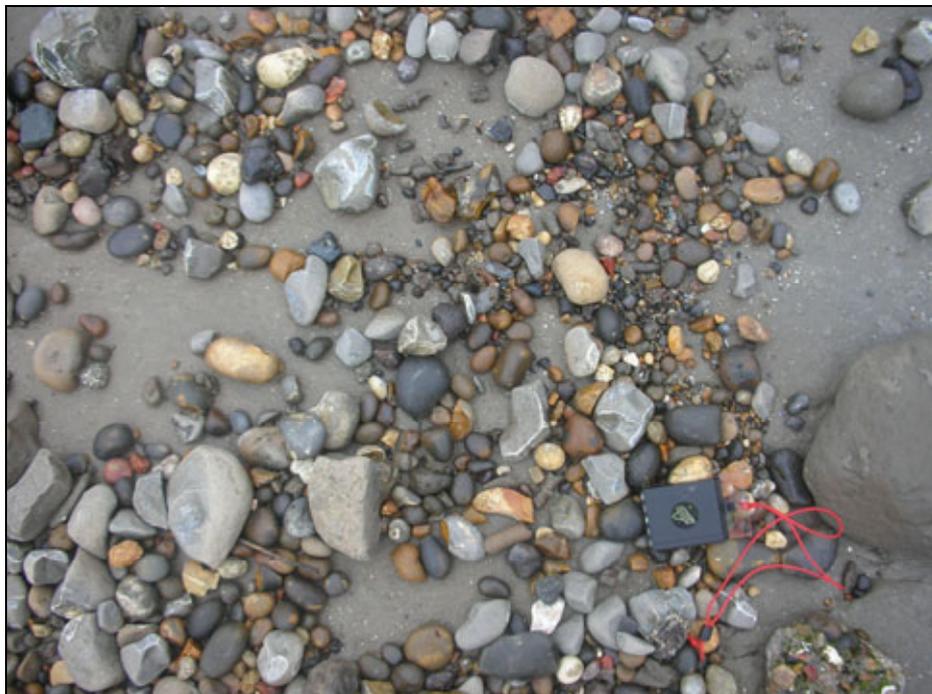
Figure 3.49. Warden Point: Beach sediment seen in February 2006 with lag gravel resting directly on London Clay platform.

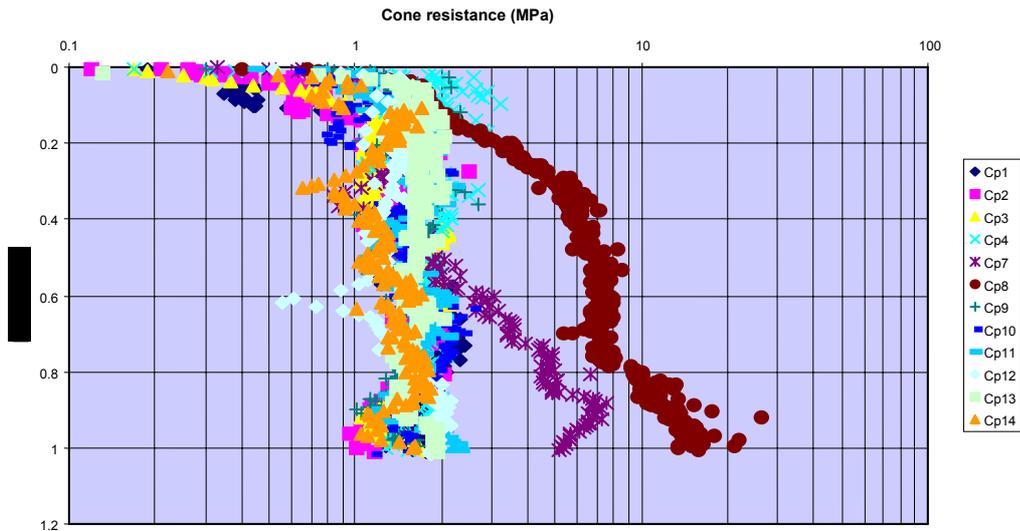
Figure 3.50. Panda penetrometer test profiles- Warden Point

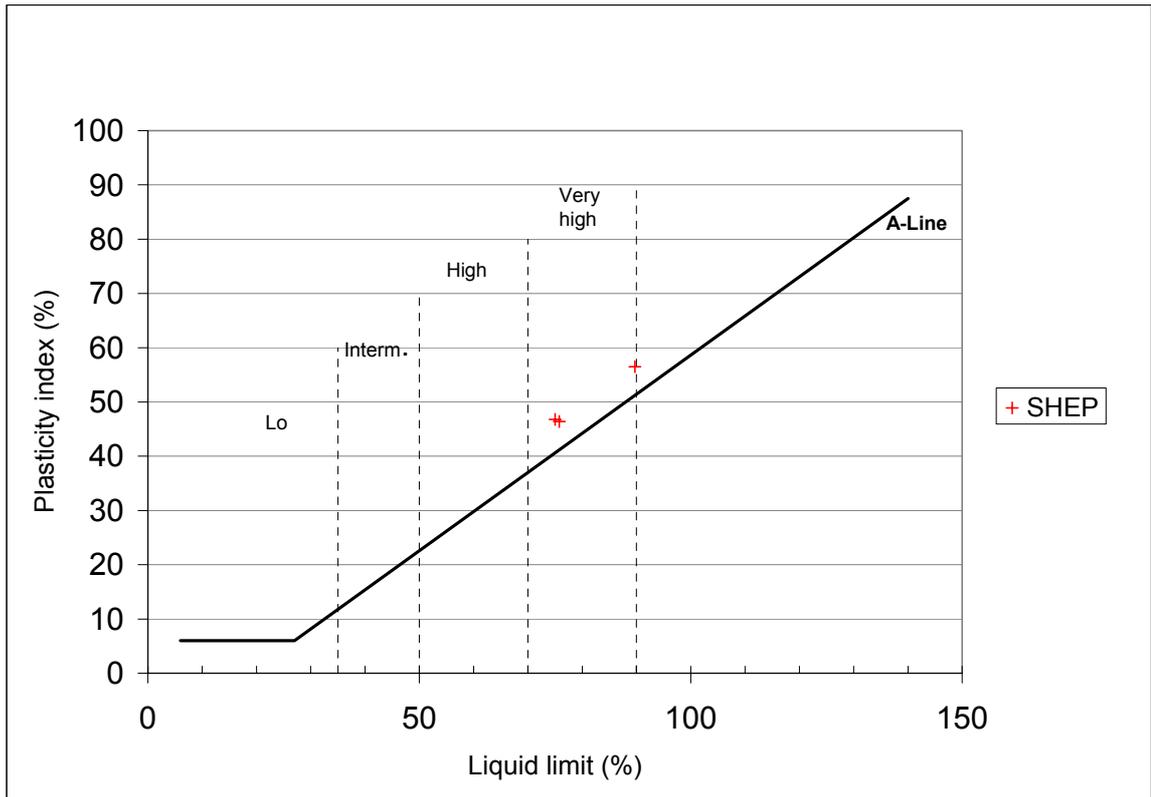
Figure 3.51. Casagrande plasticity plot for triaxial samples.

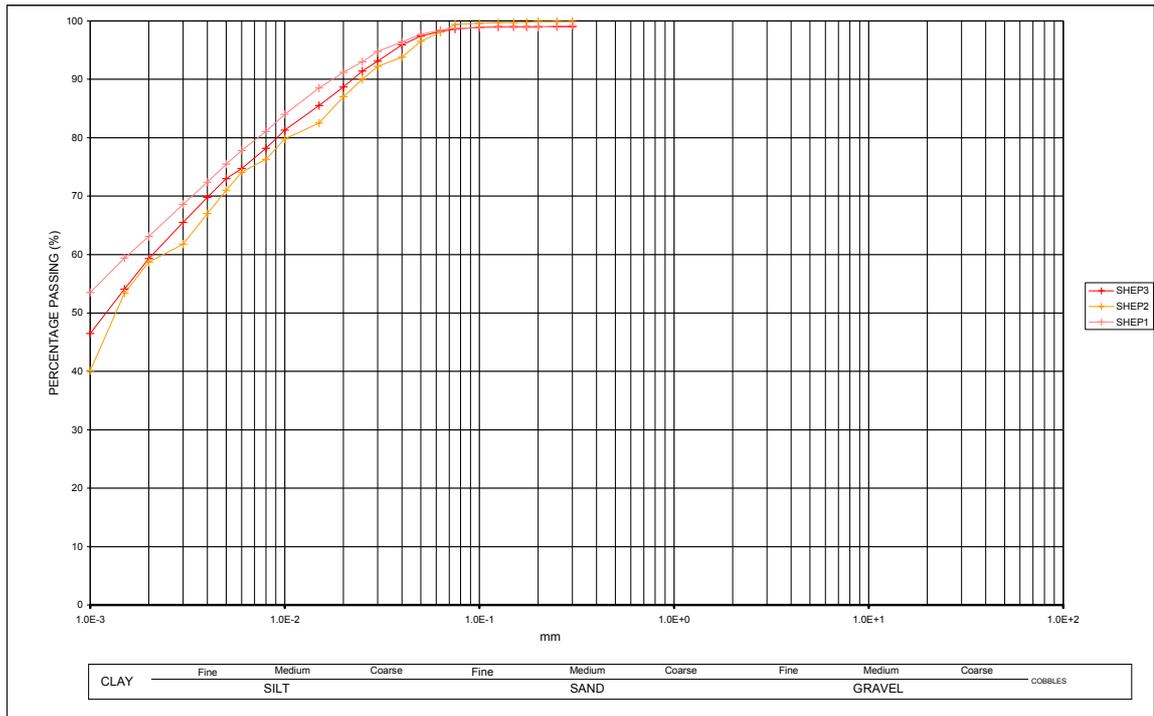
Figure 3.52 Particle size analysis grading curves matching triaxial samples.

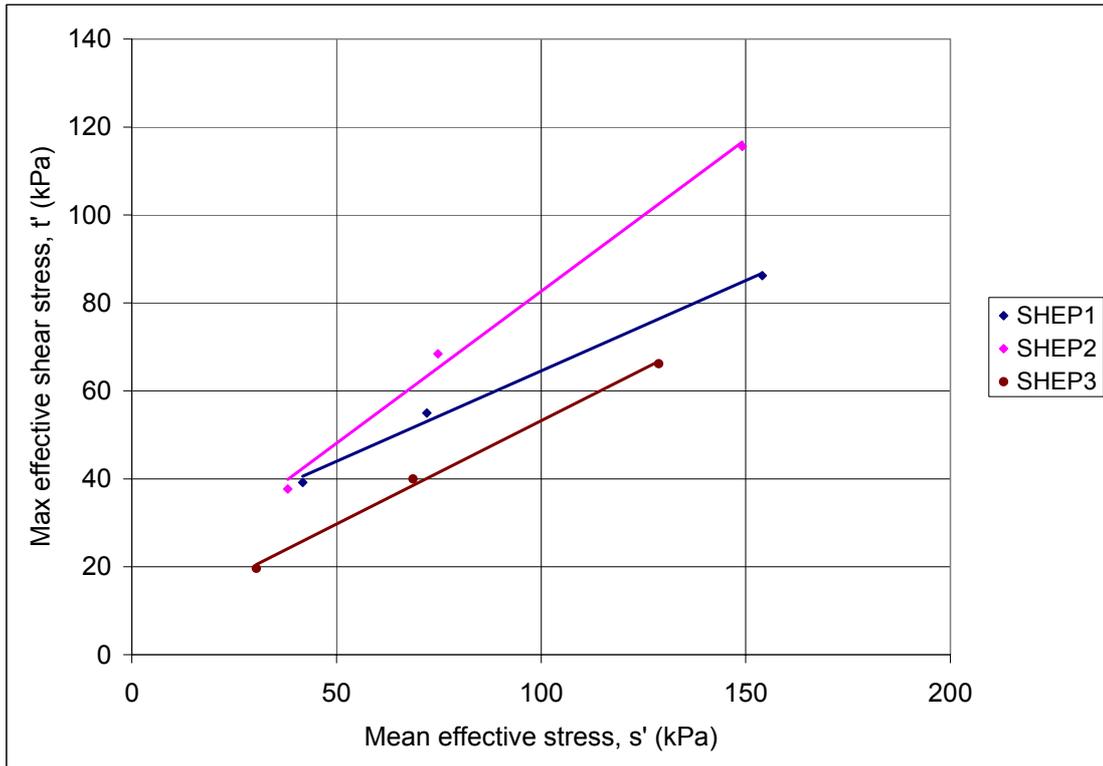
Figure 3.53. Mohr circle locus plots for triaxial tests (effective strength).

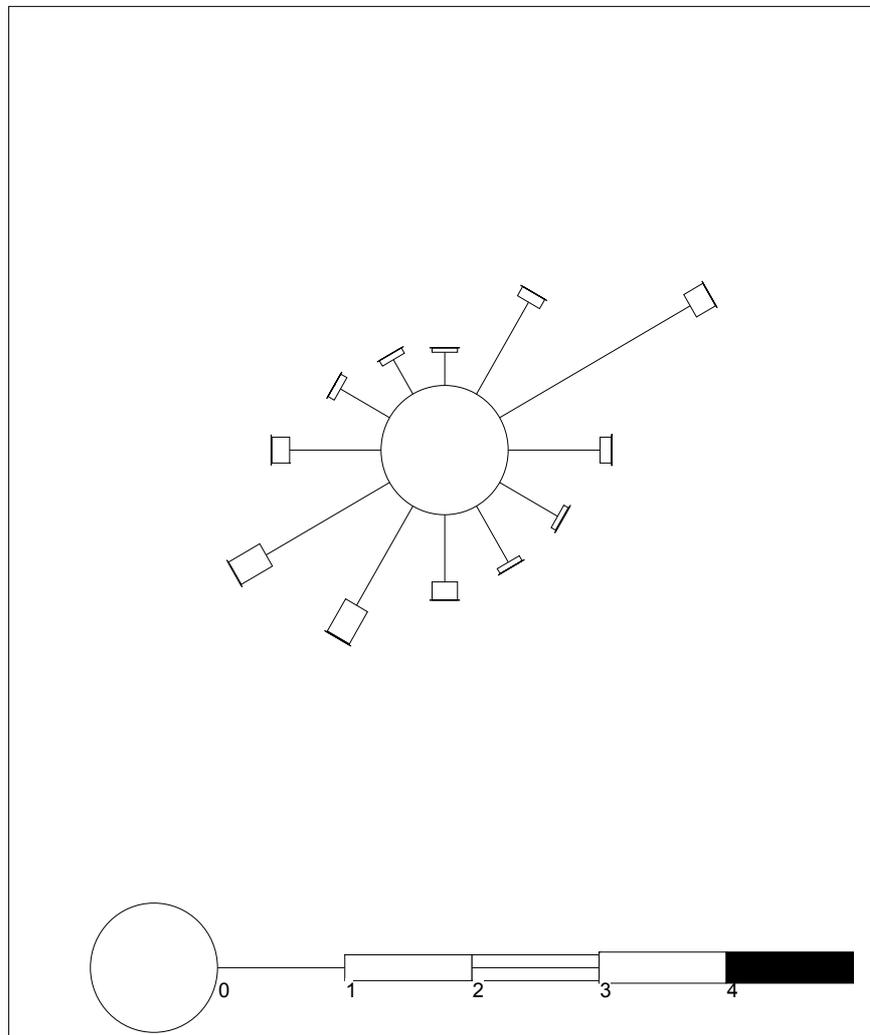
Figure 3.55. Offshore wave rose at Warden Point. Location 51.5°N, 1.1°E. Period July 1988 to October 2005. Scale is in metres

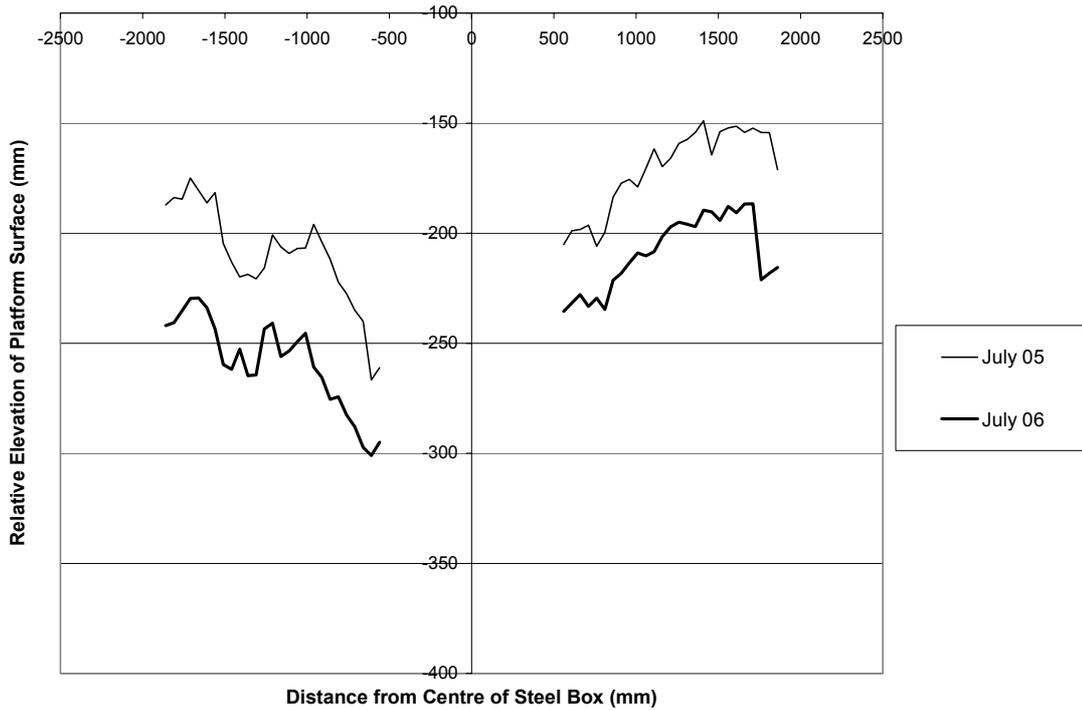
Figure 3.57. Easington, location B: changes in platform elevation, July 2005 to July 2006. Southern profiles on the left hand side, northern profiles on the right hand side.

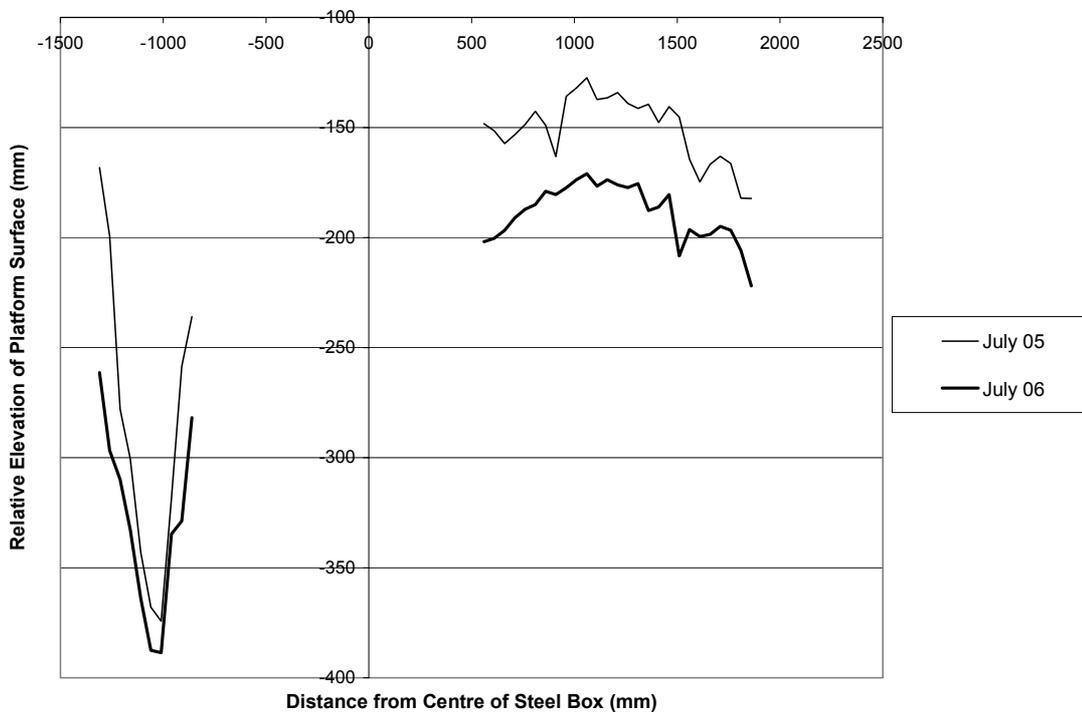
Figure 3.58. Easington, location C: changes in platform elevation, July 2005 to July 2006. Southern profiles on the left hand side, northern profiles on the right hand side.

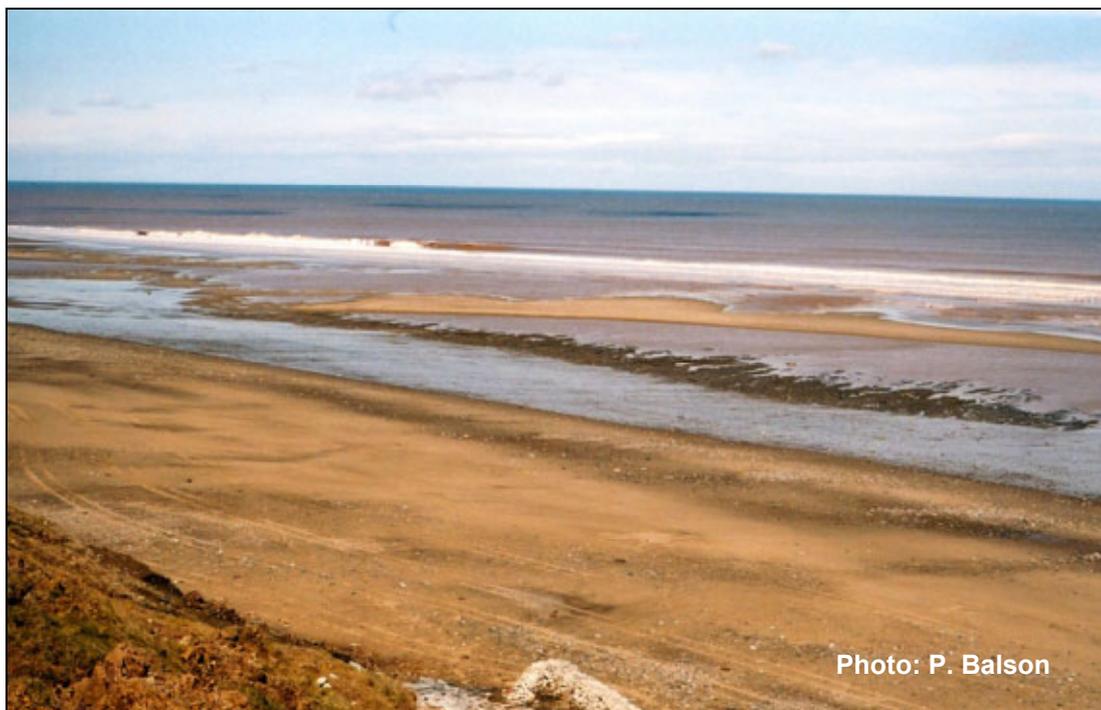
Figure 3.60. Easington: Narrow intertidal platform exposed at low water between low angle beach and nearshore shore-oblique bar (March 2006).

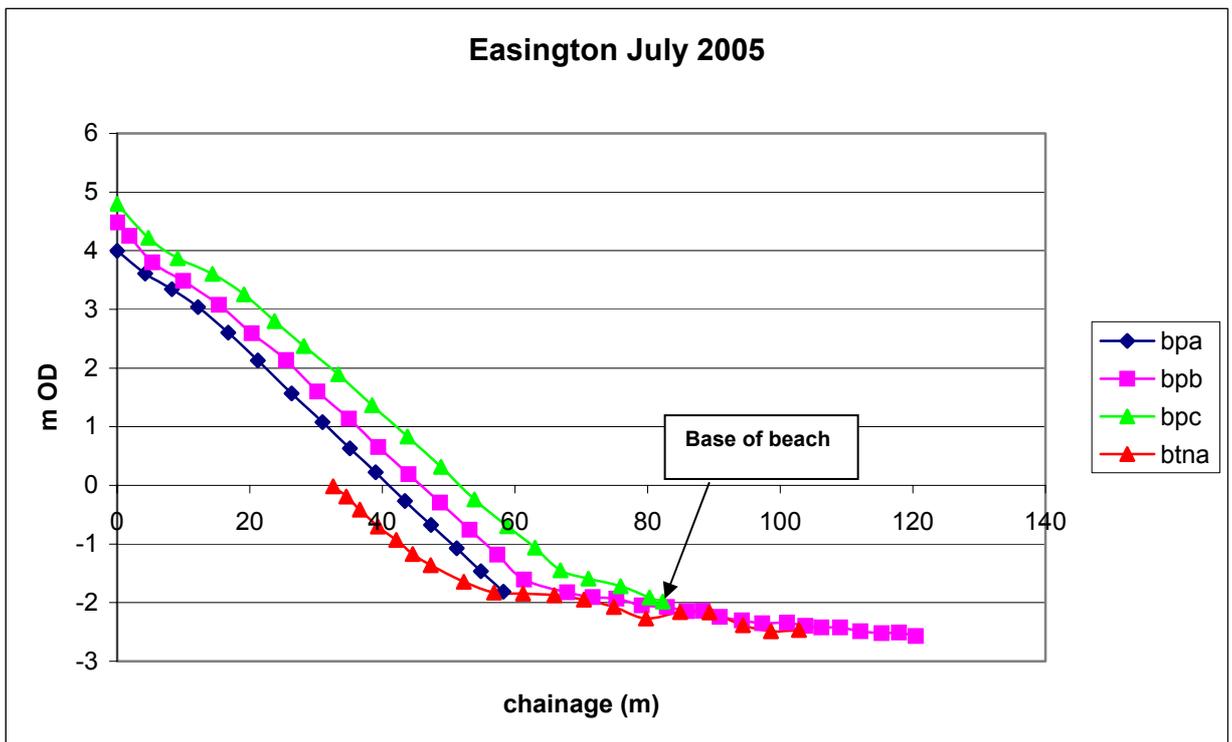
Figure 3.61. Easington: Shore-normal profiles in July 2005 showing reduction in elevation of beach profile from south (bpc) to north (btna).

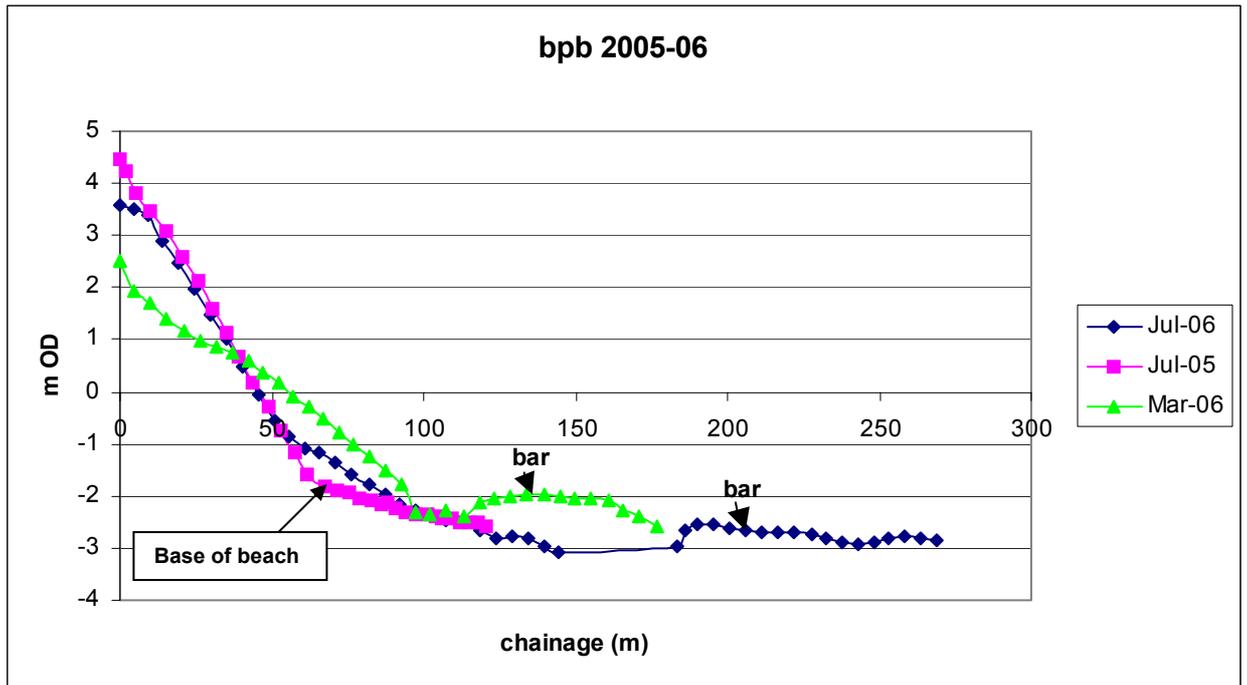
Figure 3.62. Easington: Cross-shore profile 'bpb' showing changes between July 2005 and July 2006.

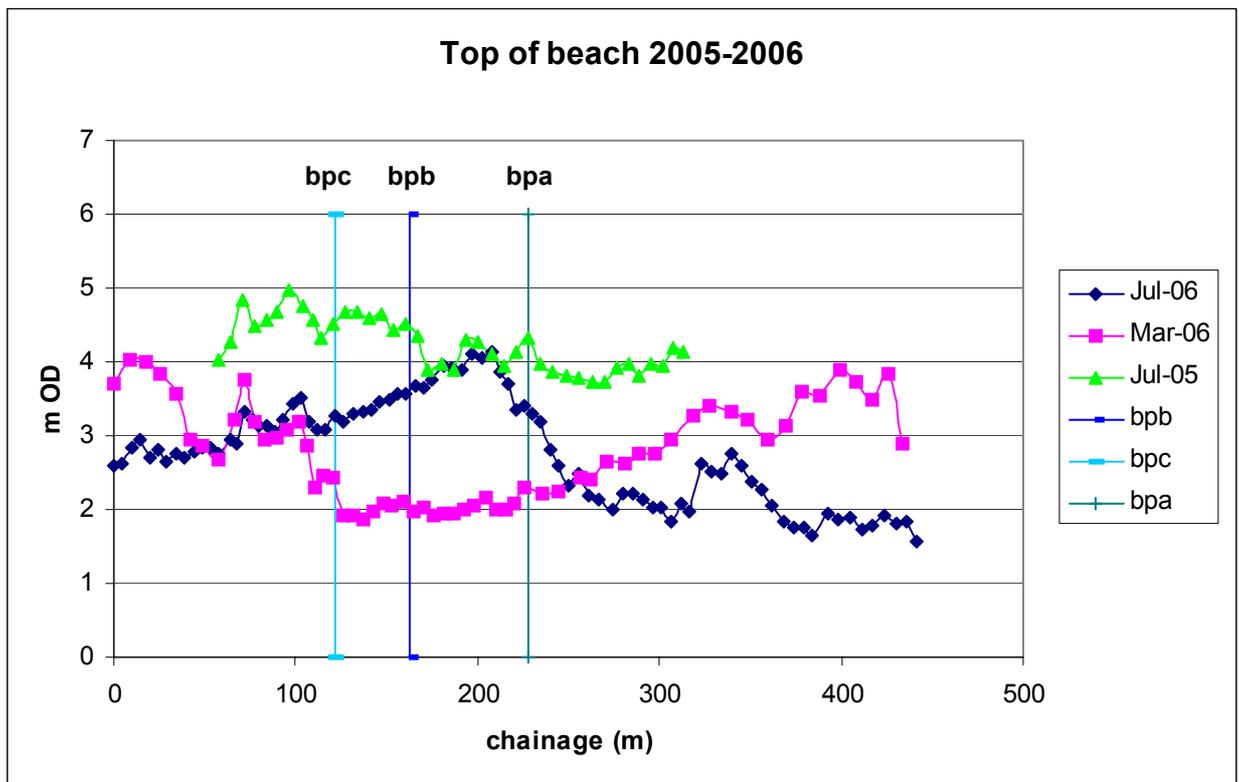
Figure 3.63. Easington: Profiles along top of beach July 2005-July 2006. Intersections with shore normal profiles bpa, bpb and bpc indicated.

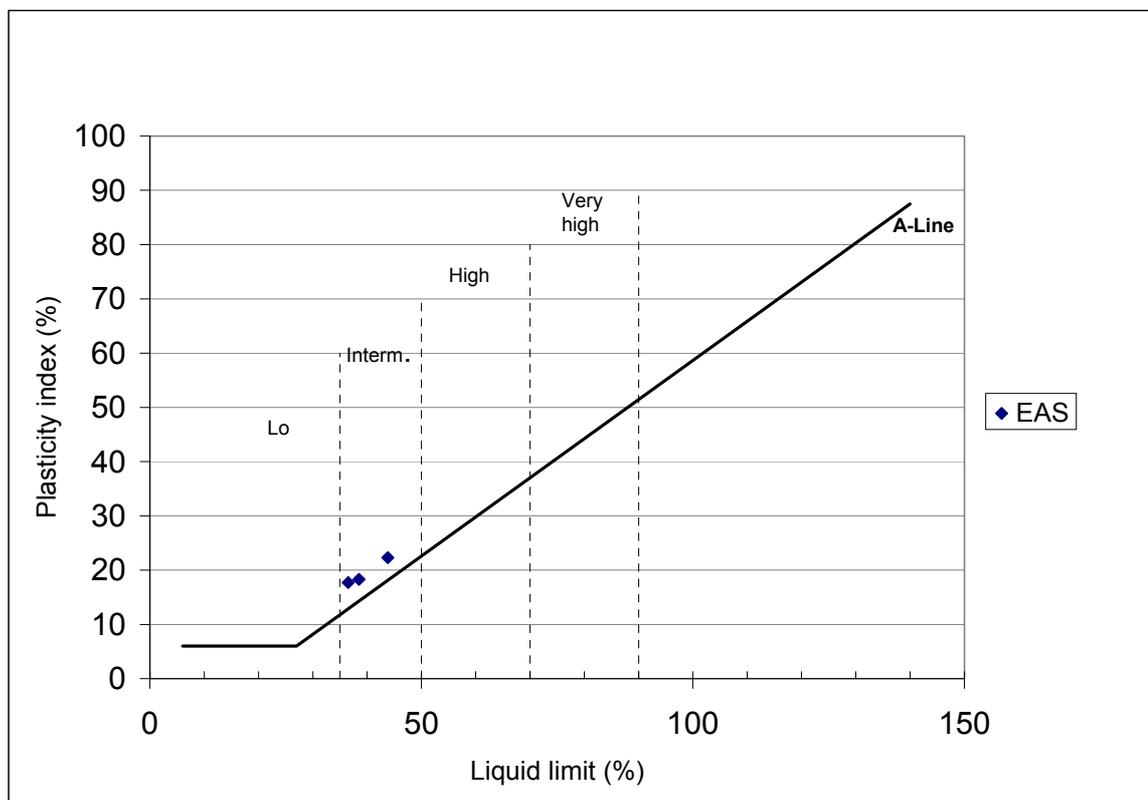
Figure 3.65. Casagrande plasticity plot for triaxial samples.

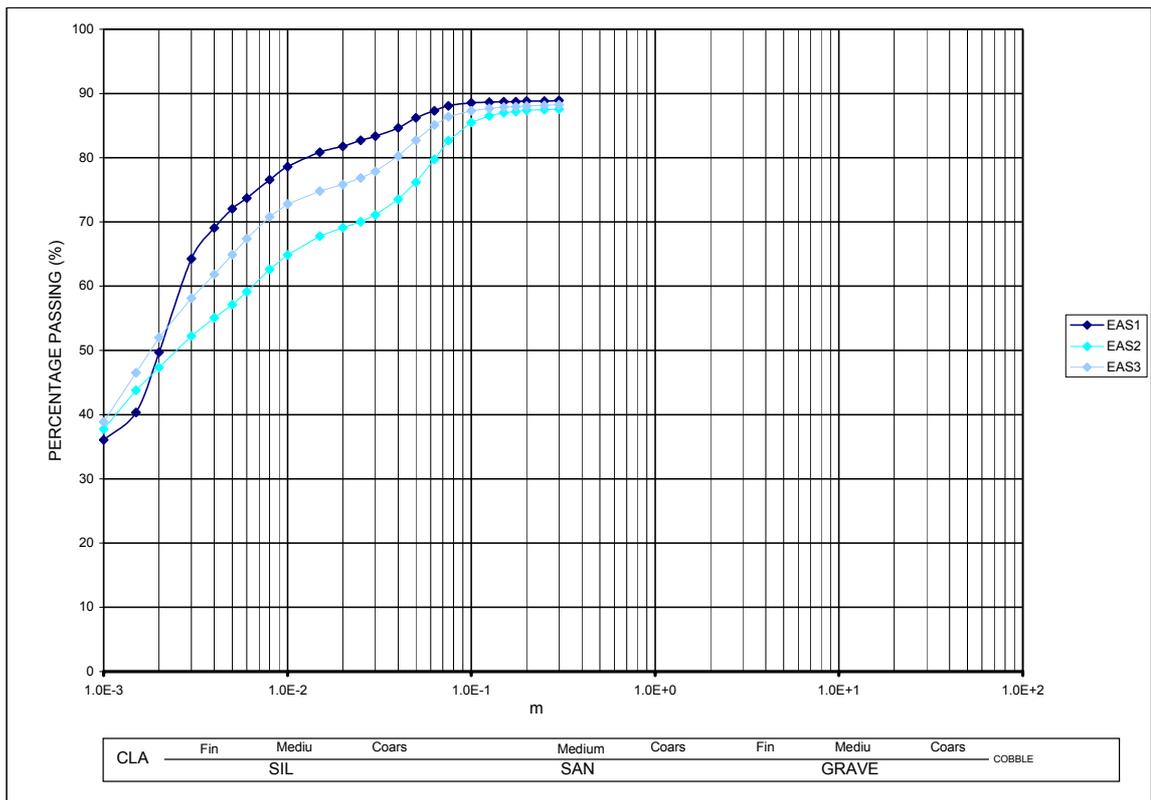
Figure 3.66. Particle size analysis grading curves matching triaxial samples.

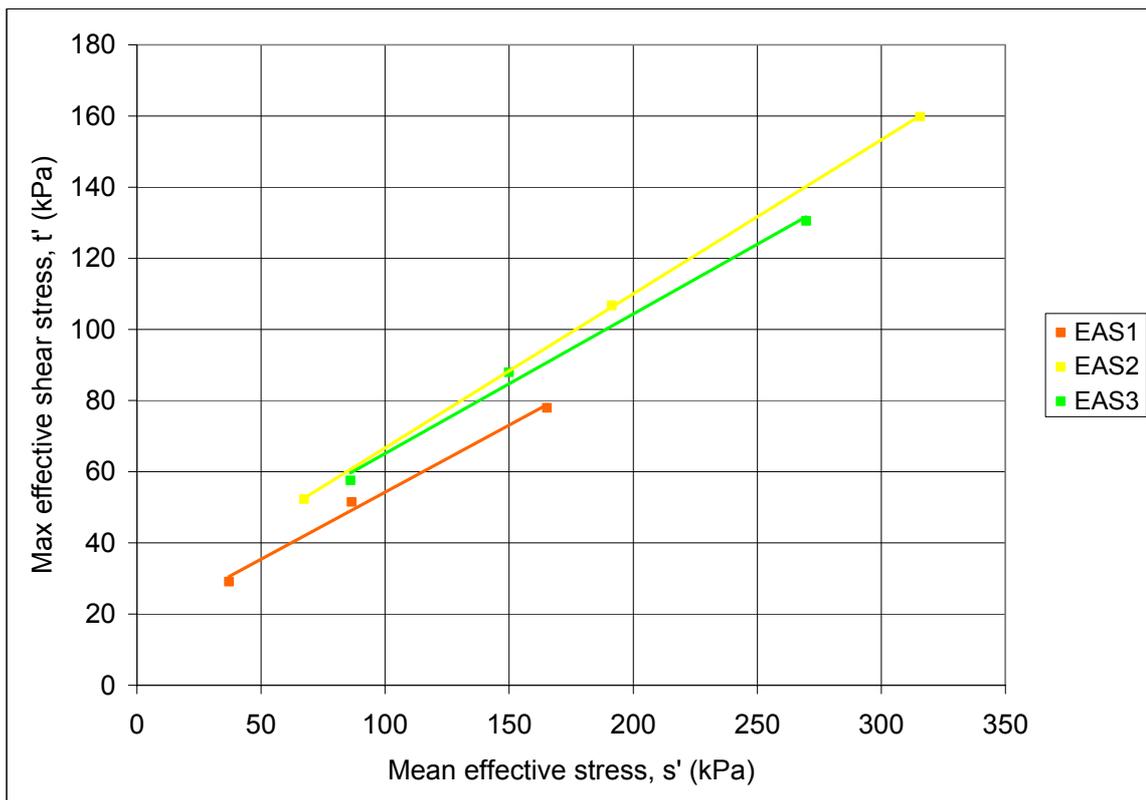
Figure 3.67. Mohr circle locus plots for triaxial tests (effective strength).

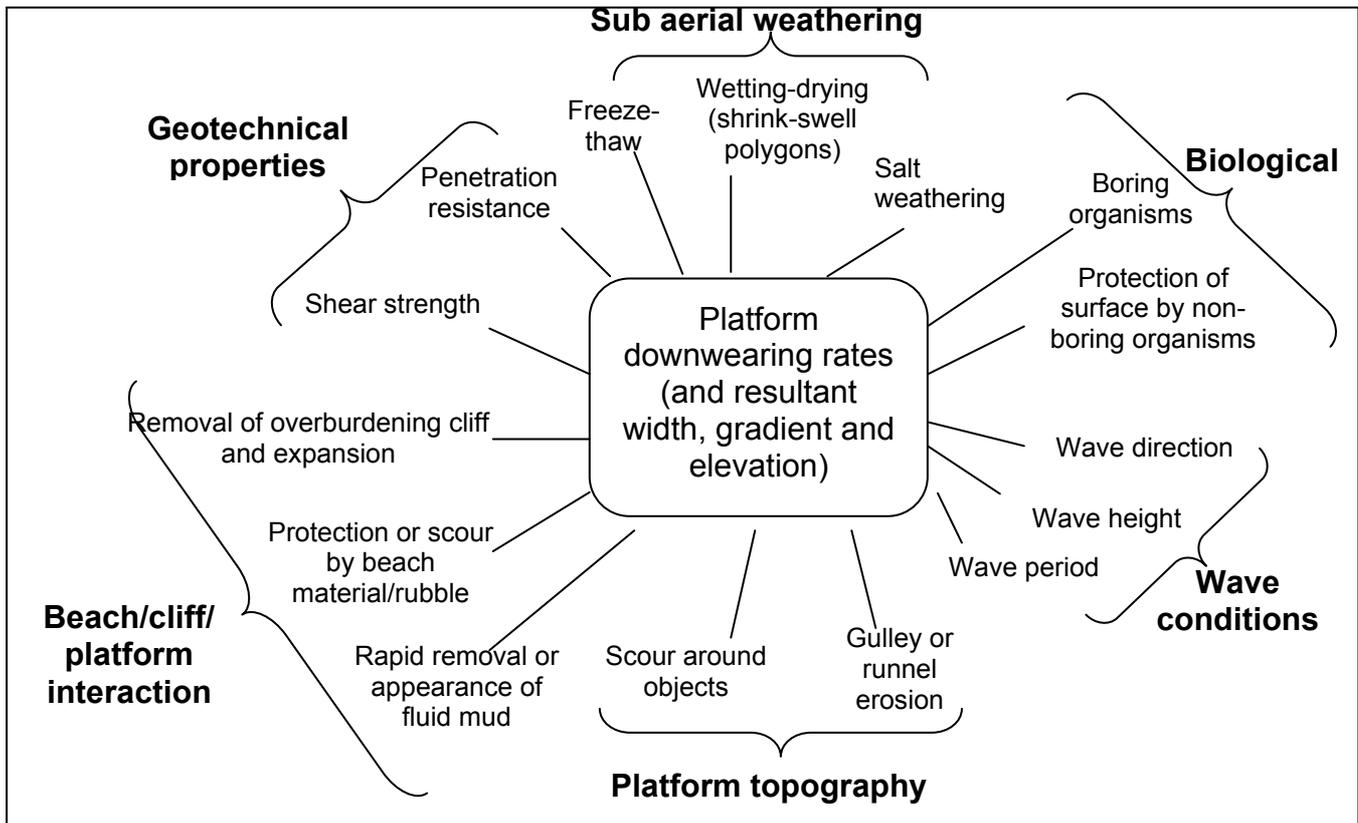
Figure 3.71. Diagram showing the major factors influencing cohesive shore platform downwearing.

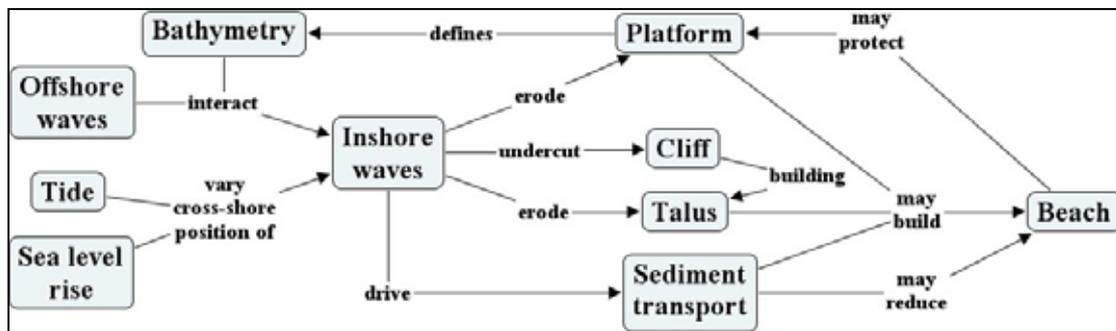
Figure 4.2. Flowchart of processes and interactions represented by SCAPE.

SCAPE is a systems-based model of the processes and interactions through which the profiles of cohesive shore platforms emerge over long timescales. The foreshore and lower cliff is represented by a series of longshore sections, each of which is composed of a stack of horizontally aligned erodible elements. The underlying equation for the retreat of each element comprises parameters representing the breaking wave conditions, tidal variations, profile slope, and insitu material strength. The model links together modules representing the above parameters with cliff recession and talus formation, sediment transport and beach behaviour.

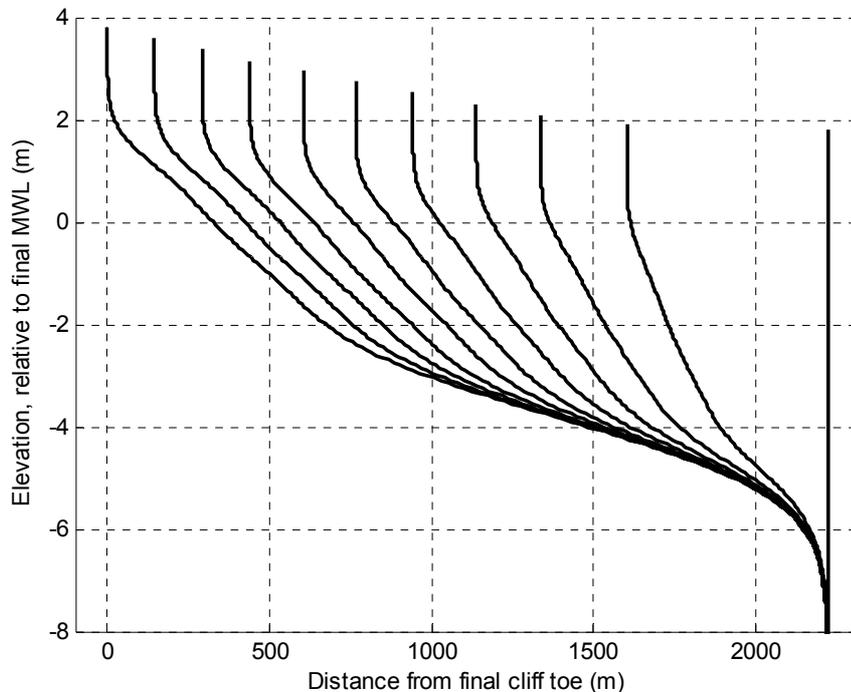
Figure 4.3. One thousand years of Warden Point model profile evolution, in 100 year ‘snapshots’

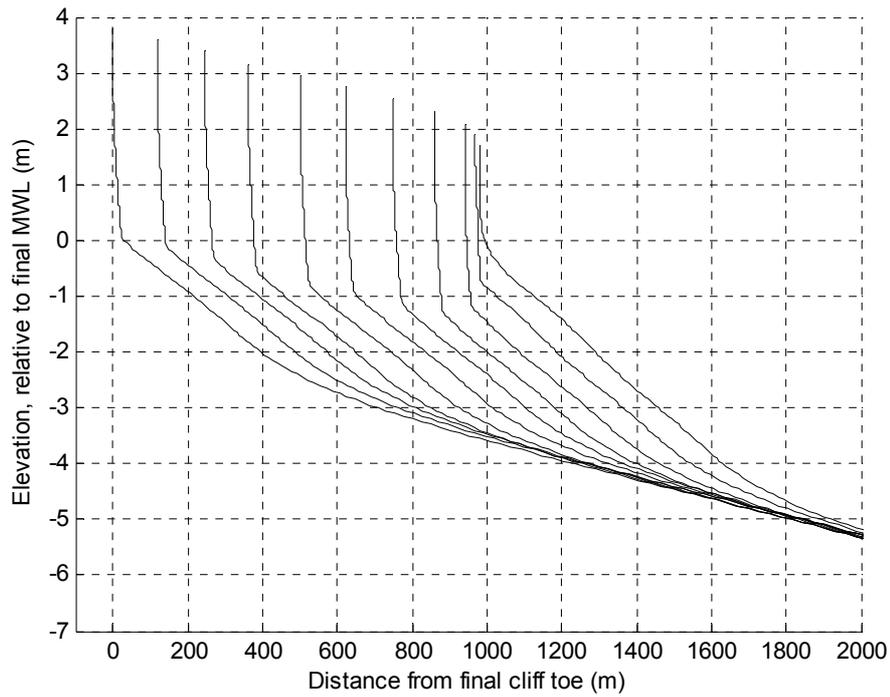
Figure 4.4. 100 year snapshots of profile evolution over 1000 years following the introduction of a beach.

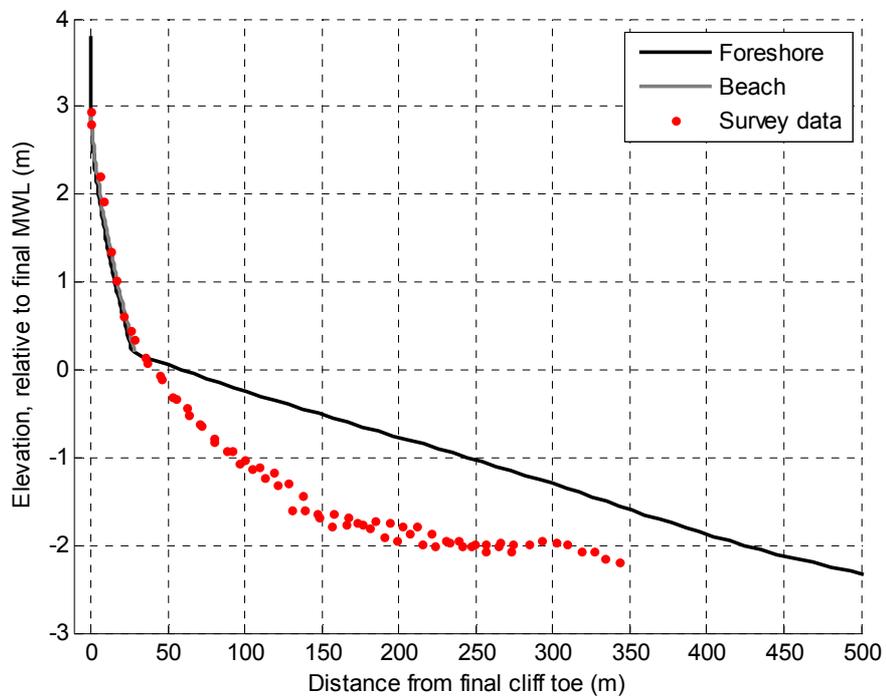
Figure 4.5. Upper model foreshore and beach, and survey data.

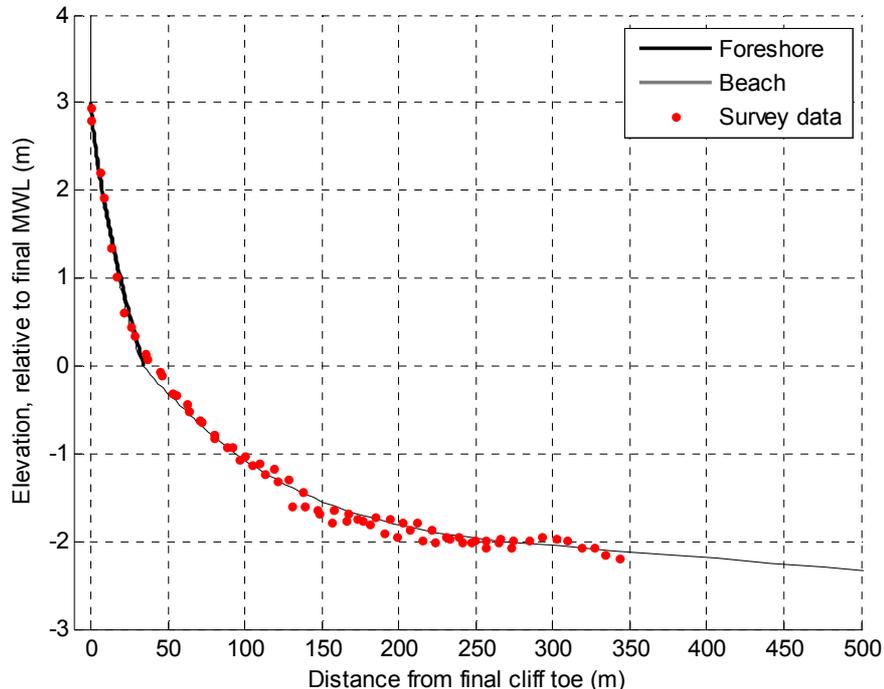
Figure 4.6. Profile obtained accounting for biological weathering ($k = 150 \mu\text{m}$).

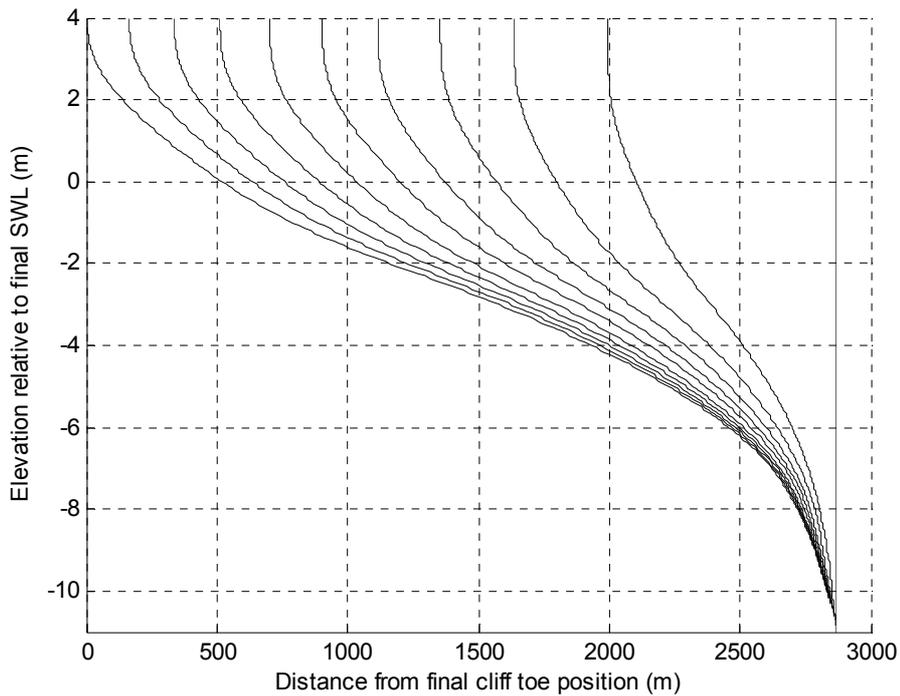
Figure 4.7. 1000 years of Easington model profile evolution, in 100 year 'snapshots'.

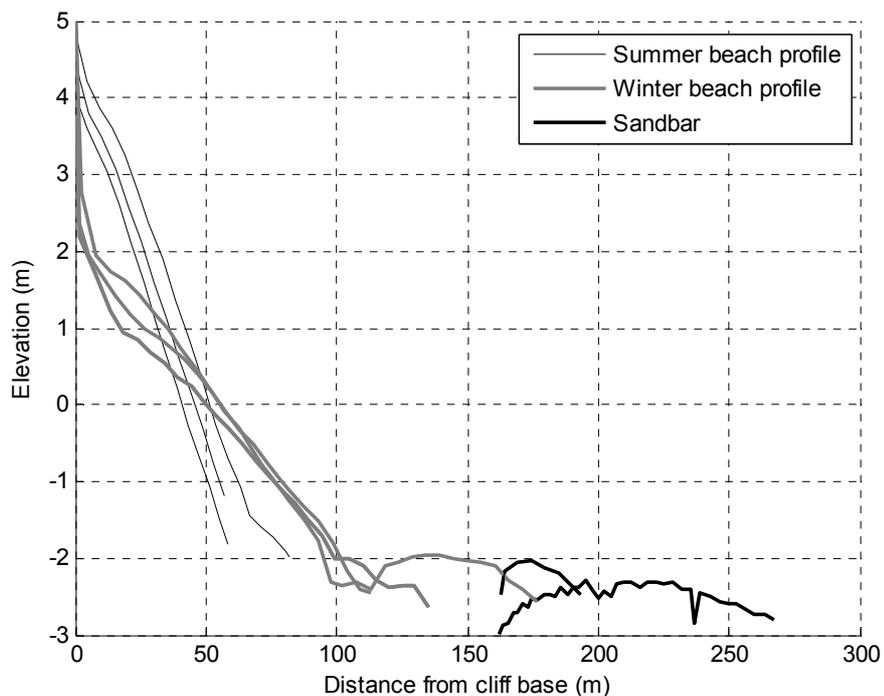
Figure 4.8. Surveyed beach profiles at Easington.

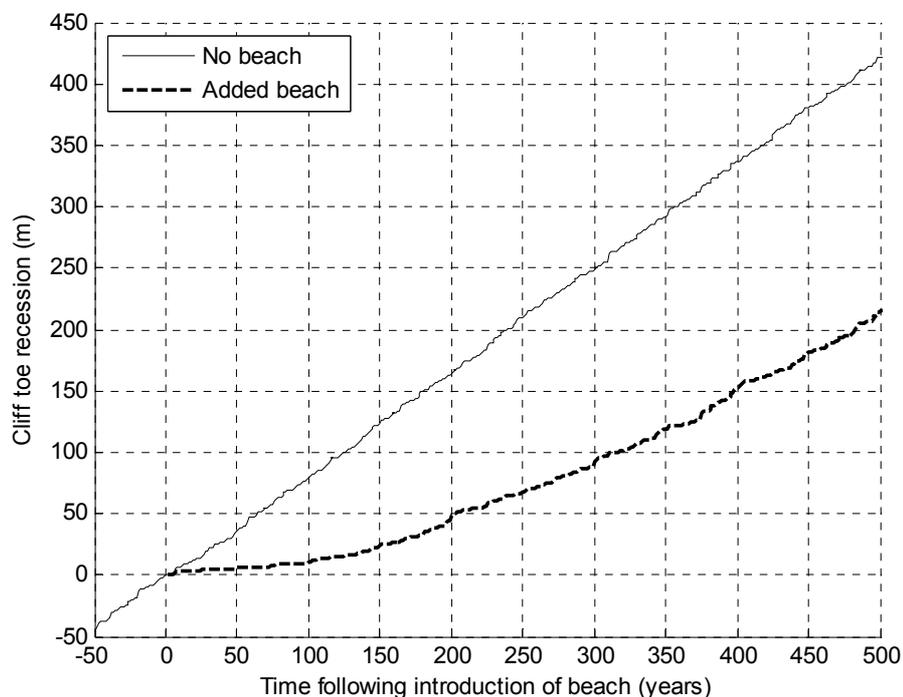
Figure 4.10. Shoreline recession with and without a beach.

Following introduction of a beach, the shoreline (measured by the cliff toe/upper platform junction) recession rate stopped initially, but then increased again over time. This was caused by the introduced beach material becoming progressively thinner and more widely dispersed across the profile. The benefits of (one-off) beach replenishment therefore were shown to diminish with time. A critical issue associated with this, therefore, is whether replenishment has any residual influence on the longer-term recession rates once its shorter-term benefits are expended. Through further model testing it was demonstrated that a highly non-linear relationship existed between beach volume and long-term recession rate. This means that engineering measures to increase beach volume will only have a lasting effect if the introduced volume is above a certain threshold, which is site-specific and dependent on tidal range, wave conditions and sea level rise.

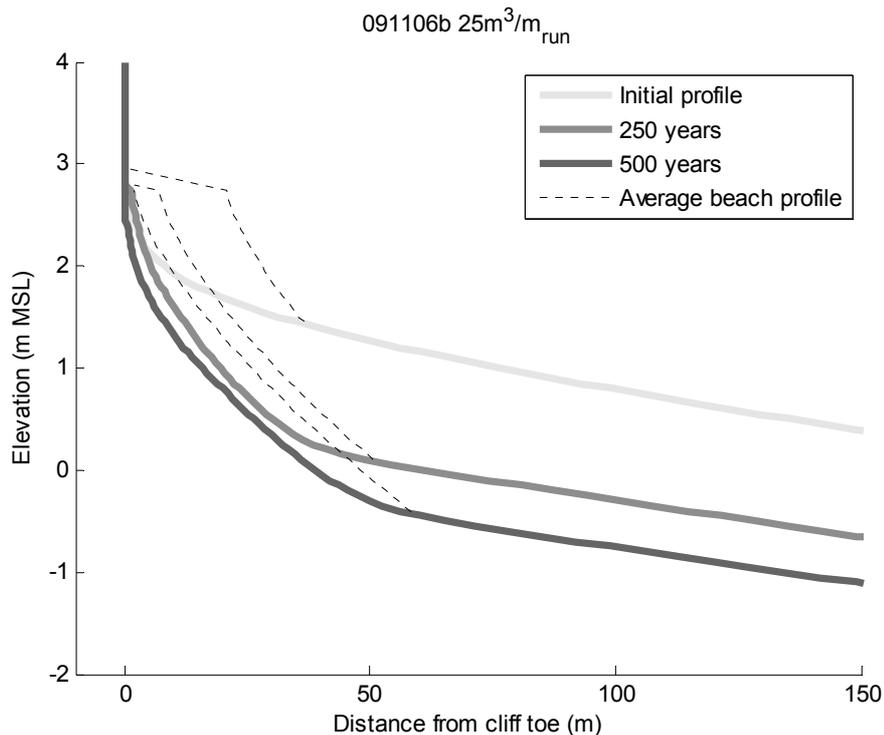
Figure 4.11. Shore profiles at three stages following the introduction of a beach (horizontally aligned by cliff toe).

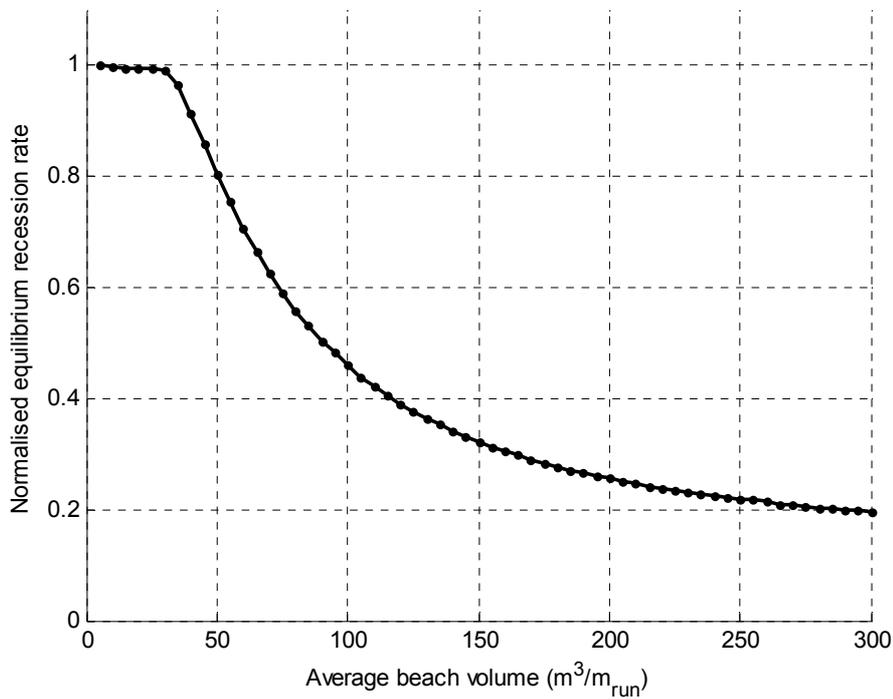
Figure 4.12. Relationship between (normalised) equilibrium recession rate and beach volume.

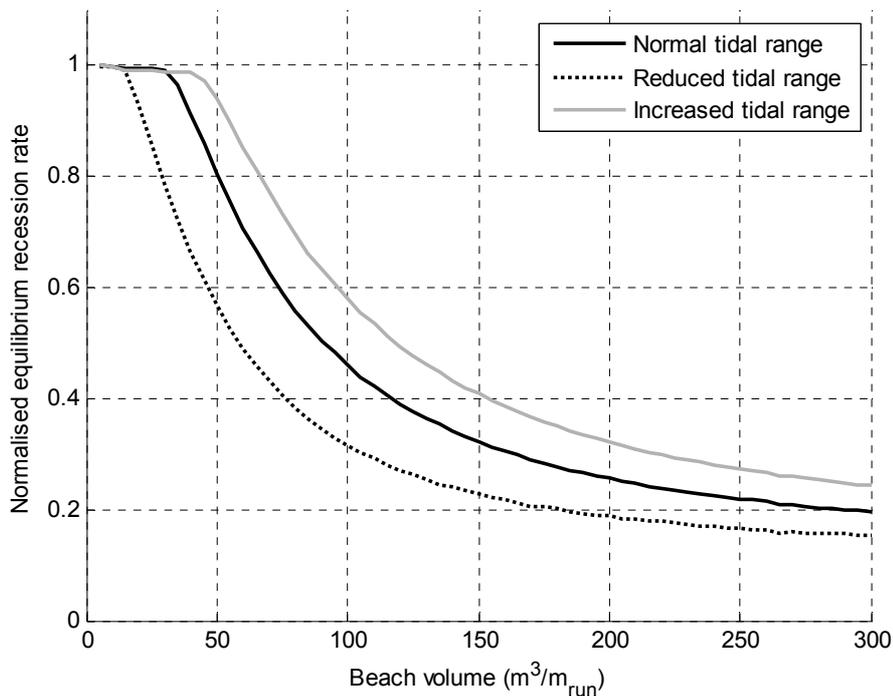
Figure 4.13. Relationship between (normalised) equilibrium recession rate and beach volume for three tidal ranges
