Understanding and Predicting Beach Morphological Change Associated with the Erosion of Cohesive Shore Platforms

R&D Technical Report FD1926/TR

Produced: December 2007

Author(s): Royal Haskoning, British Geological
Survey, University of Sussex, Newcastle University

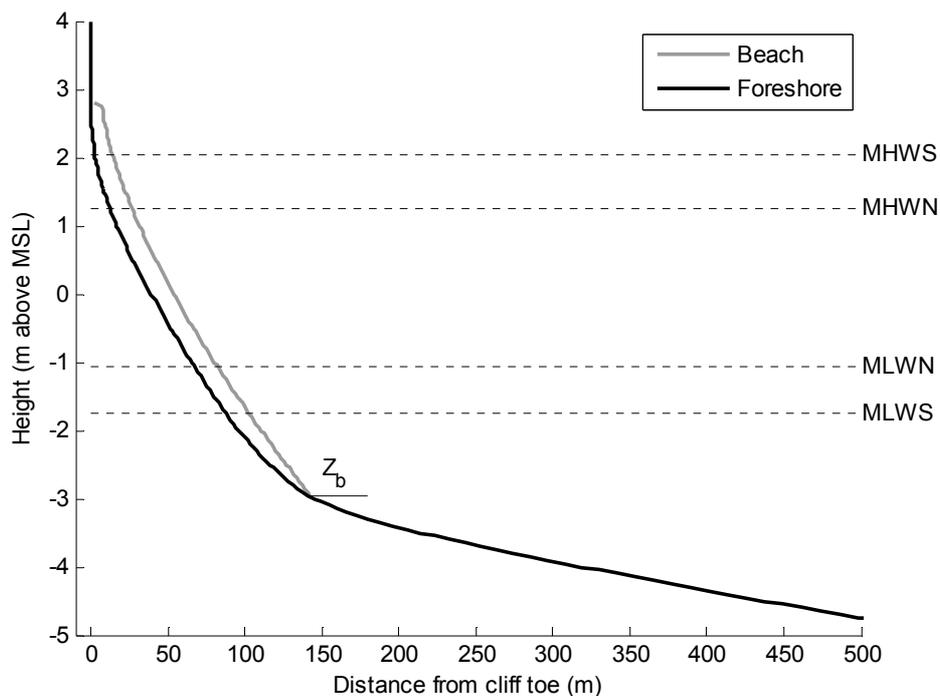
Figure 4.14. Definition of Z_b

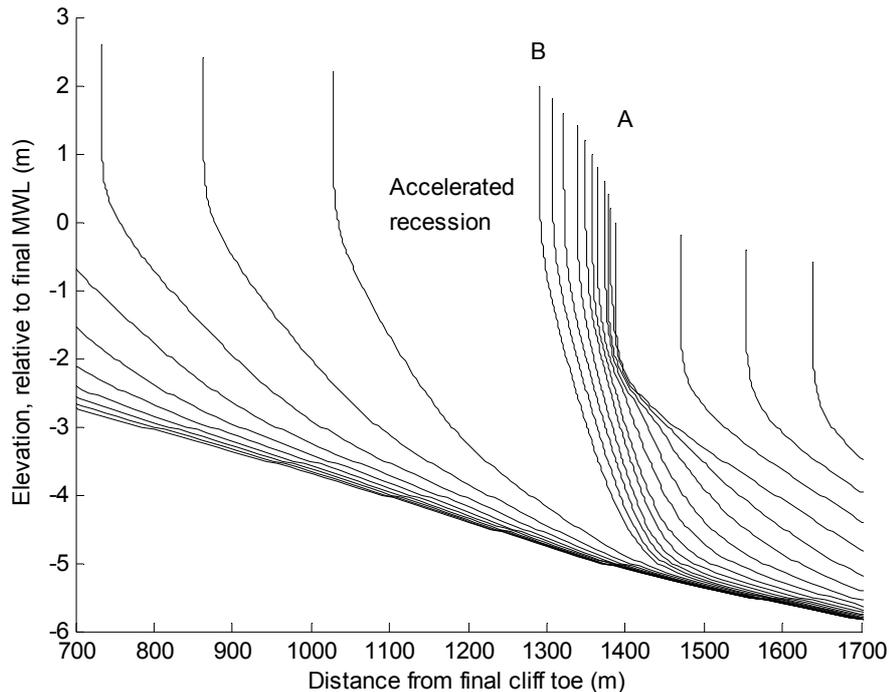
Figure 4.17. Model shore profiles in 100 year timesteps before, during and after the temporary beach nourishment.

Further model tests revealed that a decision to cease nourishment or allow groynes to fail, leading to reduced beach volumes, will result in an initially rapid rate of shoreline recession (i.e. 'catch-up'), with rates gradually returning over time to antecedent values. Consequently in these cases, the intervention works have no longer-term residual benefit once stopped or removed.

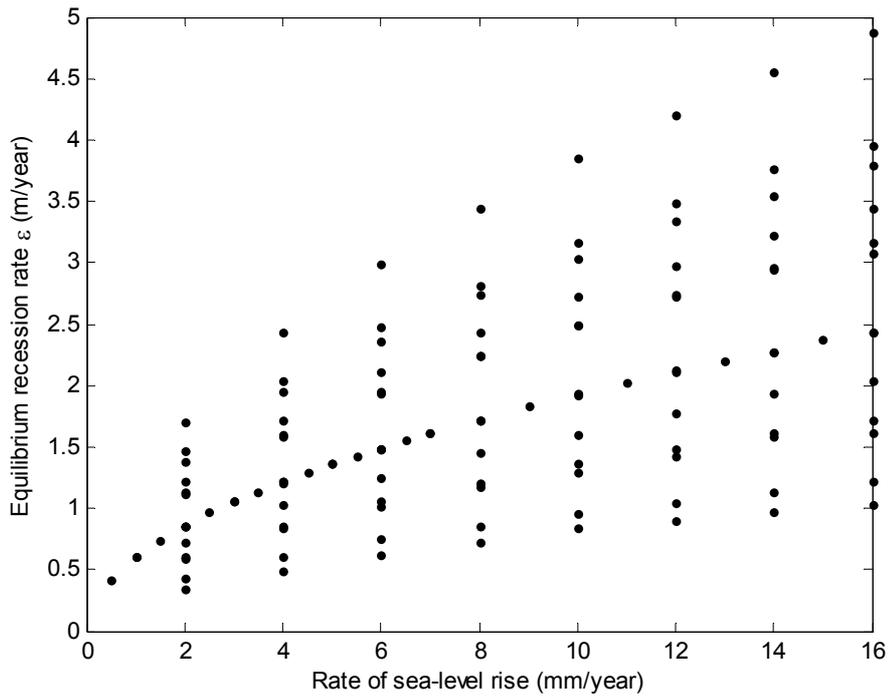
Figure 4.19. Equilibrium recession rates of the parameter tests.

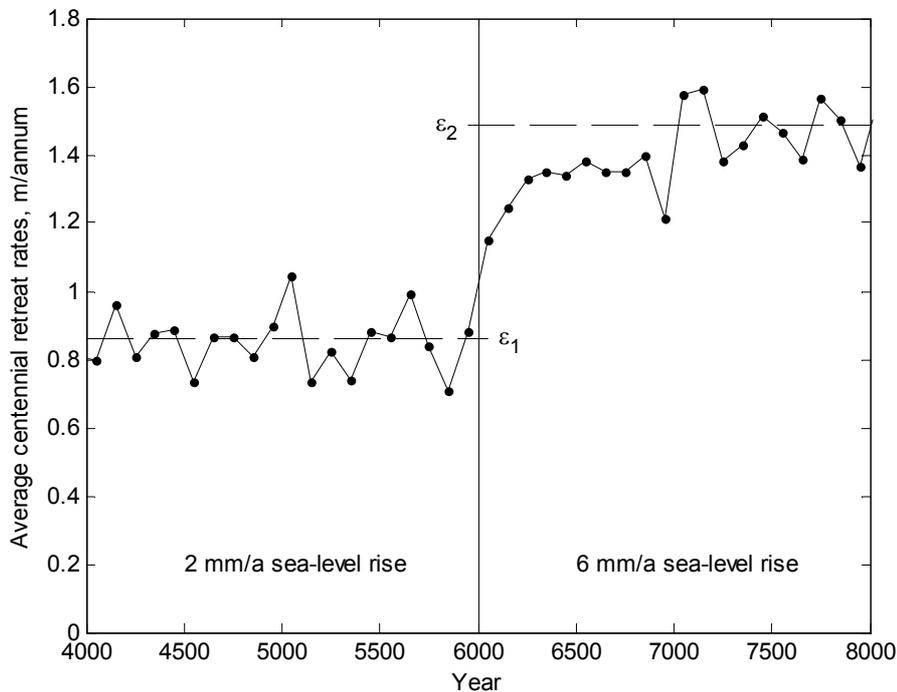
Figure 4.21. Example model recession rates before and after a step change in sea-level rise from 2mm/a to 6mm/a at 6000 years (averages of 100 year segments).

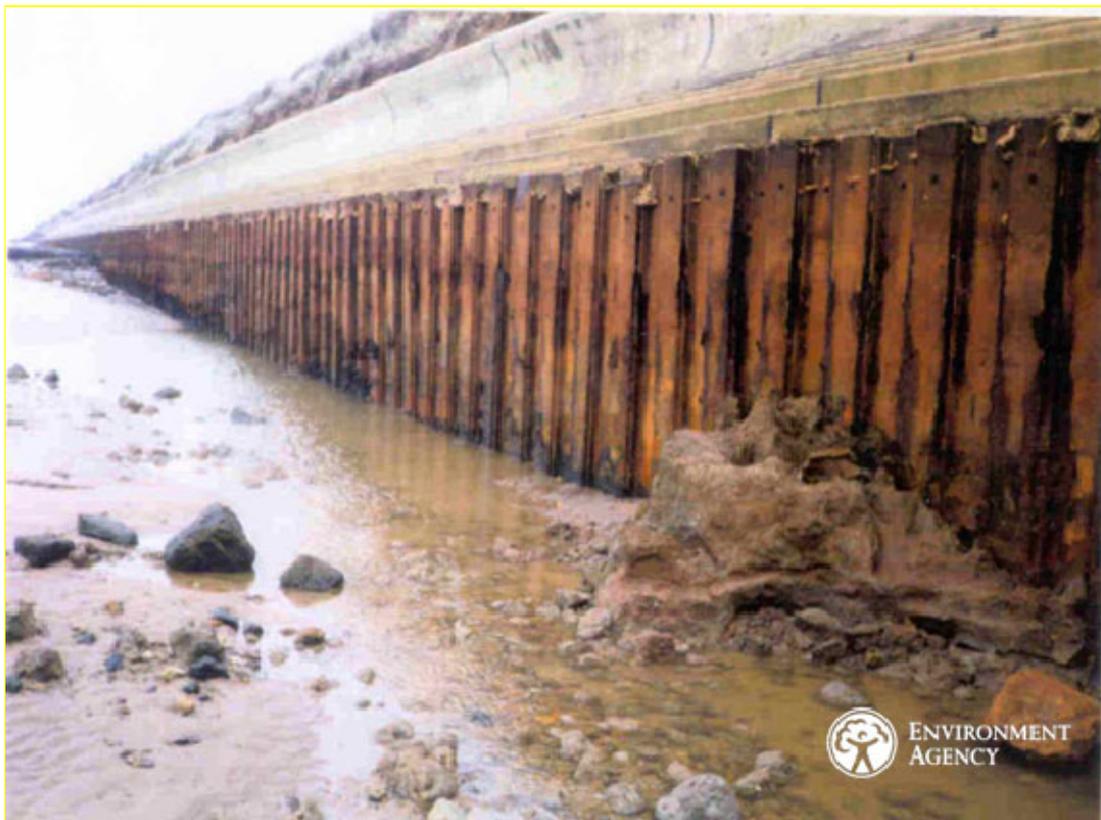
Figure 5.1 Exposure of Sheet Piling at the Toe of a Seawall

- Increased wave loading on the defence structures as the water depth in front of them increases, due to both platform downwearing and sea level rise; and
- Decreased structural stability and increased risk of undermining of the foundations of the defence structures; and
- Narrowing of the intertidal zone, potentially leading to its disappearance.
