Bevern Stream

The River Ouse Project Report No. 9

University of Sussex

University of Sussex 2017

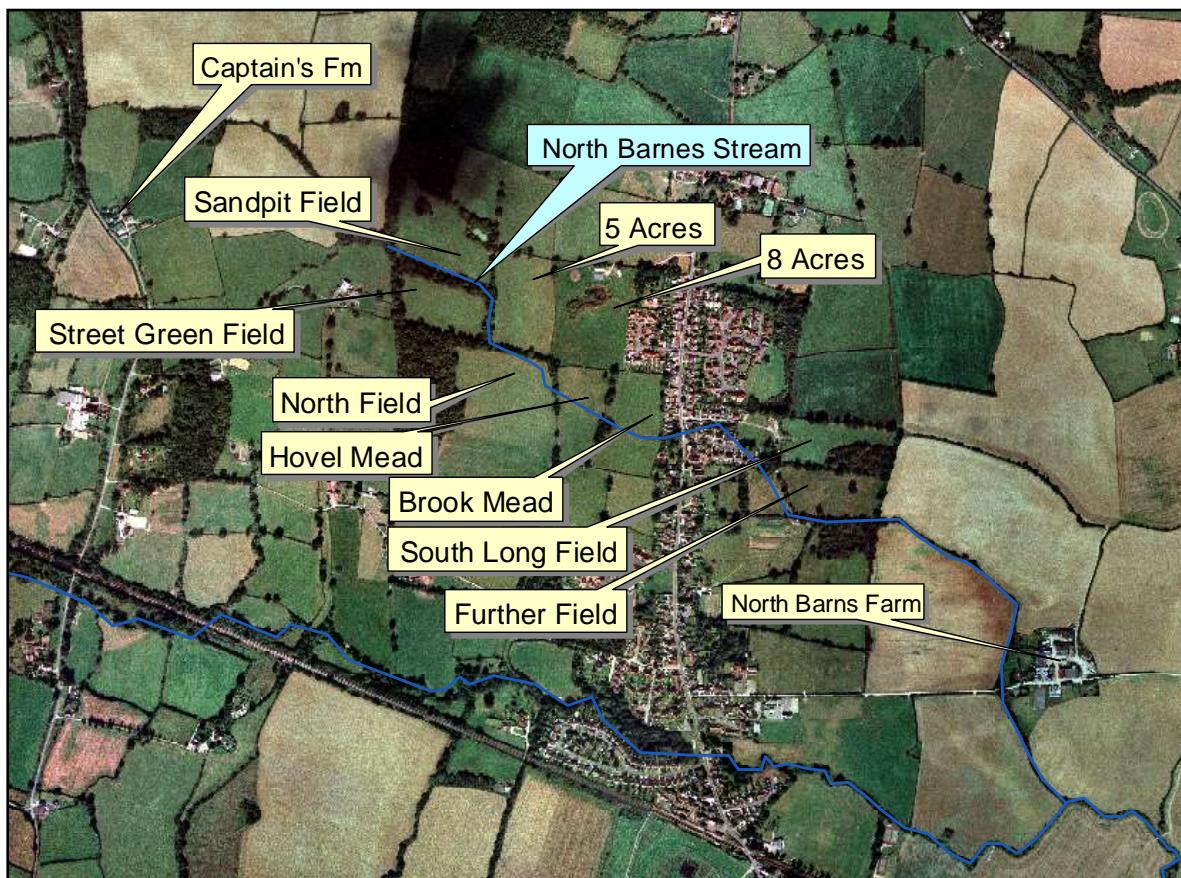
Figure 7. Plumpton Green Meadows.

North Barnes Stream rises in meadowland to the east of Plumpton Green and flows through a series of relatively species-rich, semi-improved meadows, which have been grazed by sheep and, occasionally, beef cattle, for many years. Sheep were present on 30 January 2016 when the stream had flooded into parts of Five Acres and Eight Acres (Figure 7 and 8).

At the time of the Tithe survey (1841) the stream flowed diagonally across Five Acres but has since been channelled into ditches on the west and south sides. In 1841 Street Green Field, Eight Acres and North Field were arable while Sandpit Field, Hovel Mead and Brook Mead were pasture. By 1931 the map prepared for the Land Utilisation Survey of Britain shows all the meadows as permanent pasture. Most of the fields have not been ploughed since 1945 and have been grazed by livestock, mostly by sheep. No chemical fertilisers have been used and in general the fields have been left to grow a mix of native grass and broadleaf herbs (Millum, 2006). Millum (2006) recorded 22 species in Street Green Field including Adder's-tongue (*Ophioglossum vulgatum*), Ragged-robin (*Lychnis flos-cuculi*), Red Clover (*Trifolium pretense*), Common Sorrel (*Rumex acetosa*), Common Bird's-foot-trefoil (*Lotus corniculatus*), Meadow Vetchling (*Lathyrus pratensis*), Crested Dog's-tail (*Cynosurus cristatus*) and Sweet Vernal-grass (*Anthoxanthum odoratum*). The Plumpton Wildlife Habitat Survey recorded this field as species-rich (Hutson, 2011). We were refused access for a

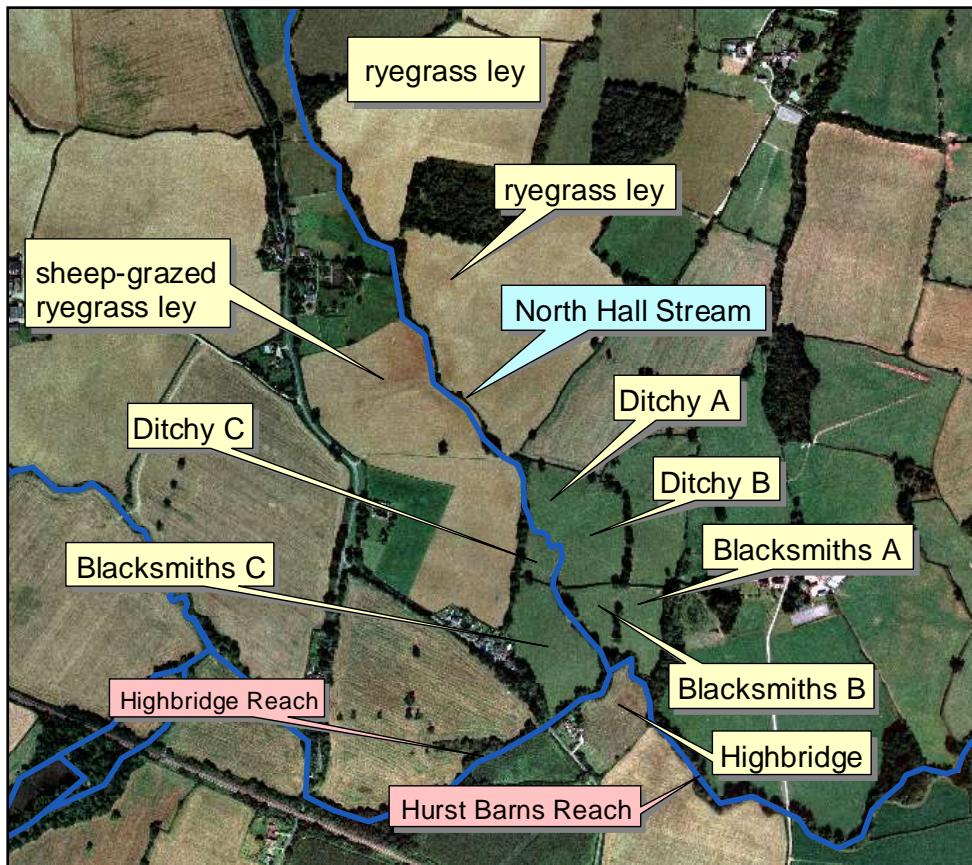
Figure 15. North Hall Stream and confluence with main Bevorn at start of Hurst Barns Reach.

North Hall Stream flows through fields that are mostly managed as short-term grassland ley before reaching the northern corner of Ditchy. Ditchy A (TQ381161) and Ditchy B (TQ380162), Figure 15) rise up steeply from North Hall Stream on the eastern side with Ditchy C (TQ380161), Figure 15) rising up similarly on the western side. All 3 areas of Ditchy were surveyed on 15 June 2016 and showed an interesting gradation towards more species-richness from A to C.

Down-stream from Ditchy, North Hall Stream flows between Blacksmiths C and Blacksmiths B (Figure 15), which were two separate fields in 1838 (Tithe Survey) but are now connected by a wide cattle bridge over the stream. Similarly Blacksmiths B was separated from Blacksmiths A by a hedge but all that remains are three large oaks and the three former fields are grazed by stock as one field. Until 2010, grazing was by sheep, but for the last 2 years sheep have grazed only in winter with cattle grazing in the summer (oral history interview with the farm manager, January 2017). They are now grazed extensively by four British White cattle. Blacksmiths C was cut for hay in 2002/3. The small flatter area alongside the Bevern had much more Perennial Rye Grass (*Lolium perenne*), less Creeping Buttercup (*Ranunculus acris*) and more Meadow Foxtail (*Alopecurus pratensis*) than the rest of the fields. Blacksmiths fields are not marked in the 1931 Land Use Survey, but in 1838 all three areas were arable. On the south side, Blacksmiths is bounded by the main Bevern Stream: Blacksmiths C by Highbridge Reach and Blacksmiths B and A by Hurst Barns Reach (Figure 15).

Blacksmiths A (TQ382160), B (TQ381160) and C (TQ380159), Figure 15. Blacksmiths A and B, surveyed as one field on 30 June 2016, were MG7b *Lolium perenne-Poa trivialis* ley (Perennial Rye Grass – Rough Meadow Grass ley), but considerably more species-rich than the average with 11 (10-13) species per sample. Blacksmiths C, surveyed as a separate field on 30 June 2016 was also MG7b and even more species-rich than Blacksmiths A and B with, 12 (9-14) species per sample. The three areas are presented together in the following table.
