# PLATFORM EROSION AT HOPE GAP

Compiled by Uwe Dornbusch (5-5-2006)

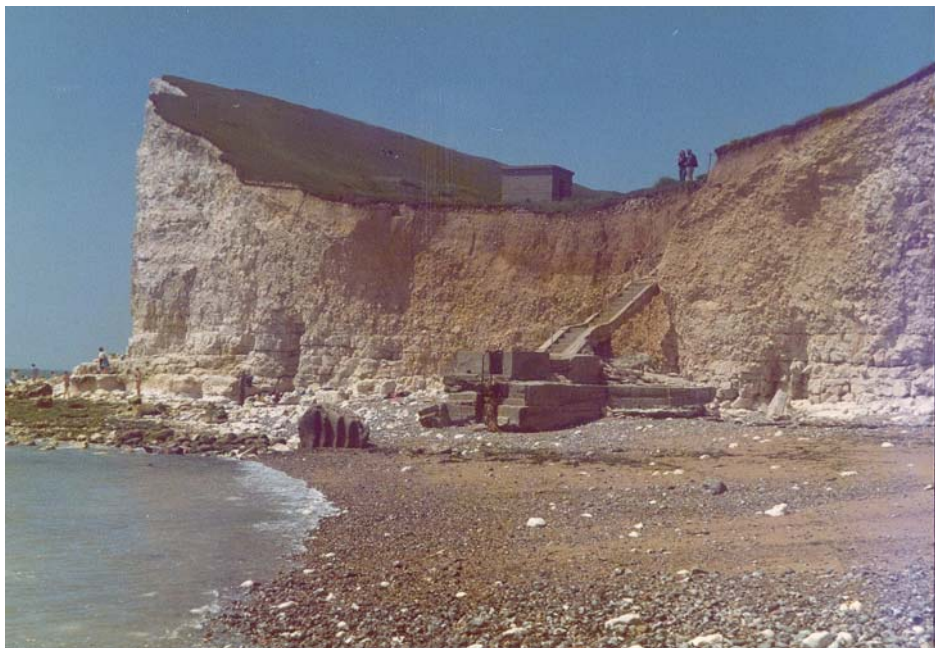
Figure 1: Old stairs at Hope Gap in 1979 (Lewes District Council)

The old stairs shown in Figure 1 were demolished in 1979 and new steps were built. For the demolition of the old steps and the excavation of the foundations for the new steps an

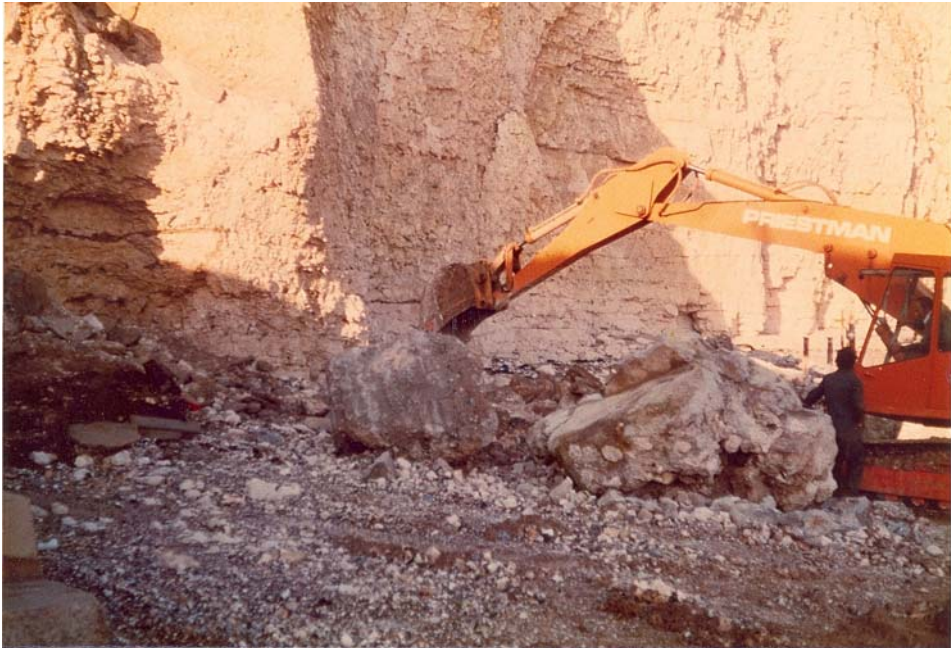
excavator was driven along the shore platform from Cuckmere Haven. The excavator was relatively small (Figure 2). The TVT can be seen in the photographs shown in Figure 3.

Figure 2: Image of the excavator used in 1979 demolishing the old stairs (Lewes District Council)

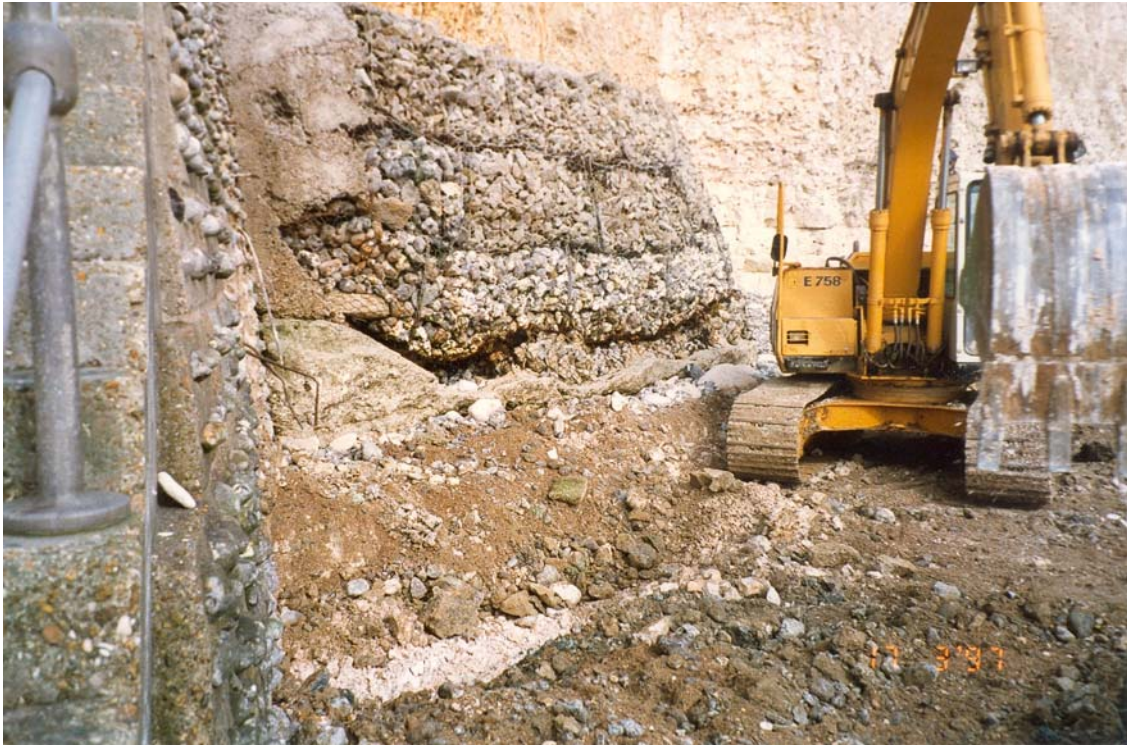
In 1997, it became necessary to repair and extend the gabions to the east of the steps. Again, an excavator had to be brought in via Cuckmere Haven to make the necessary excavations. The excavator was only slightly bigger than in 1979 ().

Figure 4: Excavator used in 1997 for the repair of the gabions to the east of the steps (Lewes District Council).
